Technical Service Bulletin

Topic	DIP Driver Assist Fault with DTC B200FF9, and/or Tailgate Latch Fault and/or additional Intermittent DTC B200000
Market area	Bentley: worldwide (2WBE), China 796 VW Import Comp. Ltd (Vico), Beijing (6796)
Brand	Bentley
Transaction No.	2080061/1
Level	EH
Status	Released for publishing
Release date	Feb 2, 2026

25MY Bentayga Series

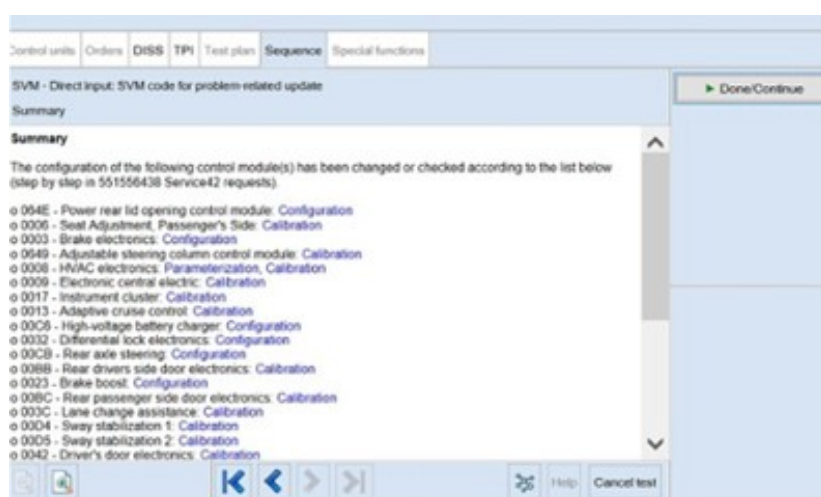
11. If the SVM code completes successfully, ODIS should display as per the image above.
