Technical Service Bulletin

OUE7 - Over-the-Air (OTA) Software Update (SW Level 3.8.11) Dealer Recovery Process - OTA Software Update Not Successful

Applicable Vehicles

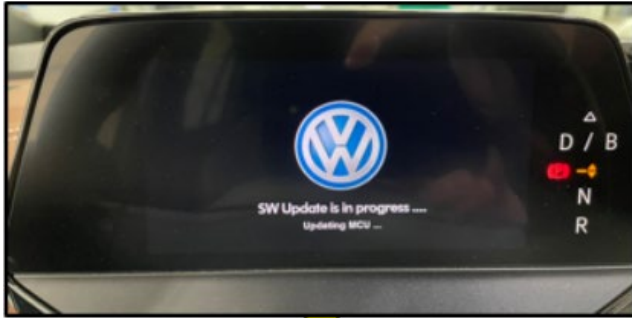
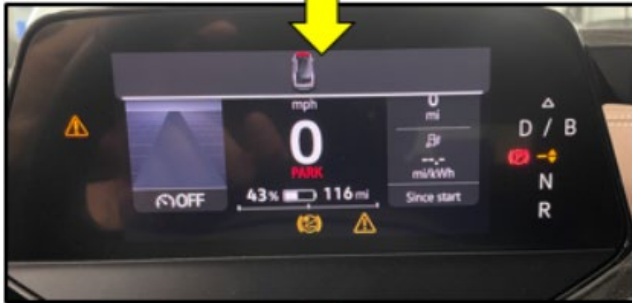
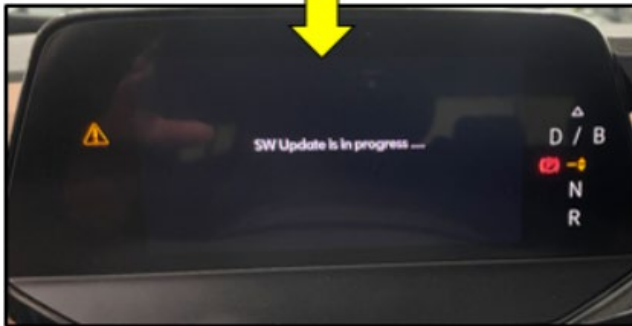
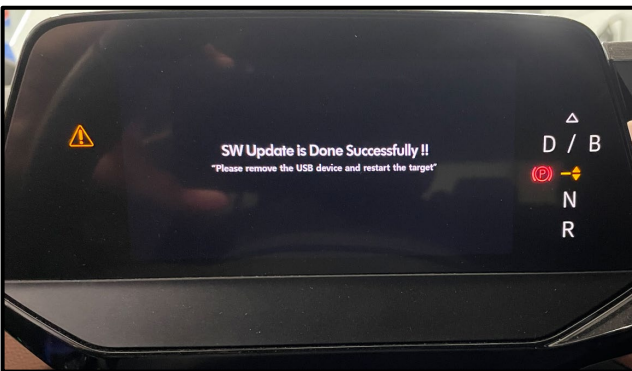
- The update will start on its own after about two minutes.
- During the update, the instrument cluster display will change multiple times.

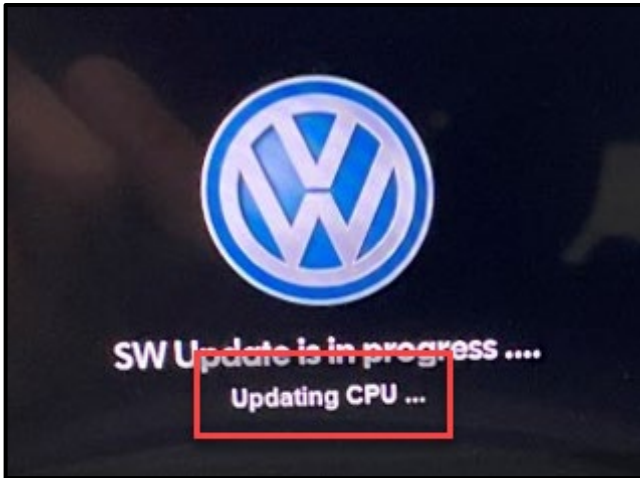
The instrument cluster may remain off, even though the update is complete. If the cluster is off after 40 minutes, cycle the ignition off and back on. The successful message should now appear.
