**SERVICE BULLETIN**

**APPLICABILITY:** 26MY Outback Models including Wilderness models

**NUMBER:** 15-335-25

**SUBJECT:** Reprogramming File Availability for Optimization of Gen 5 Denso CP25 Infotainment Systems

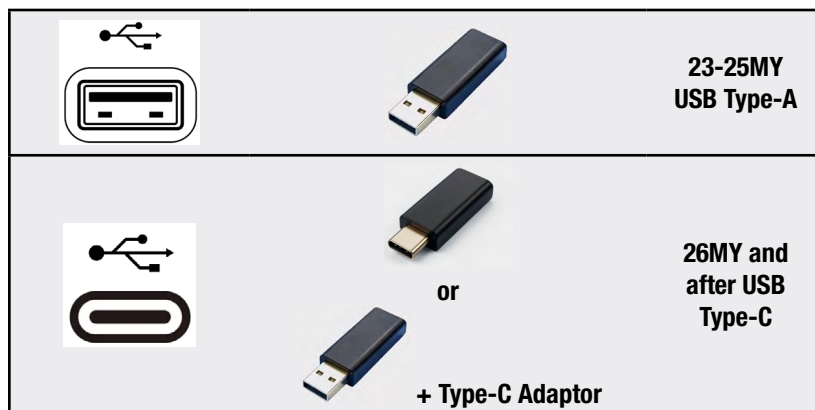
**NOTE: For 26MY and later vehicles use either a USB Type-C memory stick or a USB Type-A with a conversion adaptor to Type-C. The USB-A port is for power supply only and cannot be used to install the software update.**

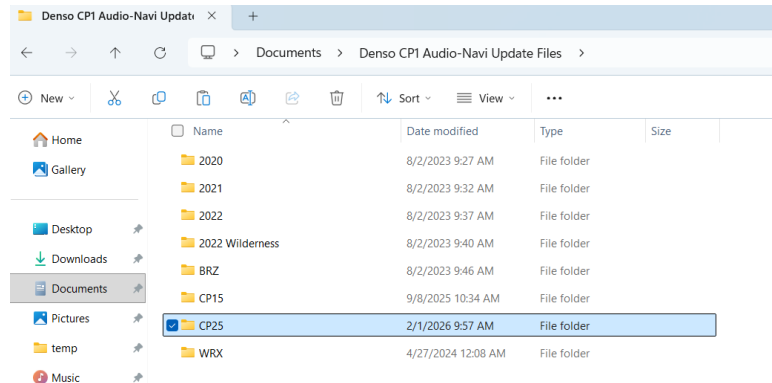
- Go to My Documents on the GUI screen click on the folder “Denso CP25 Audio-Navi Update Files” to display the list of available update files shown below.

**IMPORTANT:** Always confirm there is a correct folder. If not, the SDS notebook hasn’t been updated with the latest release. Please contact Nuspire to request they resend the update.”

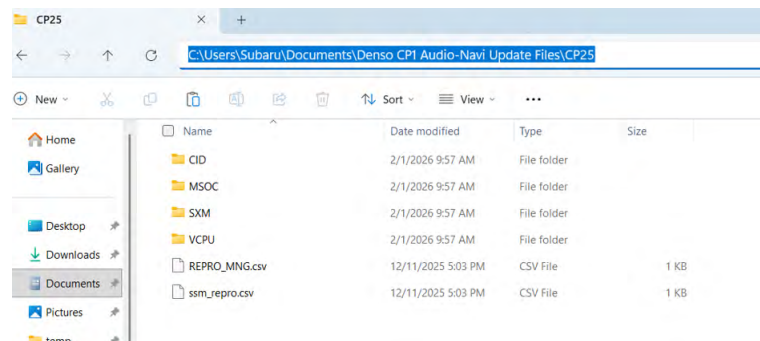
- **CAUTION:** After download is complete, **NEVER** change the file or folder names.
- Double-click on the required folder (for this example, select the file entitled “CP25”) and the update file will display as shown.

Select all folders and files and either copy / paste or click / drag them to the USB flash drive.

**IMPORTANT NOTE:** The update contains 4 folders and 2 files. When performing an update, the USB must contain the matching number of folders and files and all files must be replaced.

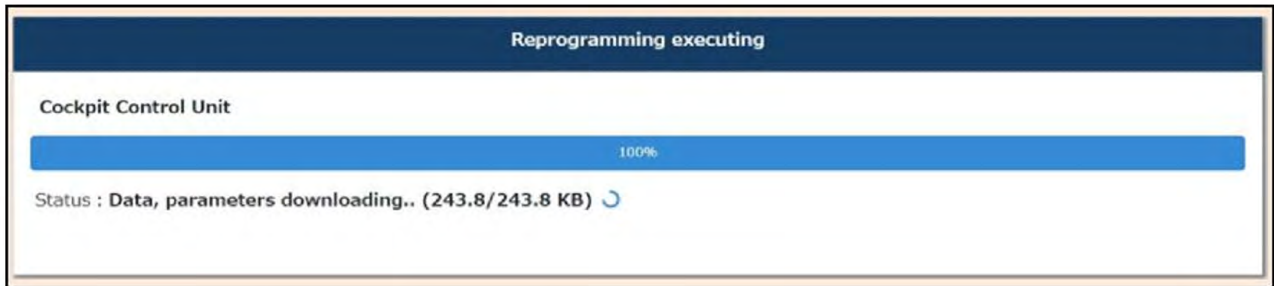
iv. The following progress bar will be displayed briefly (for a few seconds), and then it will quickly reach 100% and switch to the next screen.

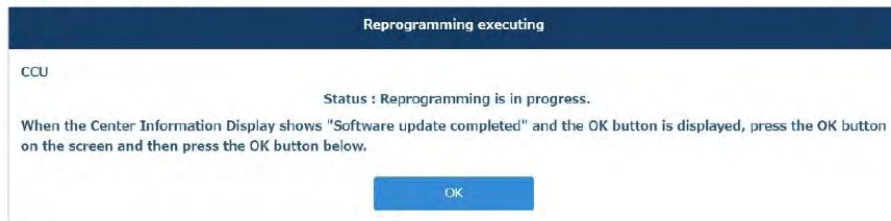
[SSM5 Display]

When the following screen is displayed, the software update starts within the CCU. The screen displayed on the CID will also switch. Wait until the CID screen displays [Software update completed].

**NOTE:** The CID screen transition takes approximately 3 minutes. Do not turn the ignition OFF until the process is complete. If the screen does not transition after waiting 5 minutes, please turn the ignition OFF-ON and try again.

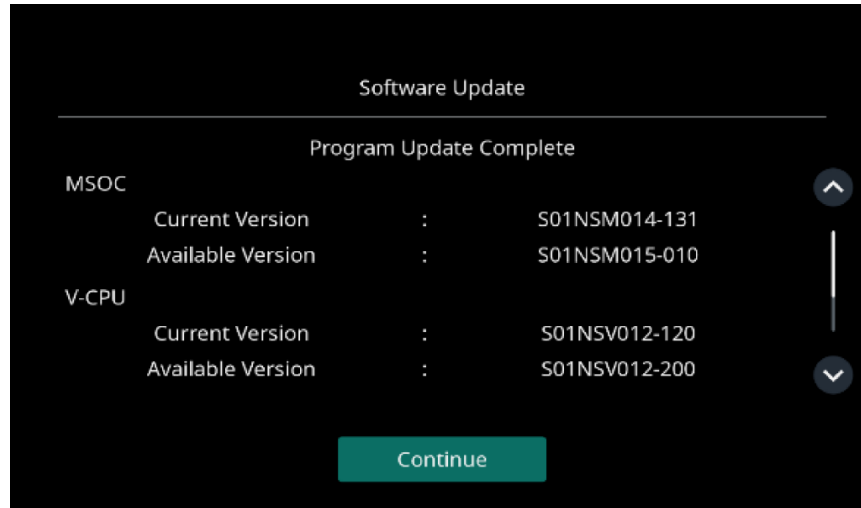
v. After “Software update complete” appears in the CID, click “Continue” on the SSM5 screen.

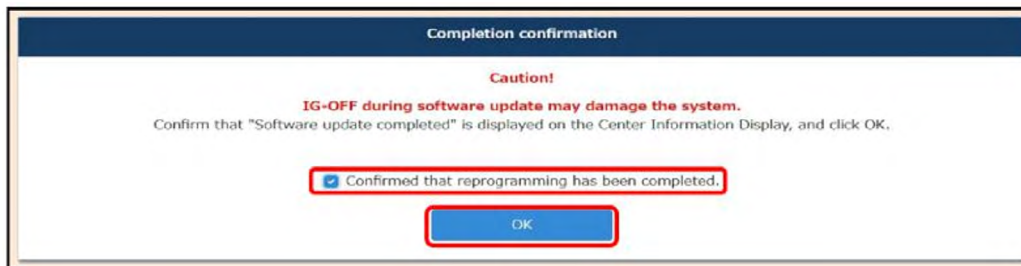
vi. Confirmation screen will be displayed as shown below. Check the box and click [OK].

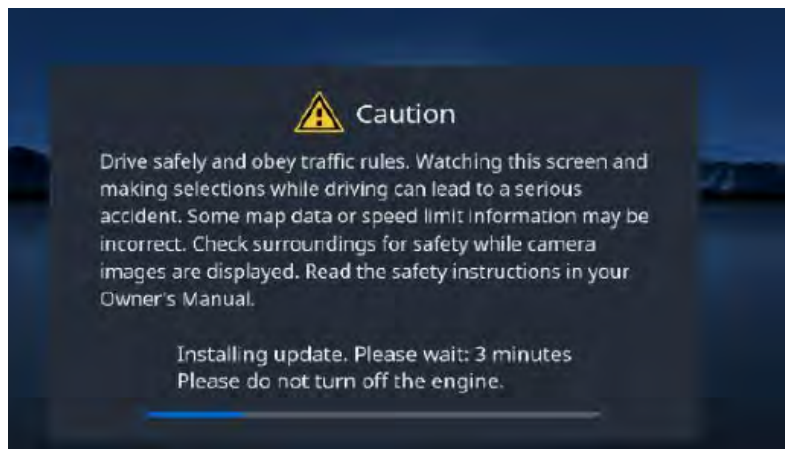
NOTE: The CID screen transition occurs between steps (vi) and (viii). After turning the ignition ON, the following screen will appear on the CID.

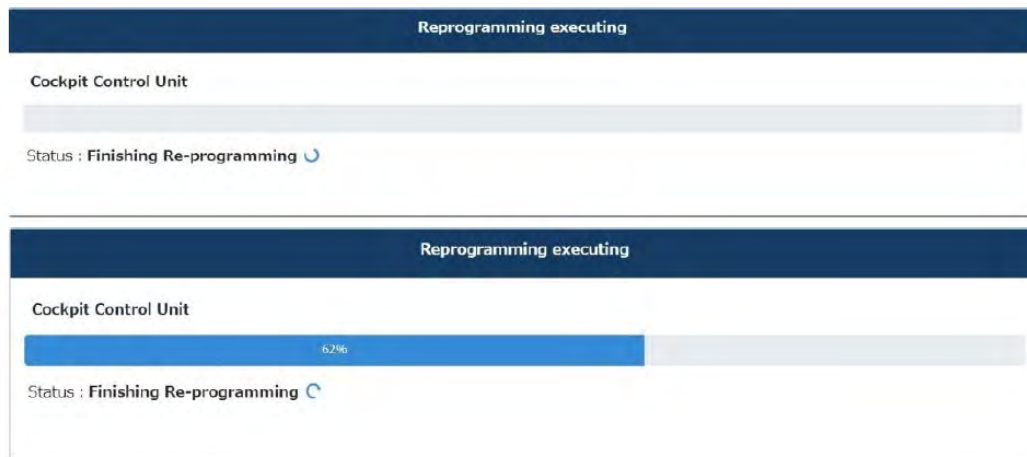
ix. While checking if the software update has been completed correctly, a progress bar will be displayed. Wait until it reaches 100%.

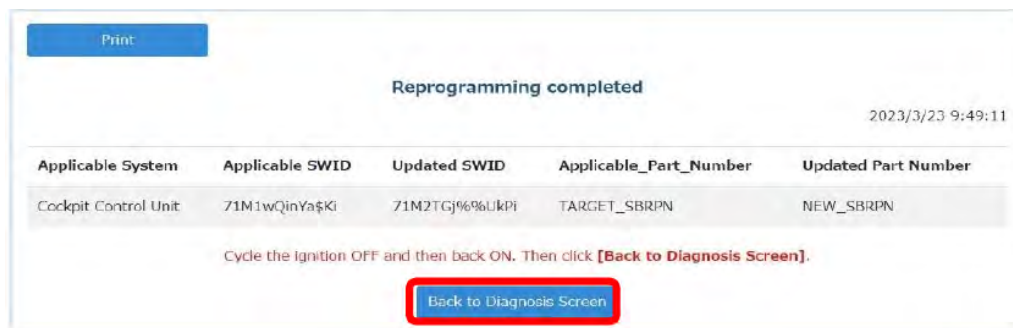
x. If the software update has been completed correctly, it will display “Reprogramming completed”. Remove the USB drive from the vehicle and click on “Back to Diagnosis Screen”.
