**SERVICE INFORMATION BULLETIN**

**APPLICABILITY:** All Models **NUMBER:** 10-105-25R  
**SUBJECT:** New Procedure and Fail Code for First-Time Undetected A/C Refrigerant Leaks **DATE:** 05/01/25  
**REVISED:** 02/06/26

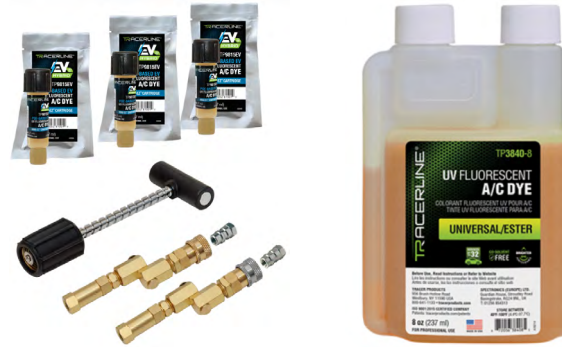
## TOOL REQUIREMENTS:

Subaru of America requires the use of Traceline dyes to assist in diagnosing refrigerant leak concerns. Traceline TP3840 can be sourced from many local auto parts suppliers. Traceline TP9815 and the required tools can be purchased at [www.subaruretailersolutions.com](http://www.subaruretailersolutions.com).
