**SERVICE PROGRAM BULLETIN**

**APPLICABILITY:** 2023-2024MY Legacy & Outback **NUMBER:** WRB-26  
**SUBJECT:** Incorrect FOTA Distribution for Data Communication Modules **DATE:** 02/11/26

The subject vehicles were incorrectly linked with their corresponding software versions during a FOTA distribution, which may have caused telematics service functions to become unavailable.

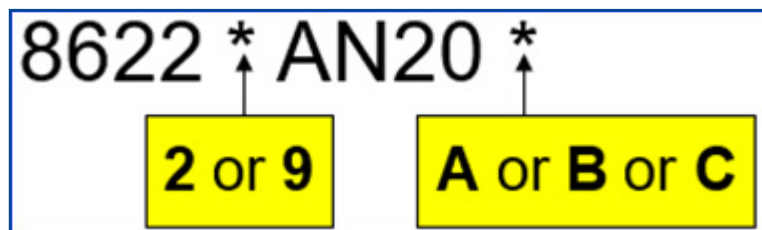
**NOTE:** Details for parts indicated by an asterisk in the DCM part numbers are shown below.

**Fifth Digit:** 2 indicates the DCM was installed by the factory. 9 indicates the DCM is a replacement part.

**Tenth Digit:** A,B, and C indicates the DCM version.

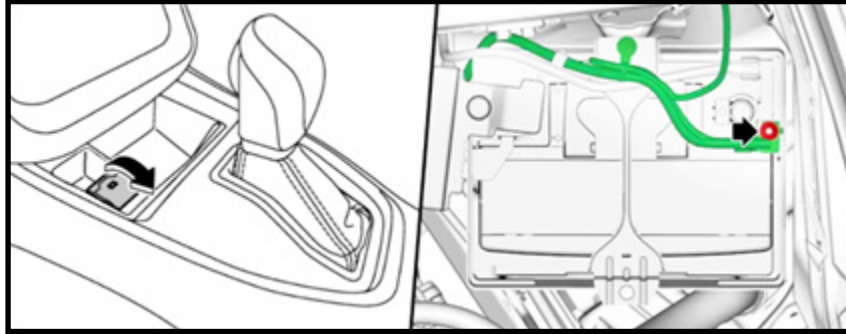
**STEP 2:** Refer to the applicable Service Manual and review: General Description > Repair Contents > Action required before & after Battery Disconnect. Additionally, record any stored seat position(s) before proceeding. Relearn any seat position memory after work is complete. If the power rear gate (PRG) height has been customized, that position must also be noted and relearned. **CARFULLY** disconnect the ground terminal from the battery sensor. Once disconnected, wait at least 60 seconds before starting any further procedures.

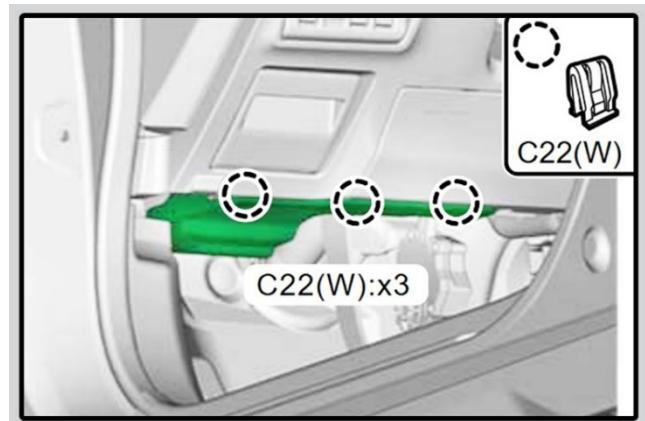
**STEP 3:** Release the three mounting clips securing the driver side front under cover. Once released, remove the cover.

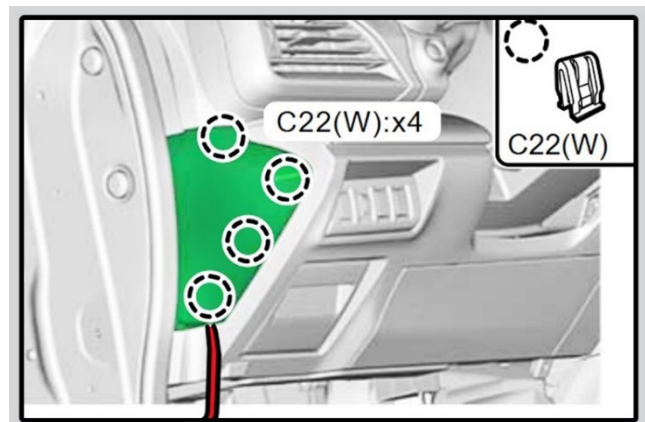
**STEP 4:** Release the four mounting clips securing the driver side instrument panel side cover. Once released, remove the cover.

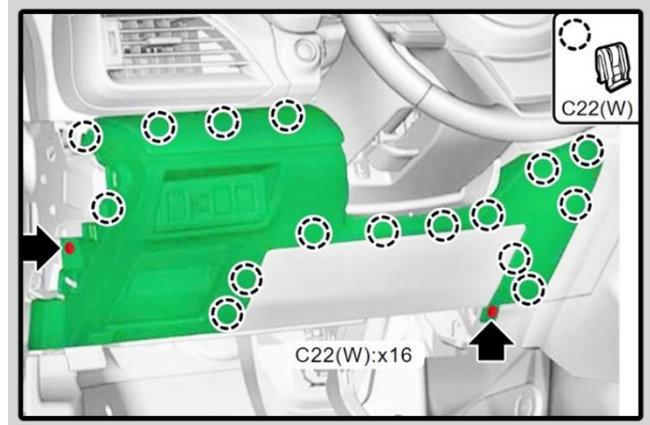
**STEP 5:** Remove the two mounting screws securing the lower driver cover. Once removed, pull the cover in a straight direction toward the rear of the vehicle to release the mounting clips. Disconnect all electrical connections. Remove the lower driver cover from the vehicle.

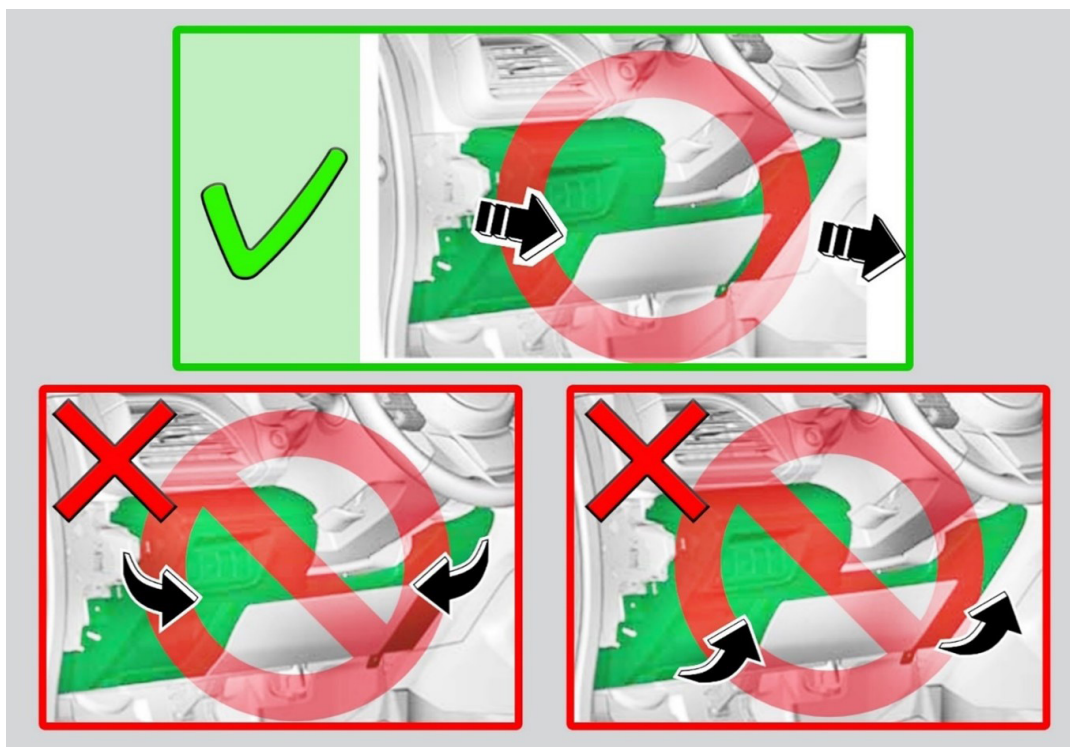
**CAUTION:** When removing the lower driver cover, **ALWAYS** pull the cover in a straight direction. Pulling in a lateral or upward direction may cause damage to the lower driver cover.

**CAREFULLY** disconnect all electrical connections. Remove the lower driver cover.

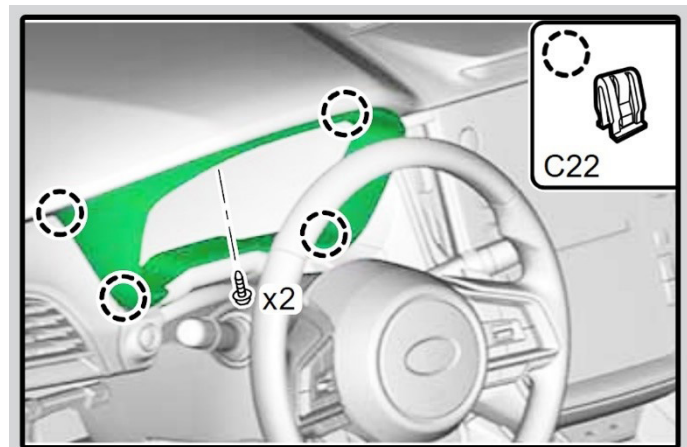
**STEP 6:** Release the steering column lock, adjust the steering wheel to the lowest level and pull it outward to its full extent. Lock the steering in this position. Using a small screwdriver, remove the two mounting screws for the combination meter trim panel. Release the four mounting clips securing the panel. The panel can then be removed.

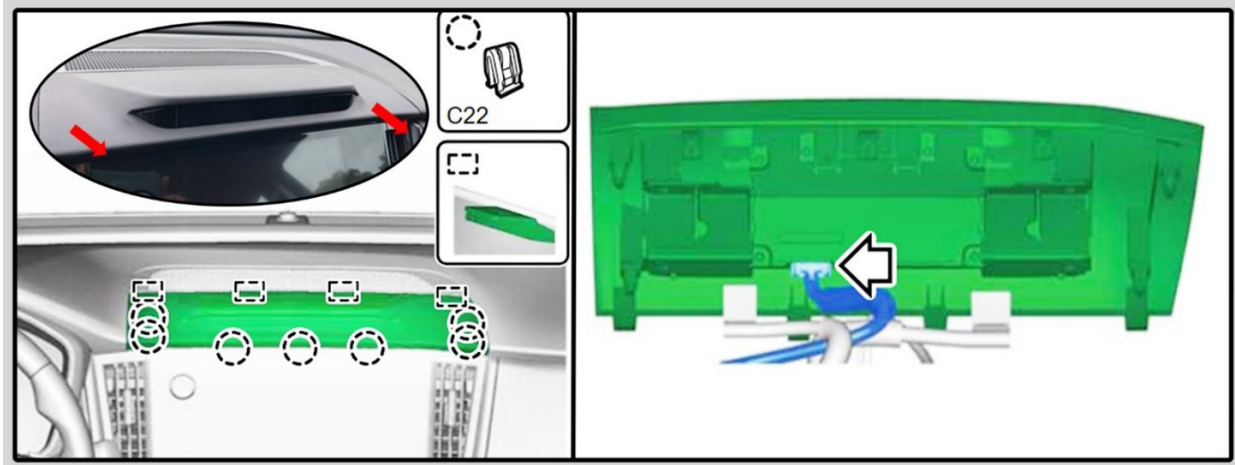
**STEP 7:** Release the 7 mounting clips from the driver monitoring unit. Once released, pull the unit toward the rear of the vehicle in a straight direction. Release the electrical connection and remove the unit from the vehicle.

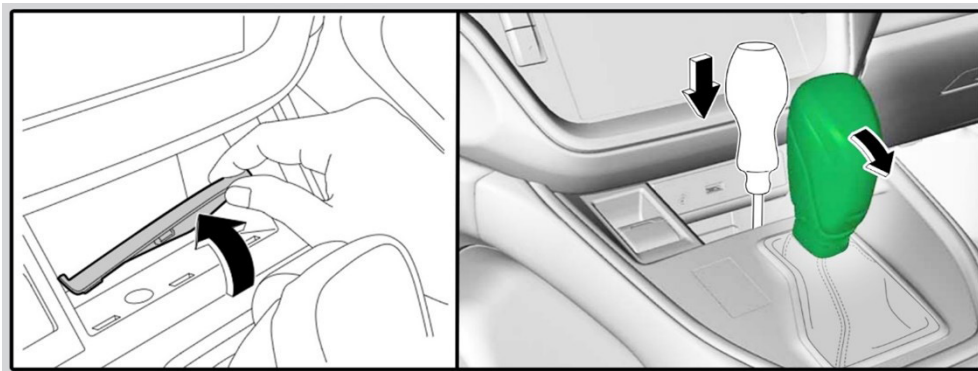
**STEP 8:** Remove the rubber grip mat from the center tray. Using a screwdriver or suitable tool, release the shift lock and shift the lever into the neutral position.

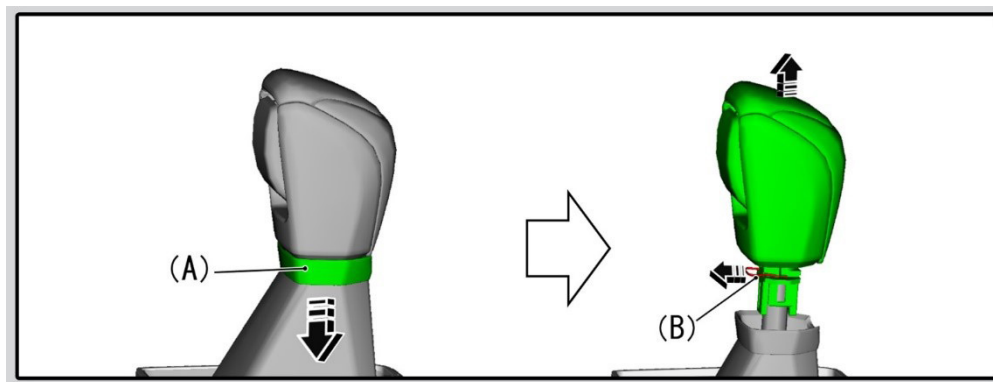
**STEP 9:** Detach clamp (A) from the shift knob. Release clip (B) from the shift knob and remove the knob from the lever. ALWAYS maintain proper shift rod alignment when reinstalling (detailed information can be found in the September 2021 TechTIPS article).

**CAUTION:** Be careful not to lose the clip.

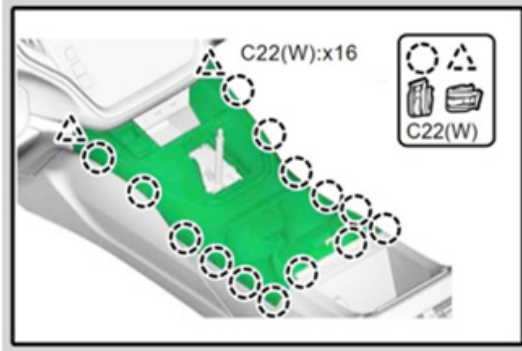
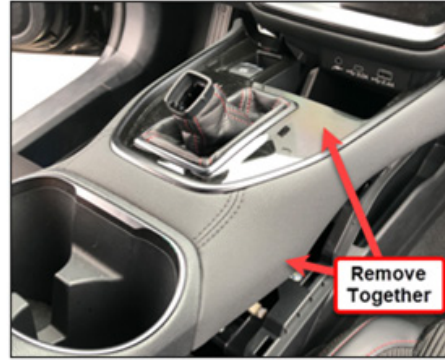
**STEP 10:** Release the center console cover mounting clips and remove the cover with the shift boot/bezel attached.

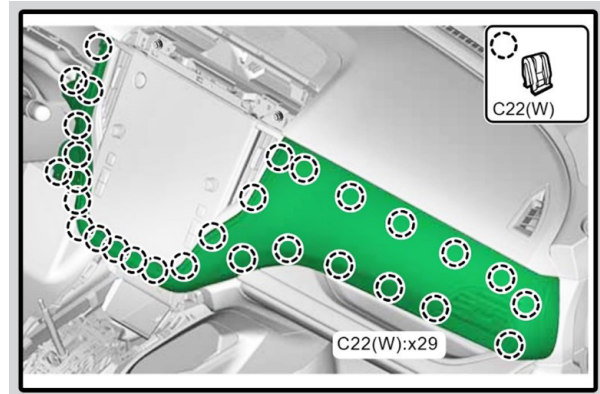
**STEP 11:** Release the mid passenger ornament panel mounting clips and remove the panel.

**NOTE:** Vehicles equipped with push button start will require the push button ignition switch to be disconnected prior to removal.

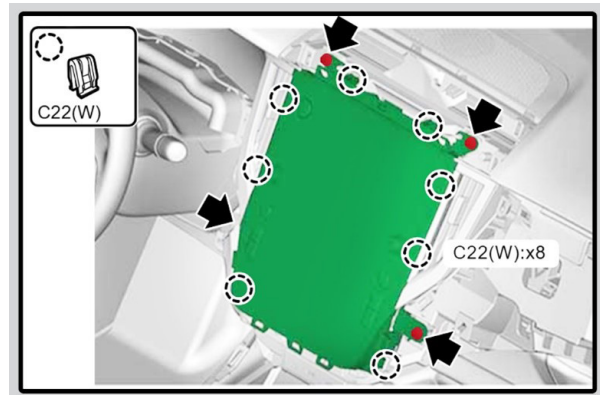
**STEP 12:** Remove the four screws securing the Center Information Display (CID) assembly. Release the mounting clips and **CAREFULLY** pull the assembly out far enough to disconnect the electrical connections. Once all the connectors are disconnected, the CID assembly can be removed.

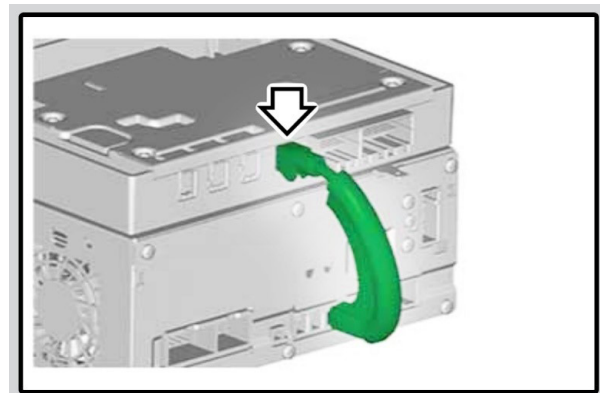
**STEP 13:** Place the CID assembly on a secure flat surface. Disconnect the Data Communication Module (DCM) cable.

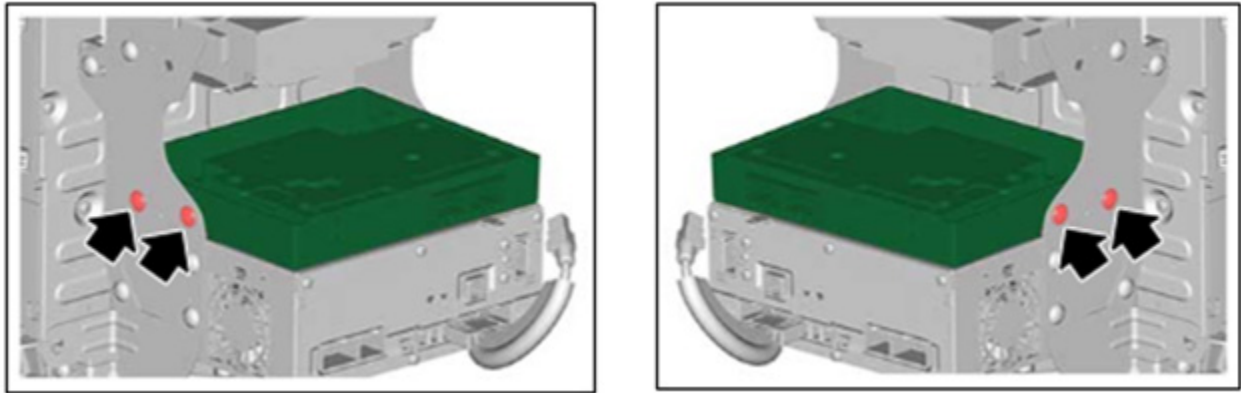
**STEP 14:** Remove the four DCM mounting screws located on the left and right side. The DCM can then be removed.

**CAUTION: DO NOT apply any impact to the CID assembly or DCM during this process.**

**STEP 15:** Inspect the part number located on the DCM label. Refer to the judgement criteria shown below.

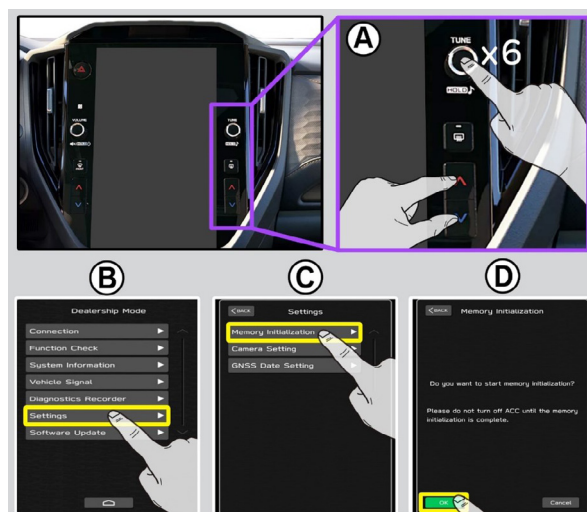
**STEP 17:** To restore CID assembly to its normal operating state, please perform a memory initialization by following the steps below.

- With the ignition on or the engine running, **Press and Hold** both the upper and lower temperature control buttons on the **Right** side, and simultaneously press the tuning/scroll knob **Six Times**. Then release all buttons to display the dealer mode menu.
- Select “**Settings**”.
- Select “**Memory Initialization**”.
- Select “**OK**” to complete the memory initialization.
