PRODUCT ENHANCEMENT PROGRAM

APPLICABILITY: 2023MY Solterra

NUMBER: EEA-23R

SUBJECT: 2.5 Product Enhancement Reprogramming File Availability

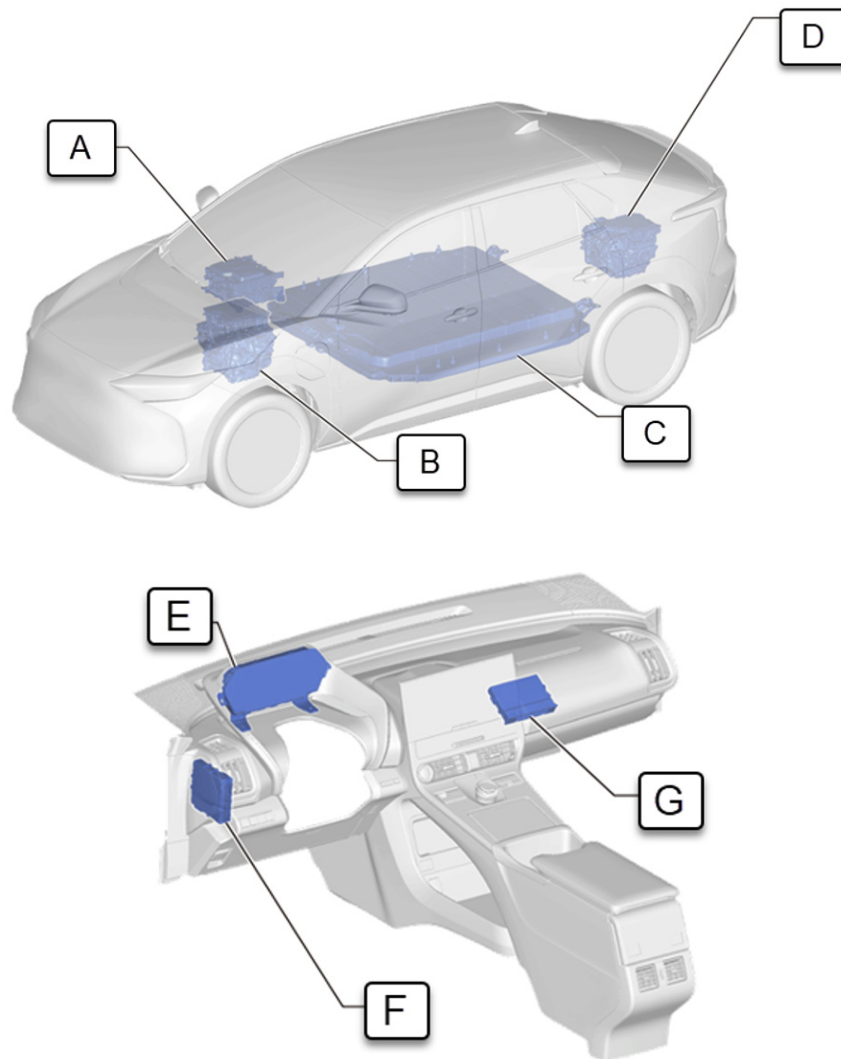
COMPONENT CONFIGURATION:

A	PWC ECU (ELECTRIC CONVERTER UNIT ASSEMBLY)	B	MG ECU (FR E-AXLE ASSEMBLY)
C	BAT ECU (EV SUPPLY BATTERY ASSEMBLY)	D	MG ECU (RR E-AXLE ASSEMBLY)
E	METER ECU (COMBINATION METER ASSEMBLY)	F	EV ECU (EV CONTROL ECU)
G	A/C ECU (AIR CONDITIONING AMPLIFIER ASSEMBLY)

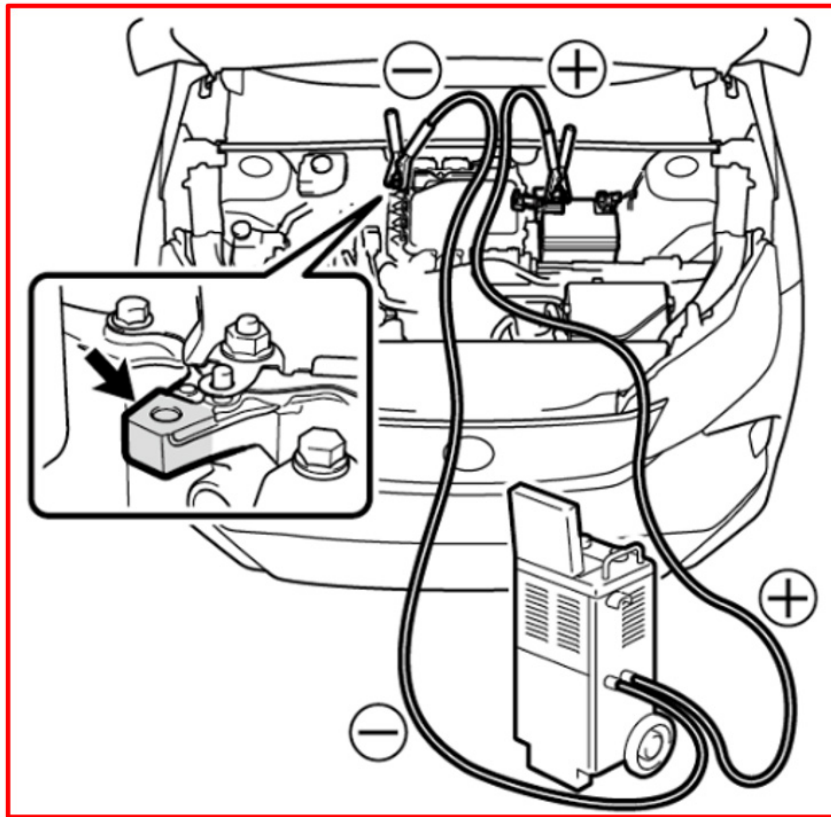
BATTERY CHARGER NOTES:

- For instructions on using the Power Supply Mode, reference the applicable User Manual for the Midtronics DCA-8000 Dynamic Diagnostic Charging on STIS.

- Select the correct battery type (Enhanced Flooded, Flooded, Gel, AGM or AGM Spiral).
- Input the CCA which matches the vehicle's battery.
- If using a DCA-8000 Dynamic Diagnostic Charging System, set the power supply voltage to 13.5 Volts.

- DO NOT connect the GTS+ until the Power Supply mode function has completed its battery test mode and the Charging Voltage has dropped to and shows a steady 13.5 Volts on the display.

- Once Power Supply Mode reaches a steady 13.5 Volts, connect the GTS+ to the OBD connector and proceed with initiating the normal reprogramming process.

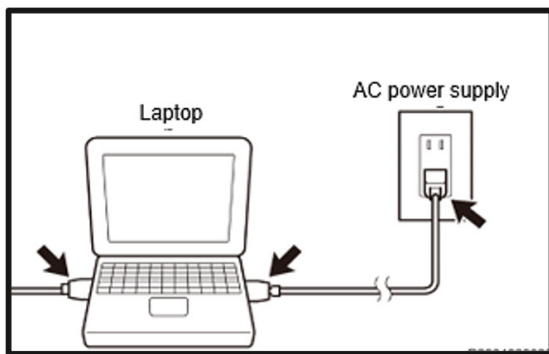
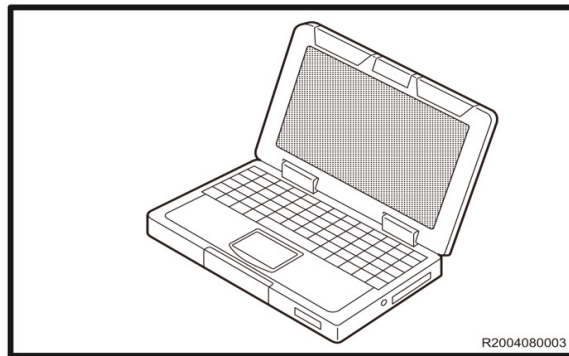
- A. **ALWAYS** connect the GTS+ laptop to an external AC power supply.
- B. Turn off the screen saver and power saving mode of the laptop for continuous power supply to the HDD/SSD.

- If the screen saver or power saving mode starts while reprogramming, the communication may be disconnected, resulting in the damage of the ECU.
- The ECU may be damaged if the battery voltage of the laptop drops while reprogramming.

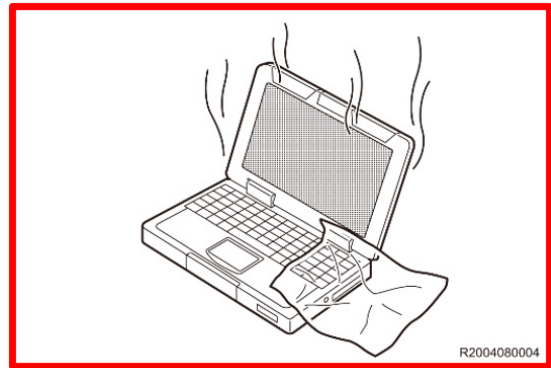
- **DO NOT** block the ventilation opening for the fan of the laptop. If the ventilation opening for the fan is blocked, the laptop may overheat, causing the laptop to stop and may damage the ECU as a result.

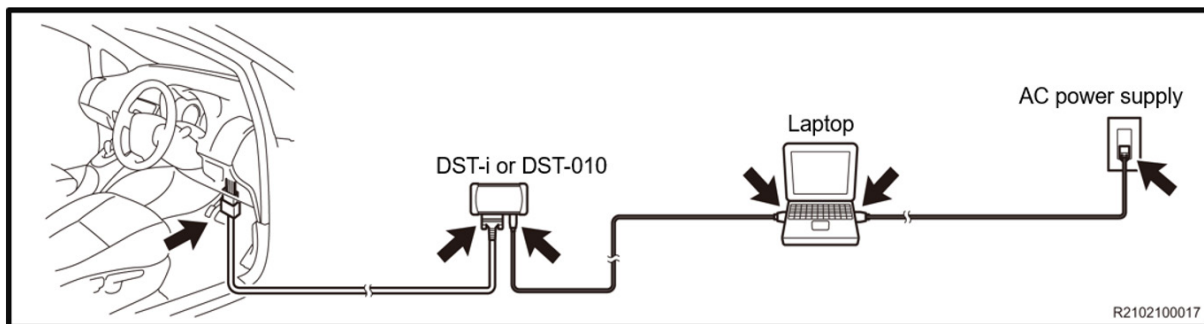
STEP 4: Secure the connection the of cables.

Confirm the power switch

is in the OFF position and connect the laptop to the vehicle.

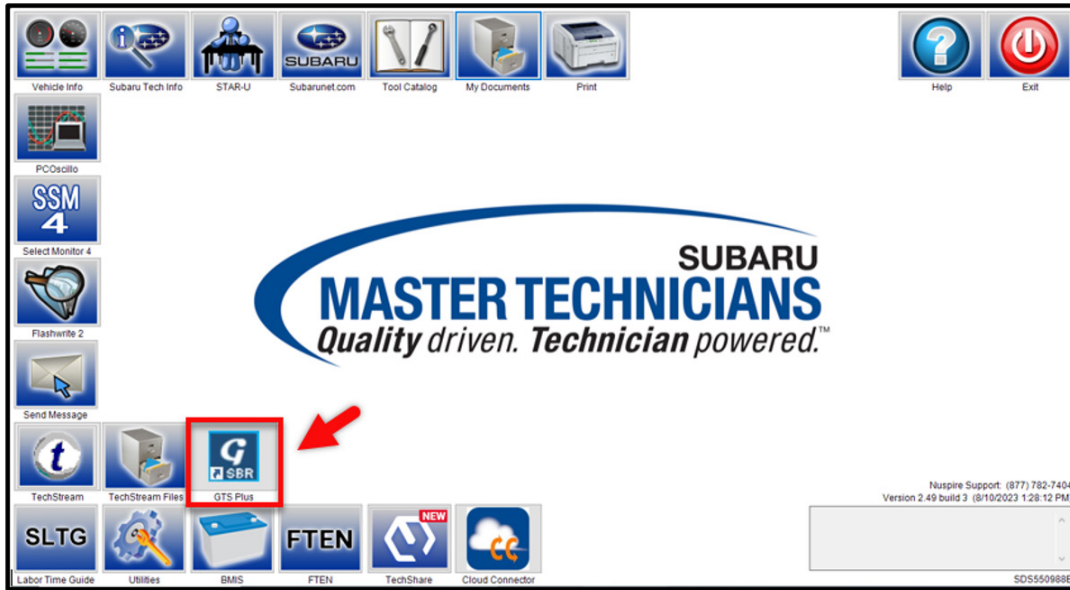
- A. Click the GTS+ icon to start the GTS+ application.

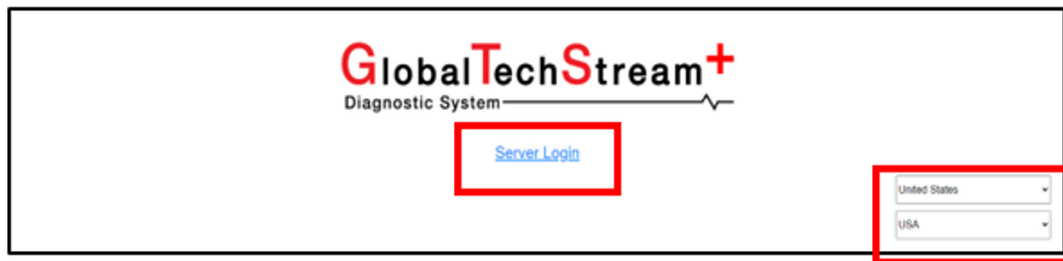
- B. SSM will automatically close and the GTS+ browser will open. Set the GTS+ application region to “United States” and set the lower box to “USA” then click the Server Login link.

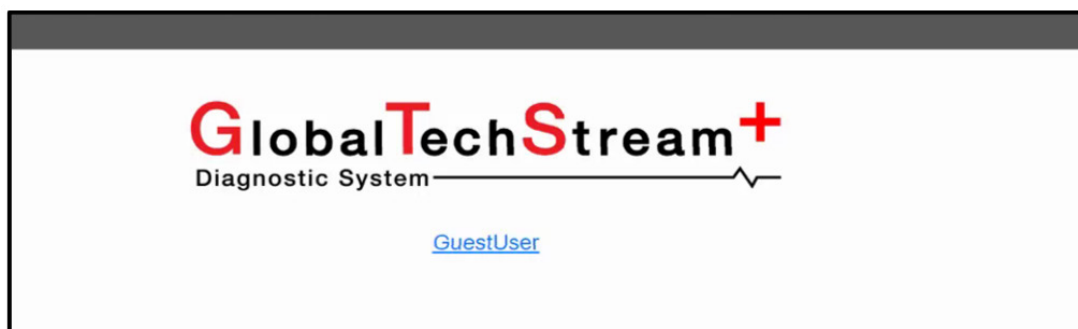
NOTE: In some instances, a user may have logged in previously. In these cases, if the PC has not been restarted, the screen below **may** appear when clicking on the GTS+ icon (Step 5-A). This is normal operation. Click the “GuestUser” link to directly login to GTS+.

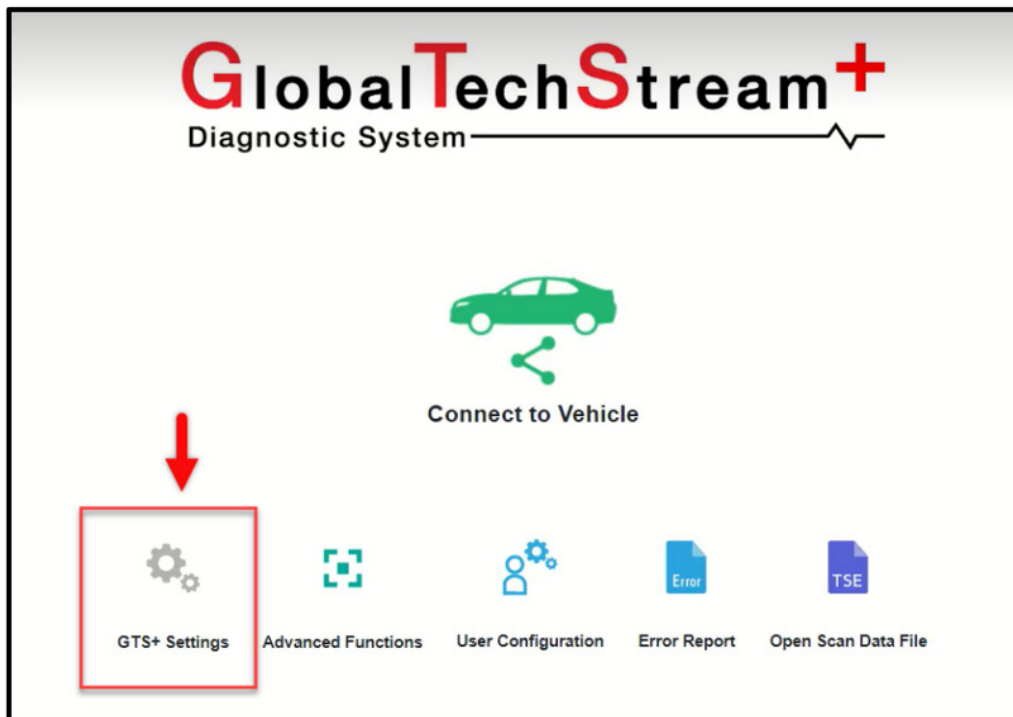
to the ON position **WITHOUT** depressing the brake pedal. Click the “GTS+ Settings” button.

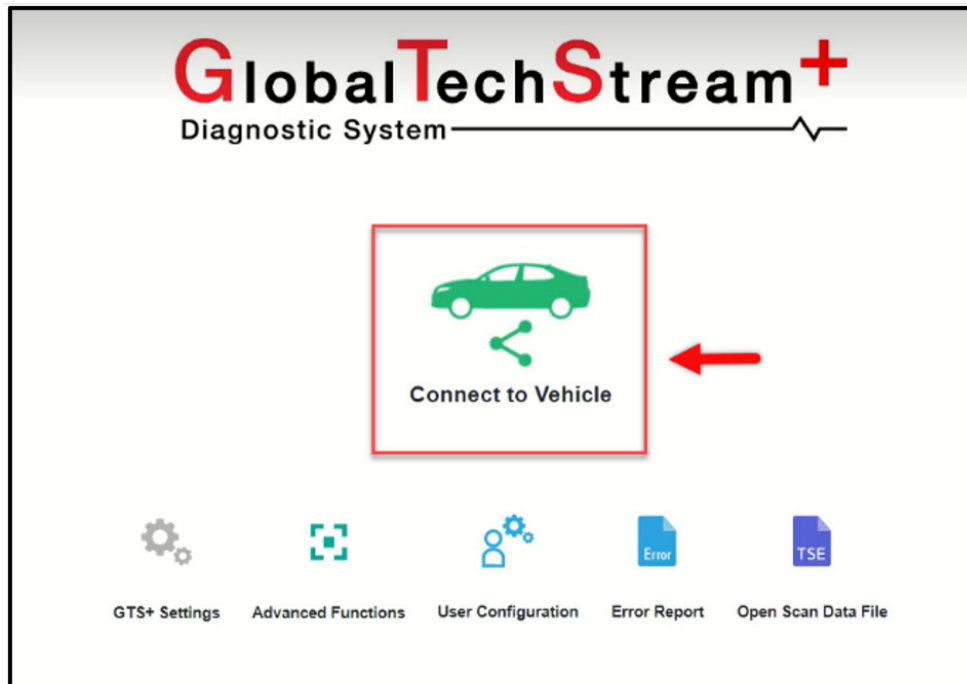
- E. In the lower portion of the GTS+ Settings page, select the appropriate Vehicle Interface Module (VIM) such as DTS-i or DST-010. Set the “Vehicle Area” selection to North America. Click the arrow in the right corner when complete.

- F. Click the “Connect to Vehicle” button. Confirm the target VIN information and continue by clicking the “Next” button.

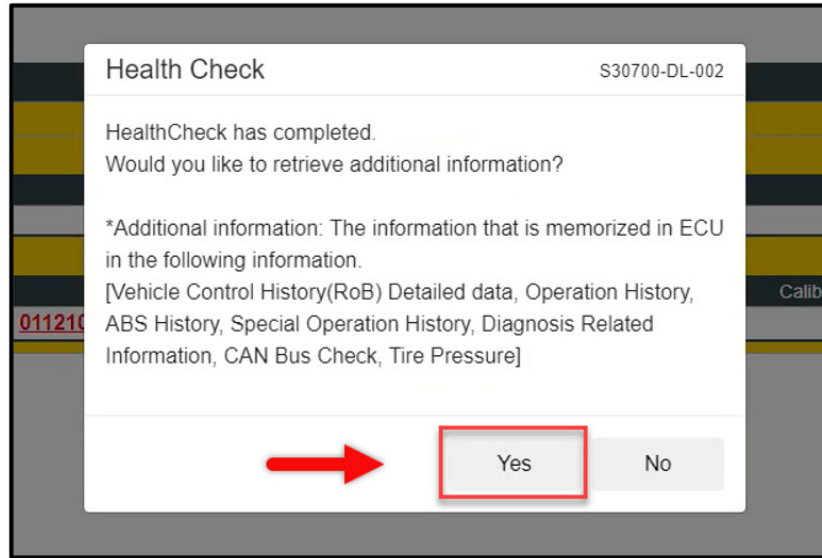
STEP 8: While the Health Check is being performed, a pop-up will be displayed asking if you would like additional information retrieved. Click the “Yes” button to continue.

NOTE: Allow time for the Health Check retrieve the stored data. This may take up to five minutes.

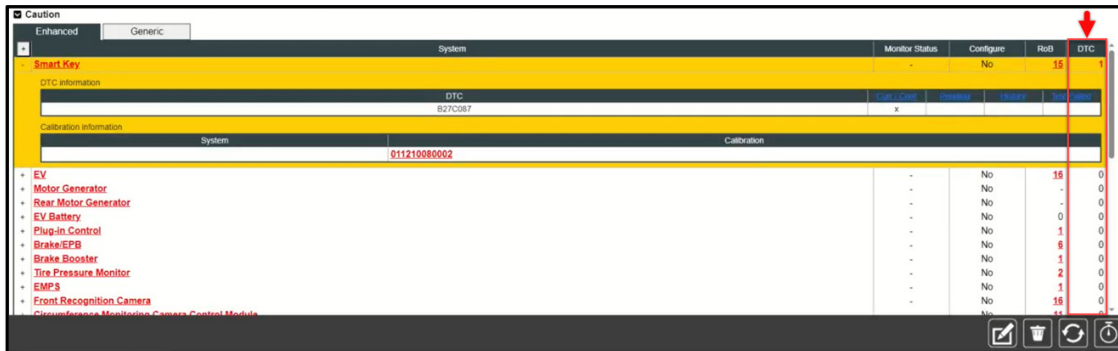
STEP 9: Once the Health Check is completed, check the results for any stored DTC(s).

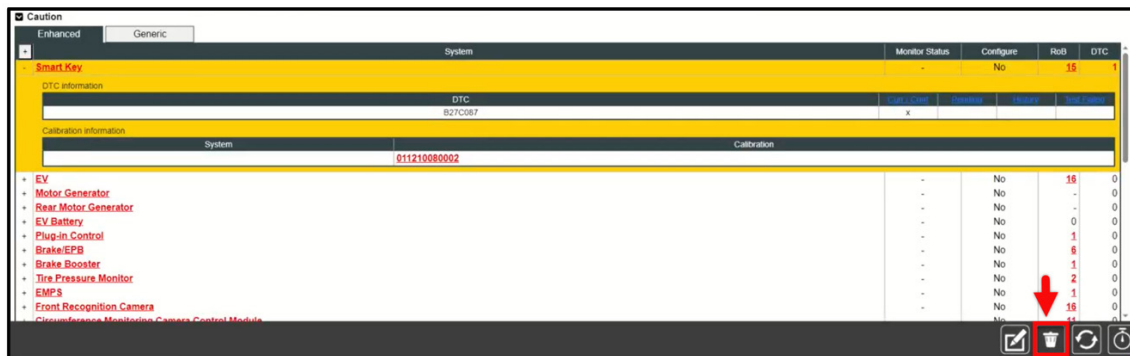
STEP 10: Clear all DTC(s) by clicking the “Erase” button.

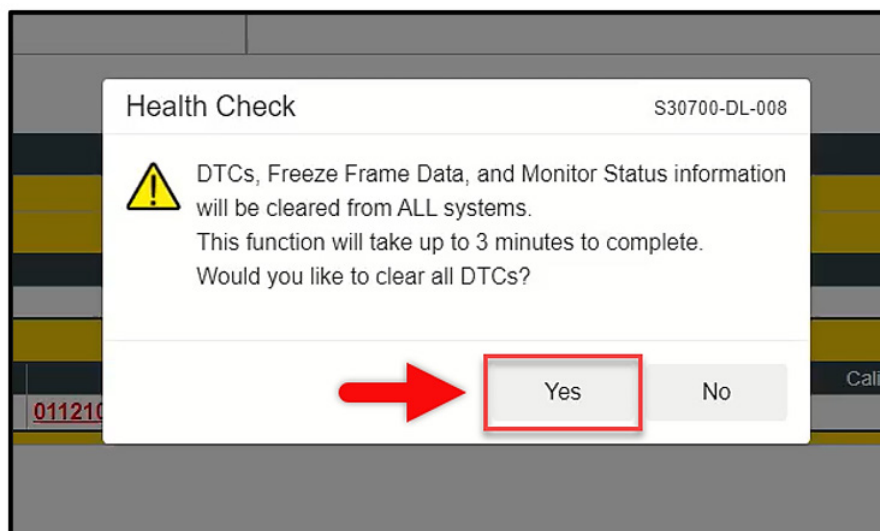
A pop-up will display reminding all Freeze Frame and Monitor Data will be cleared. Click the “Yes” button to continue.

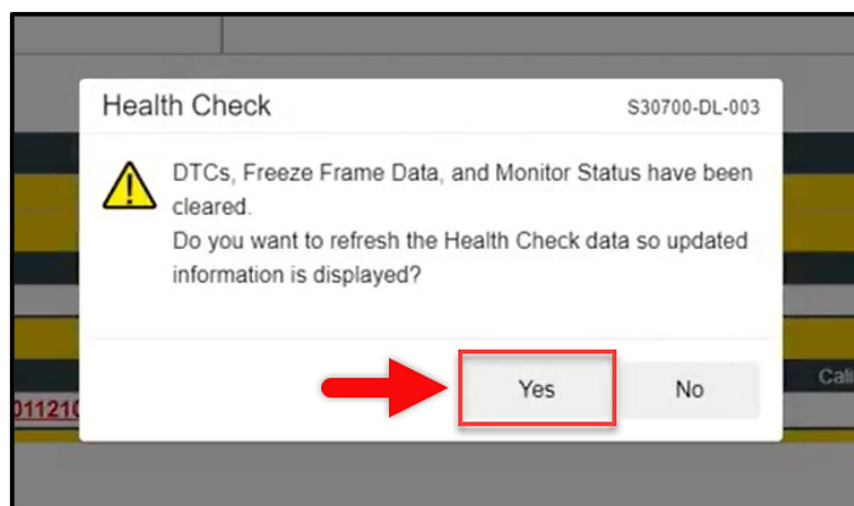
Once the clearing is complete, a second pop-up will display asking to refresh the Health Check to the updated status. Click the “Yes” button to continue. Proceed to Step 11 when no DTC(s) are detected.

IMPORTANT: If any DTC(s) continue to be stored, diagnose and repair as per the applicable Service Manual. Confirm the faults can be cleared prior to proceeding. If the DTC(s) are not cleared, the GTS+ cannot enter the reprogramming mode.

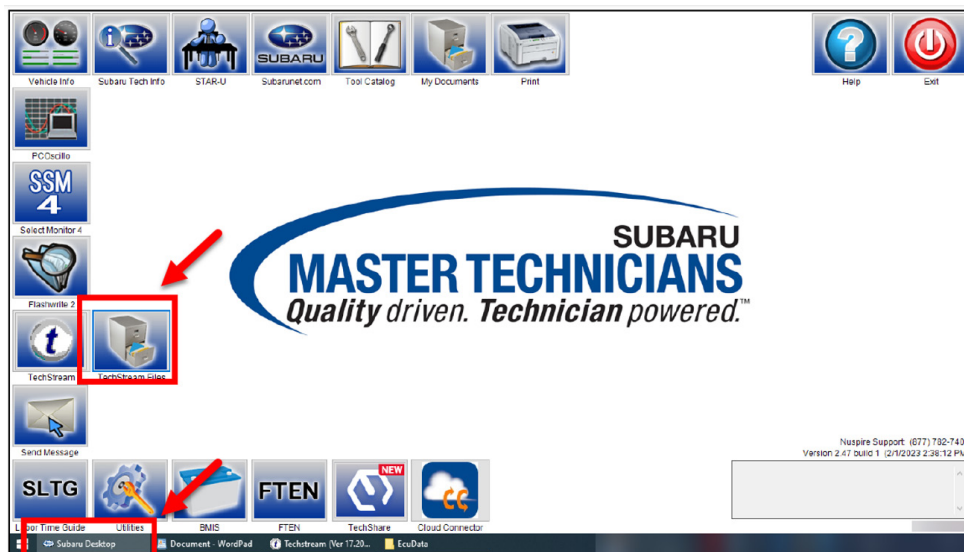
STEP 12: Prepare the 2.5 Reprogramming CUW file. Select the Subaru Desktop from the lower taskbar. Select The TechStream Files icon. Open the ECU Data folder. Locate the CUW file named:

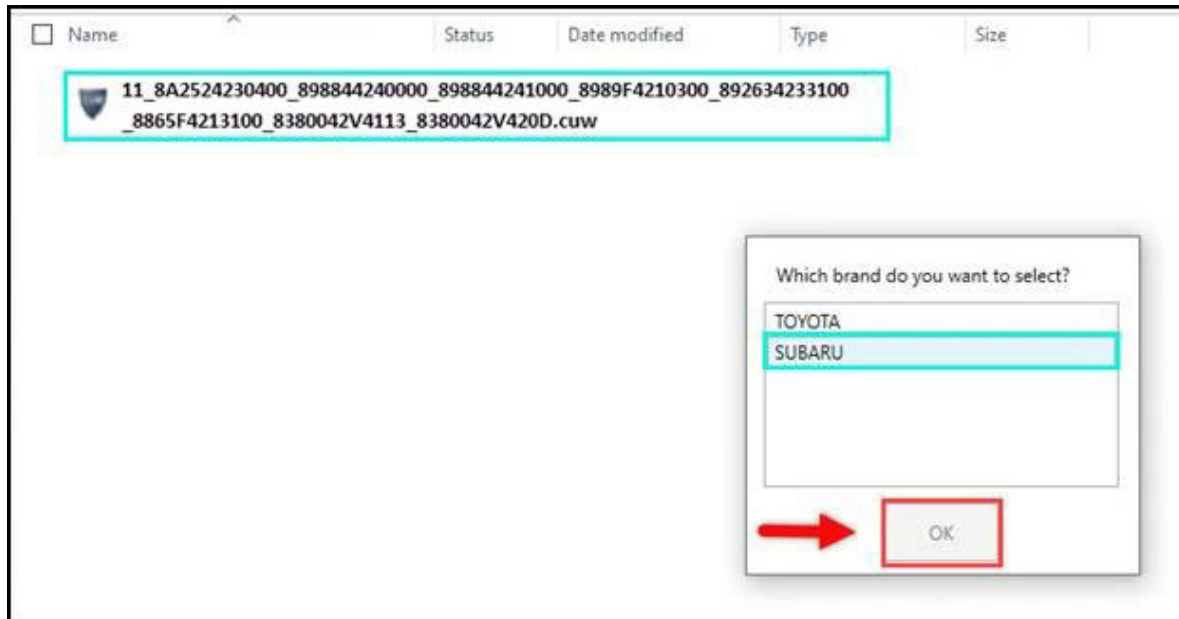
STEP 13: Double-click the applicable CUW file icon. A pop-up will display requesting a manufacturer to be selected. Select “Subaru” and click the “OK” button to continue.

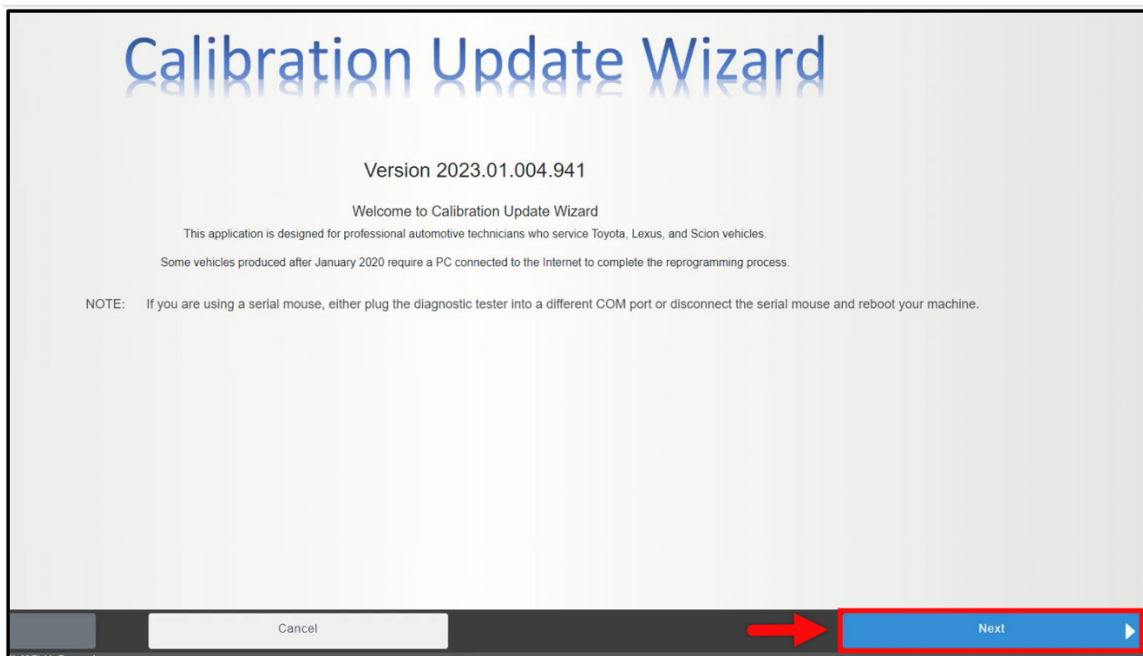
STEP 14: After double-clicking the file icon, the Calibration Update Wizard program is launched, and a new window will appear. Select the “Next” button to continue.

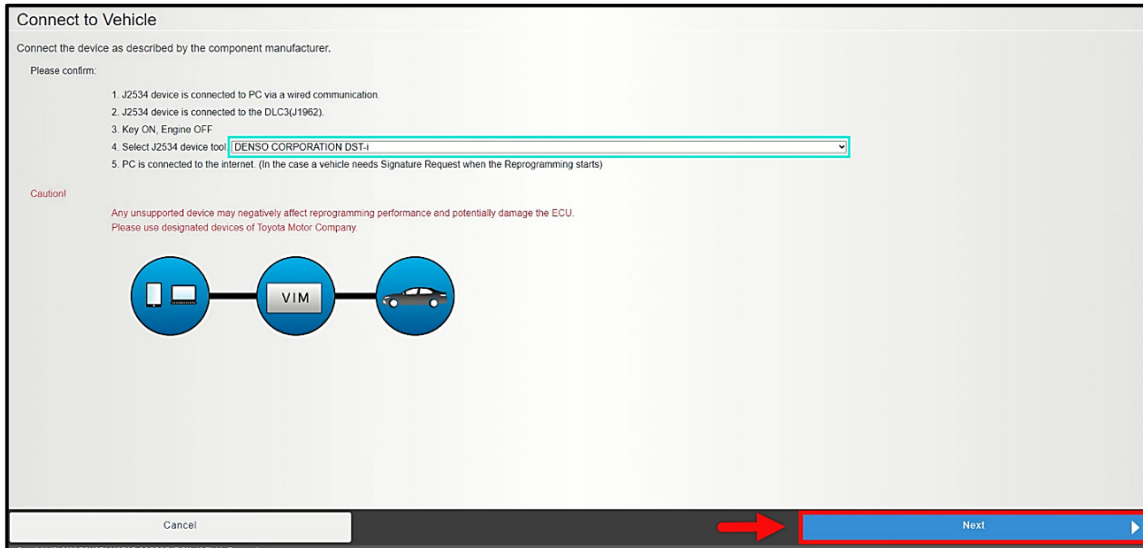
STEP 15: Confirm the pass-through device currently being used. Select the “Next” button to continue.

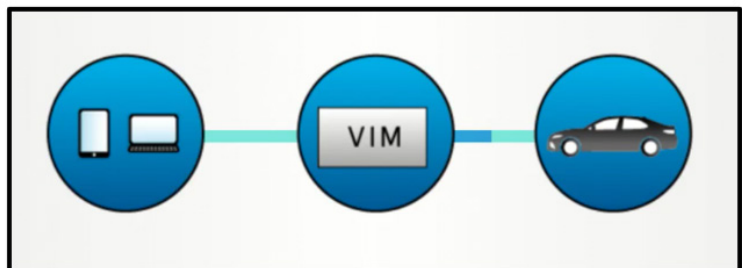
NOTE: A Progress bar will be displayed. **DO NOT** operate the power switch while the bar is shown.

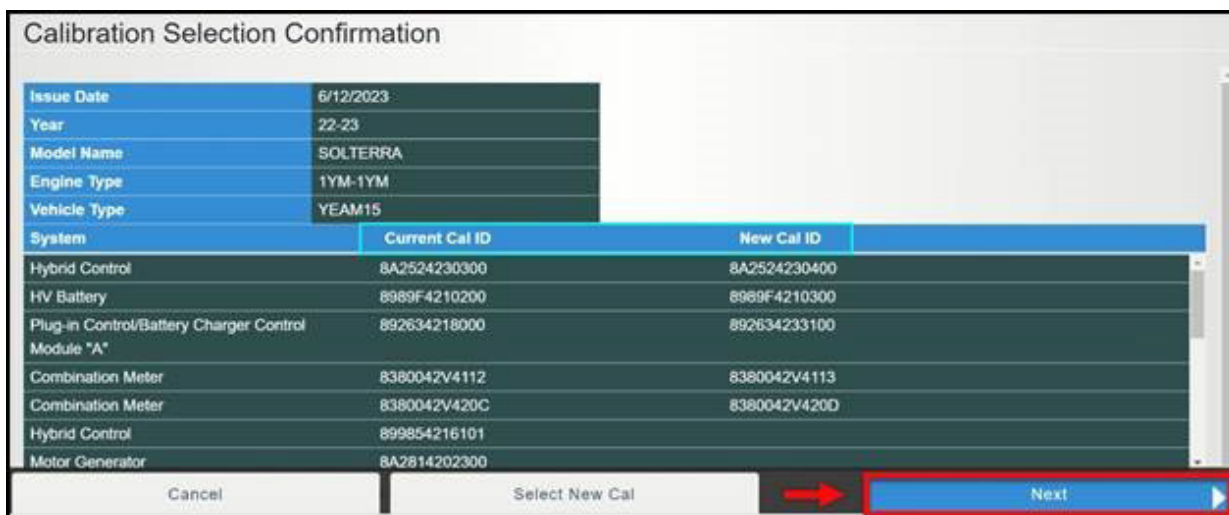
STEP 16: The Calibration Selection Confirmation window will appear. Confirm the applicable Current Cal ID and the New Cal ID. Click the “Next” button to continue.

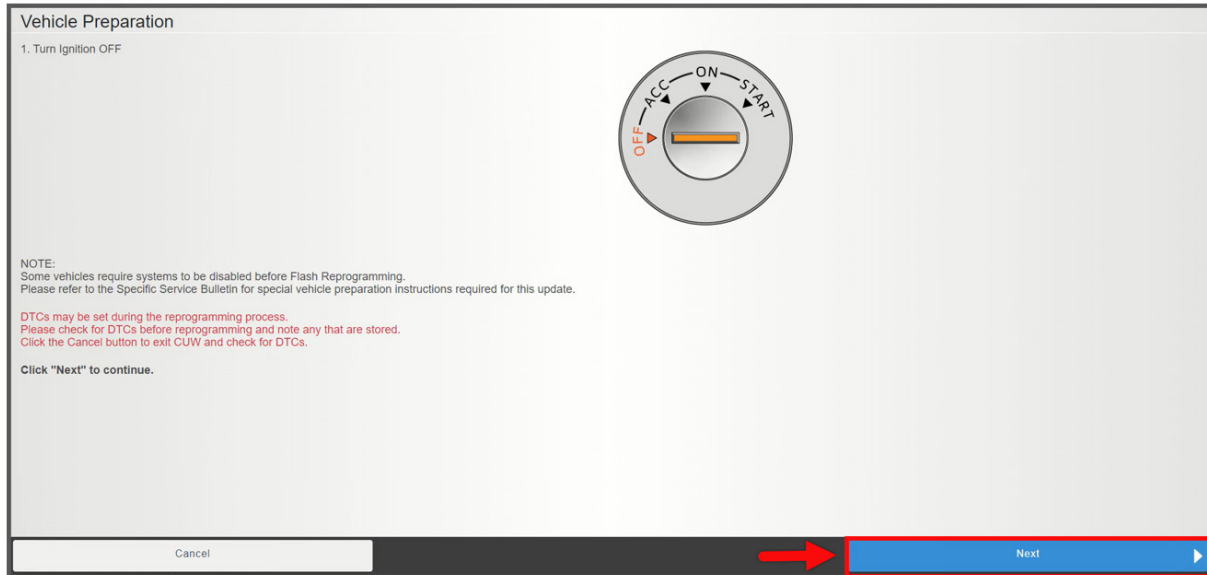
STEP 17: Review the CAUTIONS listed. Follow the on-screen instruction, turn the power switch to the OFF position. Select the “Start” to continue.

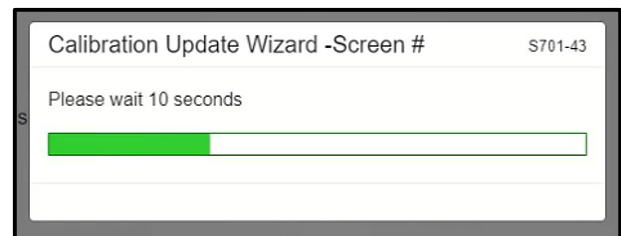
NOTE: A Progress bar will be displayed. **DO NOT** operate the power switch while the bar is shown.

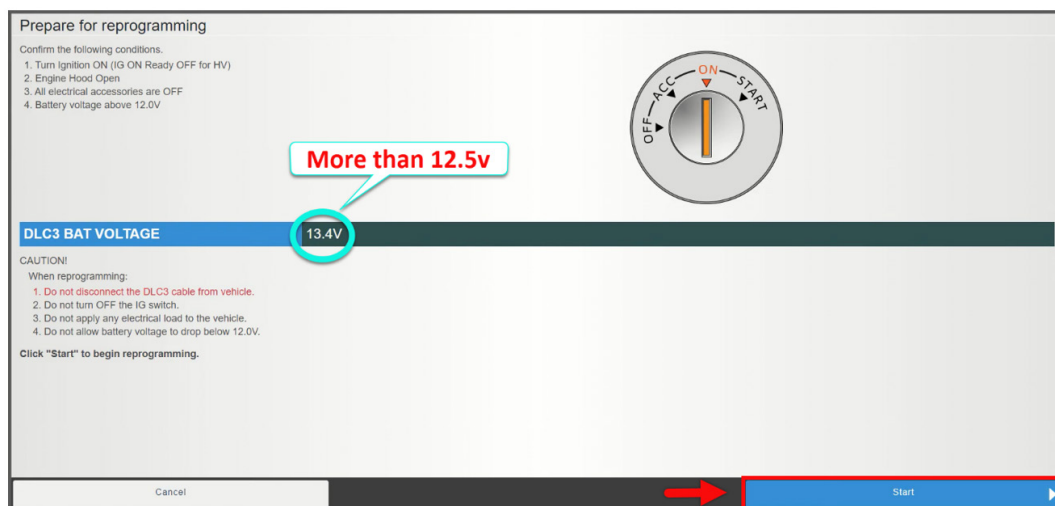
STEP 18: Review the CAUTIONS listed. Follow the on-screen instruction, turn the power switch to the ON position **WITHOUT** depressing the brake pedal. Confirm the 12 Volt auxiliary battery voltage is more than 12.5 Volts. Select the “Start” to begin the reprogramming process.

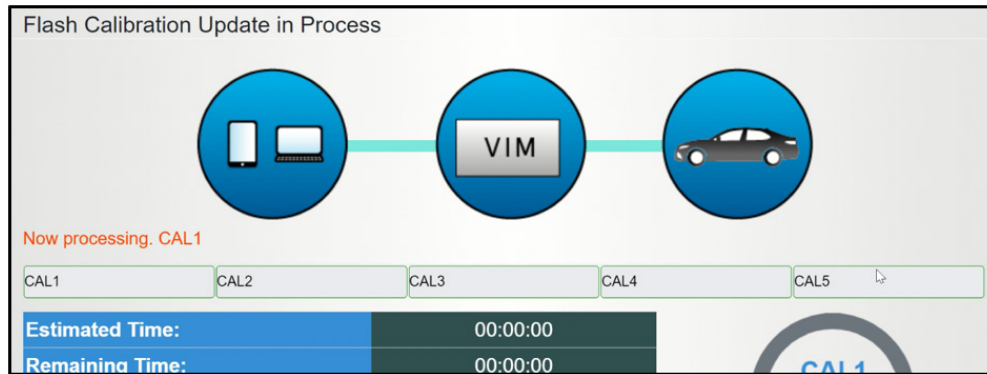
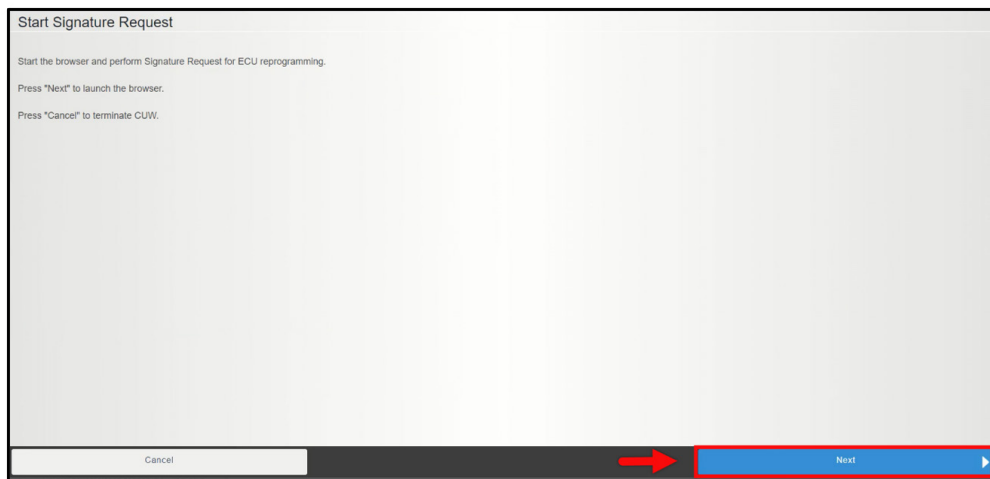
STEP 19: Once the “Flash Calibration Update” window is shown, allow the “Toyota Service Information” browser to be displayed. Select the “Next” button to continue.

NOTE: The signature is acquired in future steps, once acquired, the signature is to be pasted into the “Signature” box.

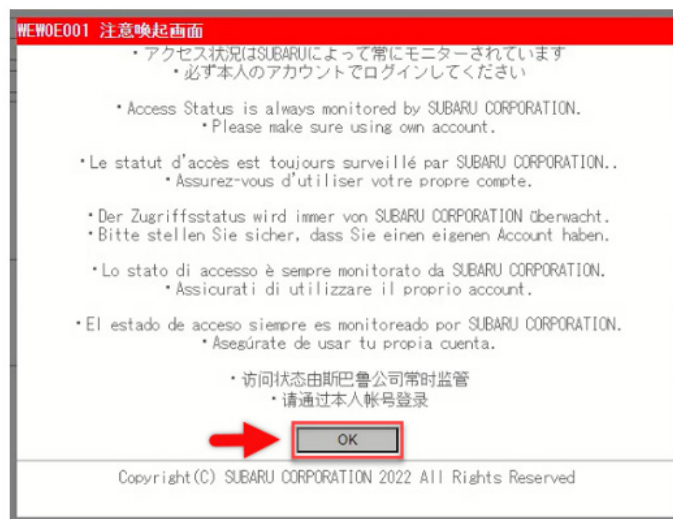
STEP 20: Once the browser is started, a pop-up will display. Click the “OK” button to continue.

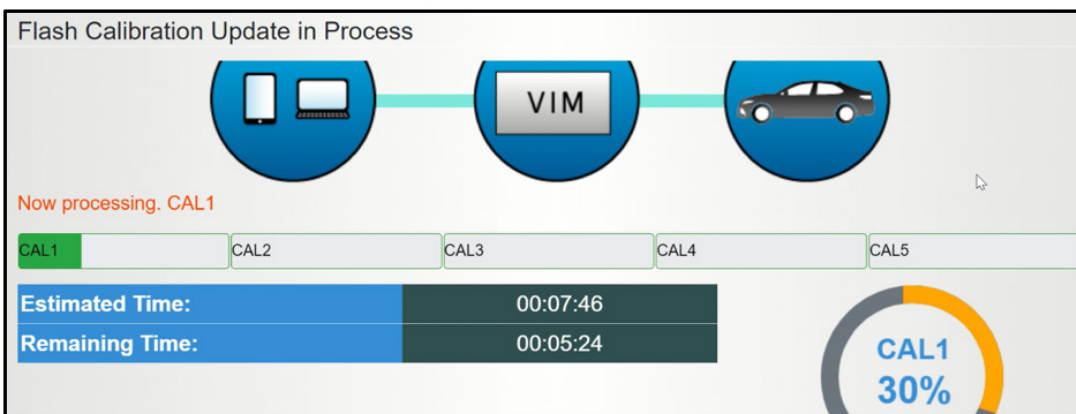
STEP 24: While the vehicle is reprogramming, the progress window is displayed. **ALWAYS** remain near the vehicle during reprogramming in order to monitor the progress.

NOTE: The headlamps may operate during this procedure.

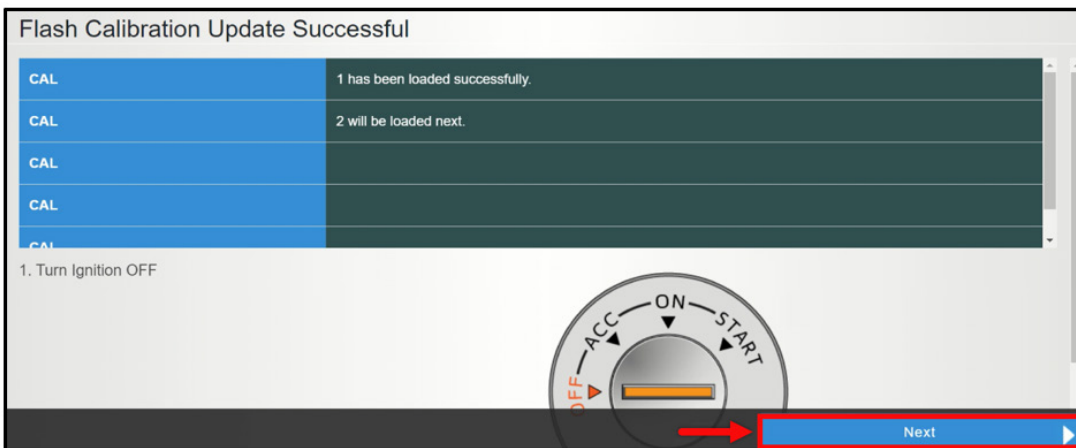
STEP 25: Follow the on-screen instructions. turn the power switch

to the OFF position. The first calibration is complete. Click the “Next” button to continue.

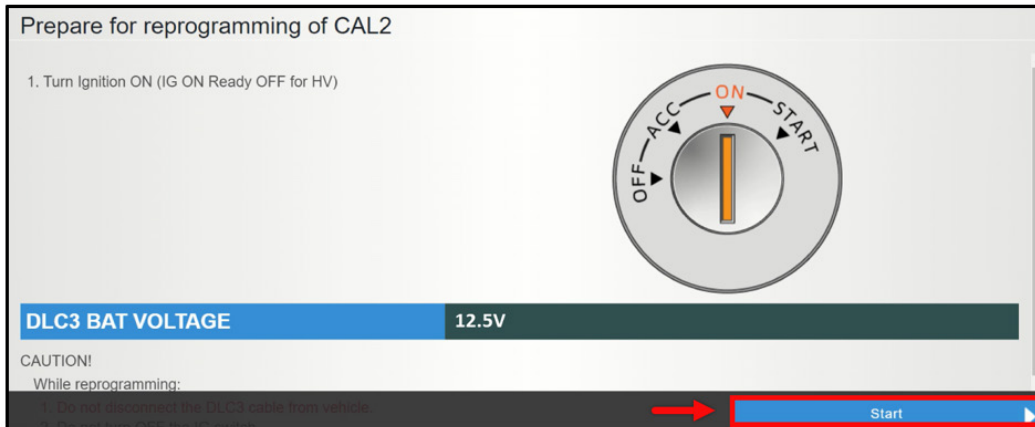
STEP 26: Follow the on-screen instructions. turn the power switch

to the ON position. The second calibration will automatically prepare. Click the “Next” button to continue to start the signature request for the second calibration.

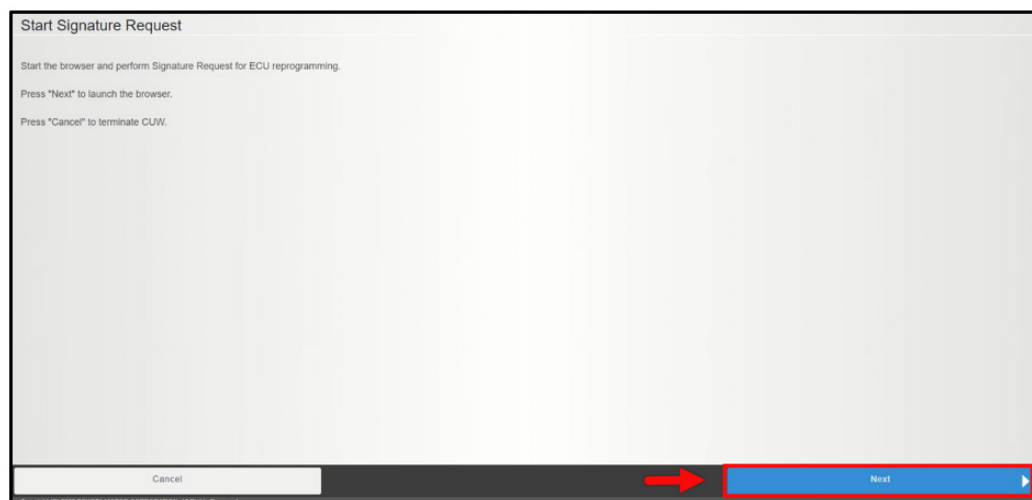
Click the “Next” button to continue.

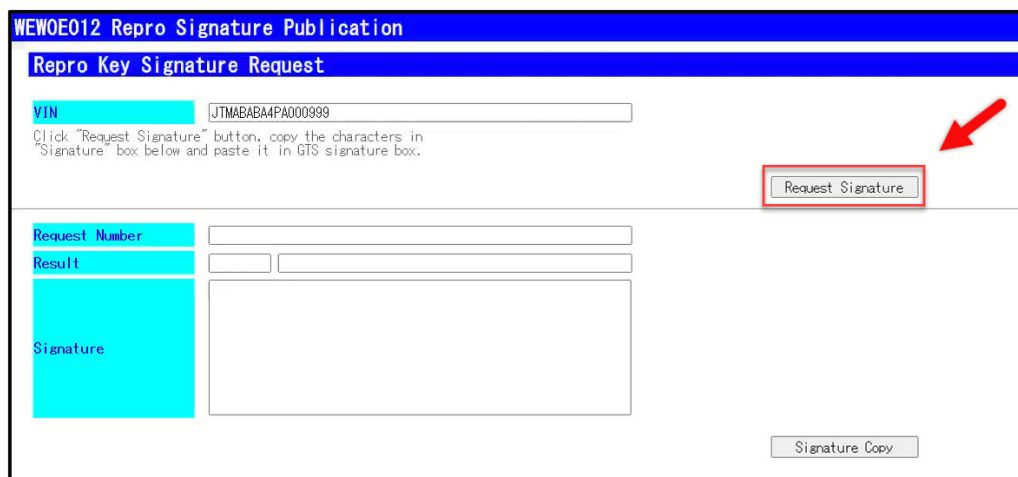
STEP 27: Select the “Request Signature” button. This will populate in the lower window.

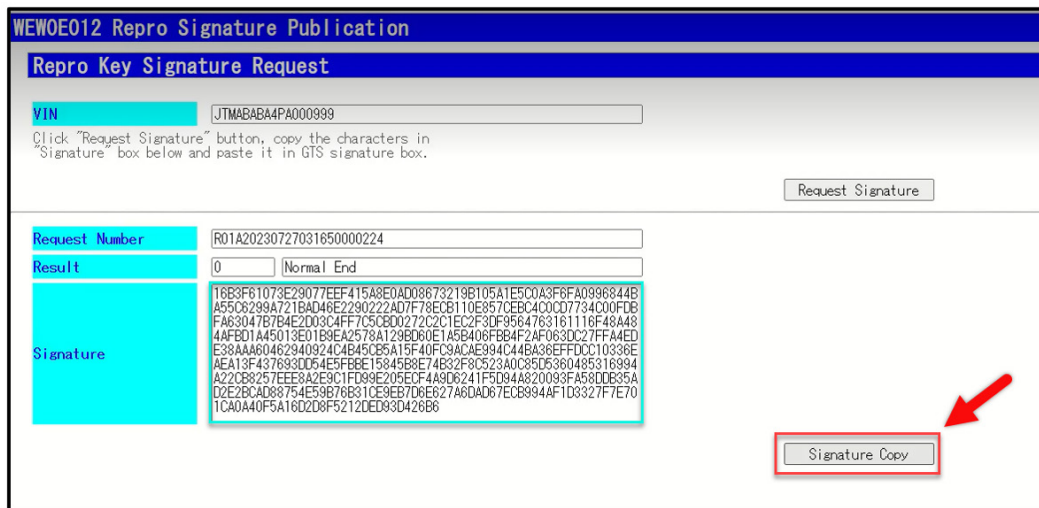
STEP 28: Select the “Copy Signature” button then minimize the window.

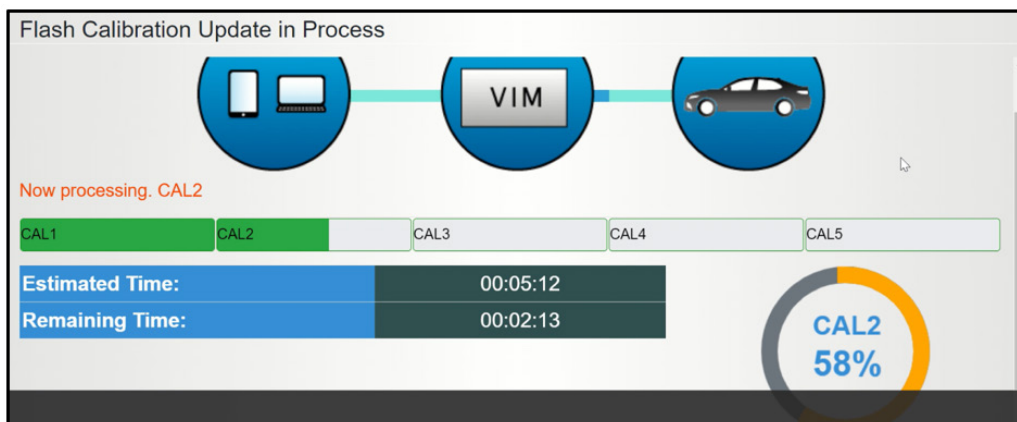
STEP 29: While the second calibration is reprogramming, the progress window is displayed. **ALWAYS** remain near the vehicle during reprogramming in order to monitor the progress.

NOTE: The headlamps may operate during this procedure.

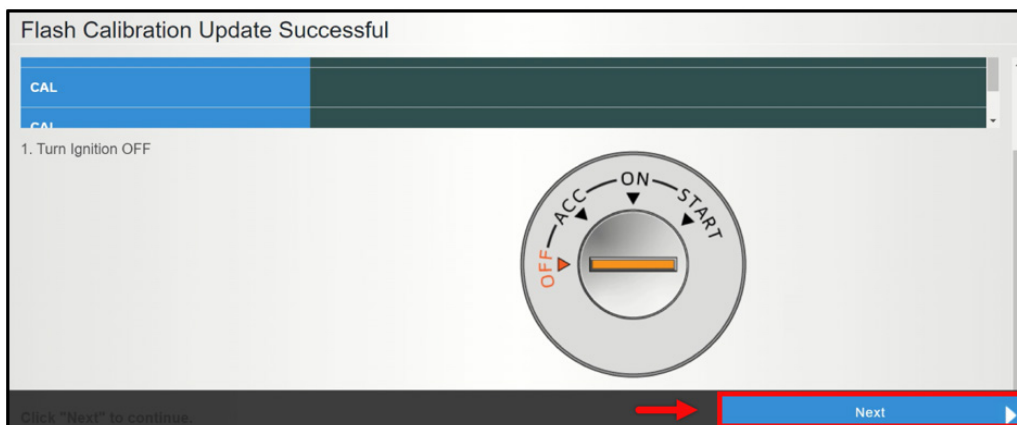
STEP 30: Follow the on-screen instructions. turn the power switch

to the OFF position. The second calibration is complete. Click the “Next” button to continue.
