**APPLICABILITY:** 26MY Outback Models including Wilderness models

**NUMBER:** 15-336-25

**SUBJECT:** FOTA (Firmware Over-The-Air) Reprogramming for DENSO Gen 5 CP25 Audio Navigation Infotainment Systems via DCM

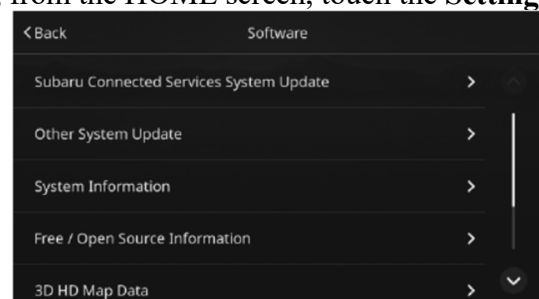
2) Press the **Software** button. Use the down arrow to scroll to **System Information** then press to display the System Information / Version information.

Please note the last six digits of the software version (014-850) would determine an eligibility for the software update. If the last six digits of the software version are not listed in the table below proceed to section “FOTA REPROGRAMMING OVERVIEW” below. Otherwise the unit already has the latest software version installed. No update is required at this time.

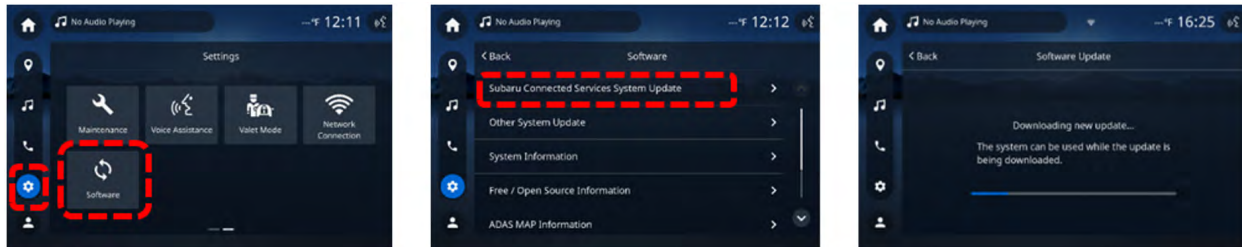
1. Download takes 5 to 30 minutes, depending on the service provider and LTE signal strength. To confirm the download status, please select “**Settings > Software > Subaru Connected Services System Update**”.

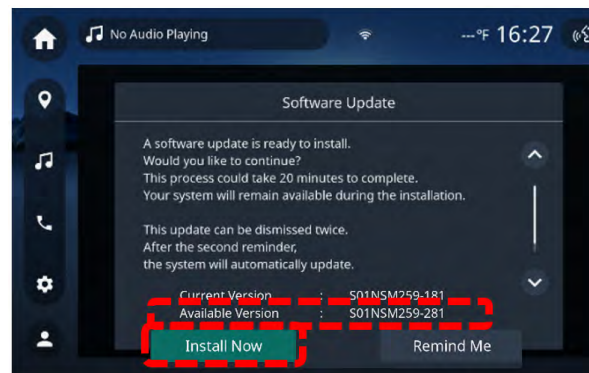
After the download completes in the background and the vehicle is stopped, the following popup will appear.

Follow the on-screen instructions displayed in the popup.

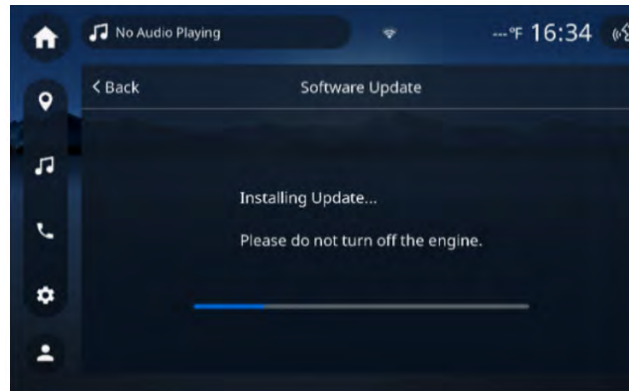
2. Wait until the progress bar indicates 100% completion of the installation.

Note: Installation takes 10 to 40 minutes, depending on the system load status. During the installation, other functions remain available as usual, and you can navigate to any screen.

To return to this progress screen, select “Settings tab > Software > Subaru Connected Services System Update”.

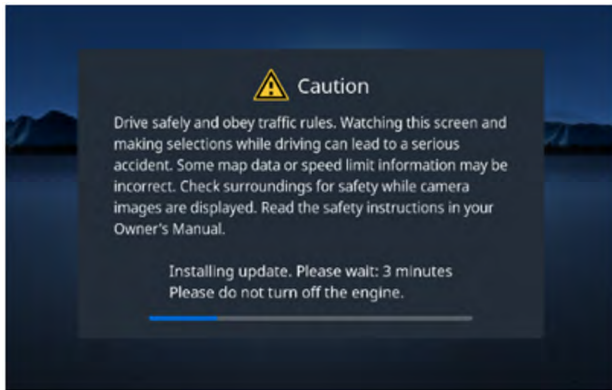
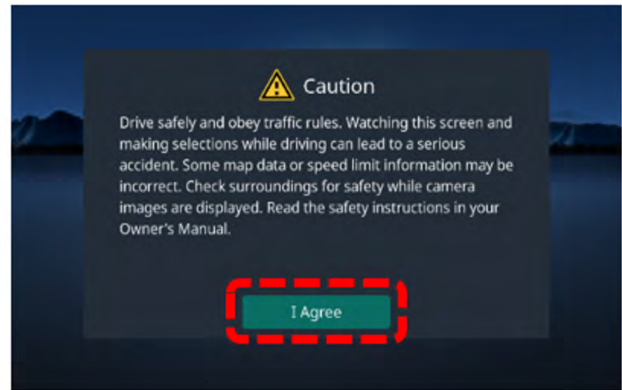
- When the engine/ignition is turned ON, “Caution” screen will be displayed.

Note: As instructed on the Caution screen, wait for 3 minutes without turning the engine off. After 3 minutes, press the “I Agree” button.

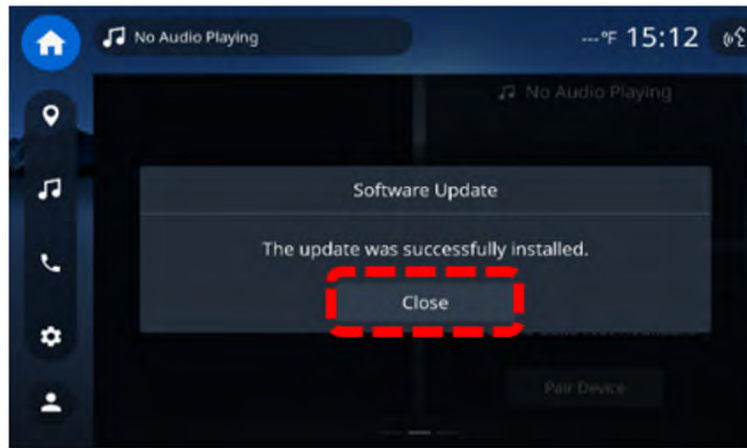
- After the software update is completed successfully, the following pop-up will appear. Press the “Close” button.

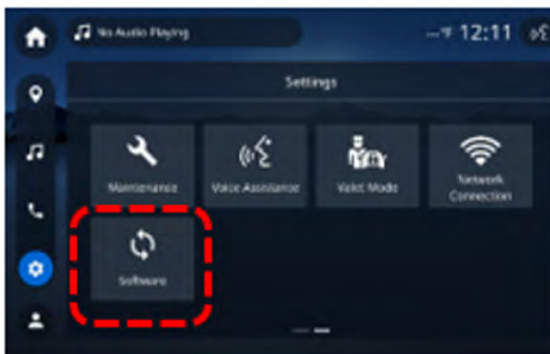
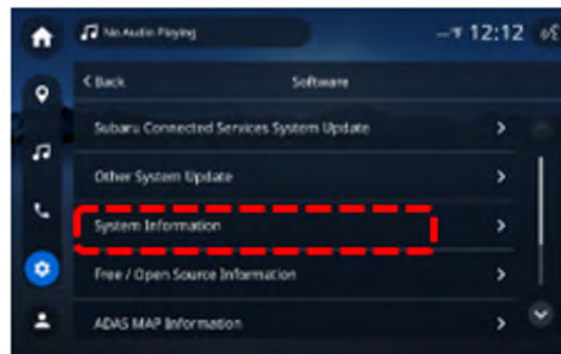
To verify whether the software update has been successfully completed, check the current software version by following the steps below.

- Select “Settings > Software > System Information

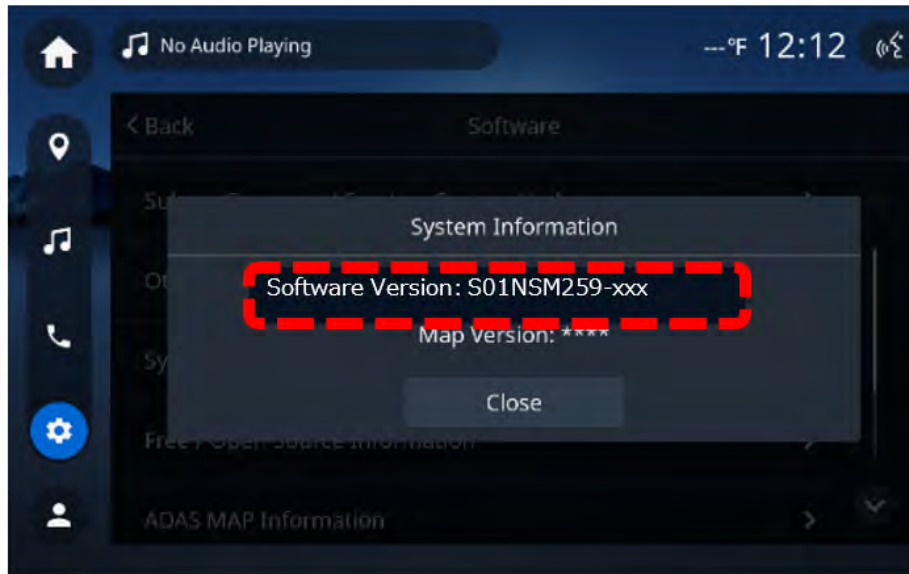
2. Verify whether the “software version” matches the “Available Version” noted on page TBD.

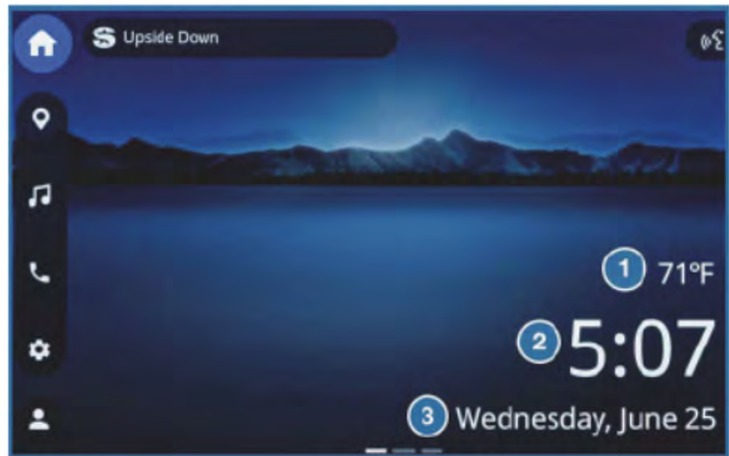
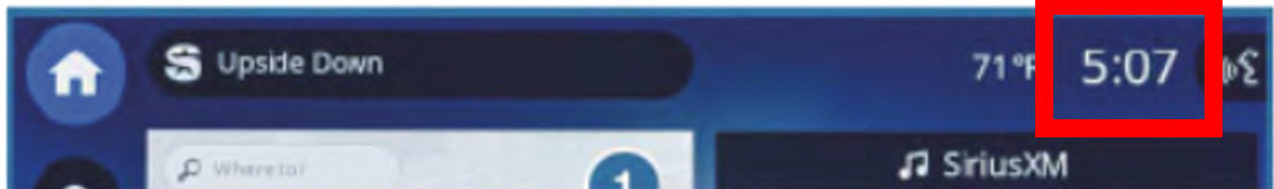
#### Calm Screen

Software Update availability notification only works, if the clock has been set accurately. Check if the time is correct or not shown on the Home screen or shown on the status bar

- 1 Outside Temperature:**  
Displays the temperature outside of the vehicle.
- 2 Clock:** Select to display the clock setting screen.
- 3 Date and Day of the week:**  
Displays the date and day of the week.

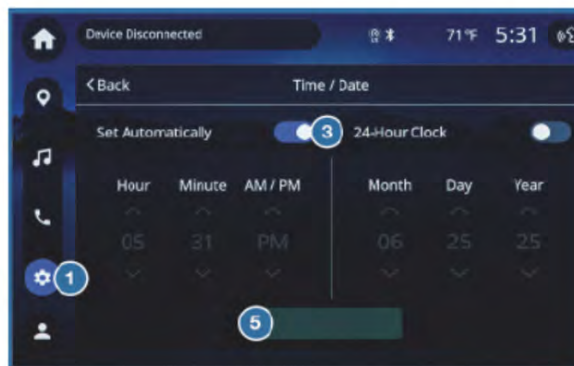
To set the clock automatically:

- 1** Select the Settings icon.
- 2** Navigate to and select "Time/Date".
- 3** Select "Set Automatically". You can also adjust the clock format (12H or 24H).
- 4** The time and date arrows will become inactive.
- 5** Once you are finished, select "Apply".
