SERVICE INFORMATION BULLETIN

APPLICABILITY: All 2026MY Vehicles Equipped w/ Gen4 Telematics

NUMBER: 07-240-26R

SUBJECT: DTC B2A20 Diag Strategy & Service Impact Verification

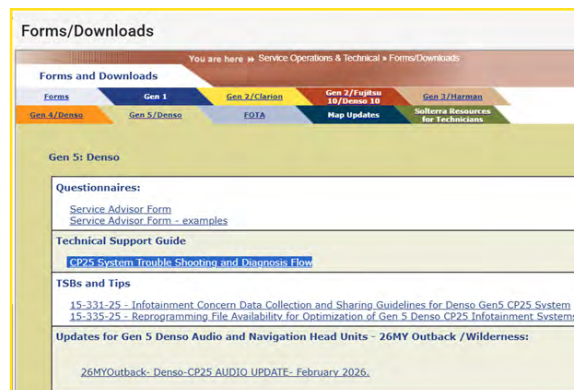
- Current DTC might impact SSM5 interaction with CCU resulting in complications for CP25 software update covered by TSB 15-335-25. In that case, please follow applicable diagnostic procedures for each DTC as well as apply information presented earlier.
- Additional resources for CP25 diagnostic are available on Subarunet: Service Operations & Technical-> Forms/Downloads as shown below.
