## Technical Service Bulletin

**GROUP****CAMPAIGN****NUMBER****26-01-019G****DATE****FEBRUARY 2026****MODEL(S)****GV80 COUPE (JX1)**

**SUBJECT:** INTEGRATED ELECTRIC BOOSTER (IEB) OBD II FAULT DETECTION SIGNALS SOFTWARE UPDATE (SERVICE CAMPAIGN 917G)

**Description:** Certain GV80 Coupe (JX1) vehicles may have Integrated Electronic Booster (IEB) modules with incorrectly configured On Board Diagnostic II (OBD II) fault detection signals. This bulletin provides instructions to update the IEB to correct the configuration.

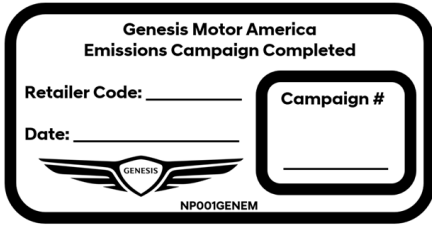
| Model | Part Name | Part Number | Figure | Remarks |
|---|---|---|---|---|
| GV80 Coupe (JX1) | Emissions Label | NP001-GENEM | | Apply to all vehicles regardless of state. |

1. Fill in the Dealer Code and Date on the emissions label, and apply adjacent to the existing label, on the underside of the hood, as shown.

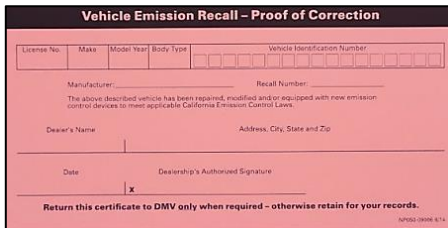
| Model | Part Name | Part Number | Figure | Remarks |
|---|---|---|---|---|
| | Vehicle Emission Recall - Proof of Correction Card | NP050-09006 | | Order only for states:<br>CA, CO, CT,<br>DE, ME, MD,<br>MA, NJ, NY,<br>OR, PA, RI,<br>VT, WA |

The Vehicle Emission Recall - Proof of Correction card must be completed by the Dealership's Service Manager using a permanent ink pen. A fine point pen is recommended. When filling in the information, copy the information directly from the vehicle, not from the repair order.

1. Enter Vehicle's License Number
2. Enter "Genesis"
3. Enter Model Year
4. Enter model name (e.g. GV70)
5. Enter the vehicle's VIN
6. Enter Campaign Number: **917G**
7. Enter Dealership Name
8. Enter Dealership's Address  
**NOTE:** Enter the physical address, not the mailing address (not a P.O. Box)
9. Enter Date of Repair
10. Service Manager Sign Here

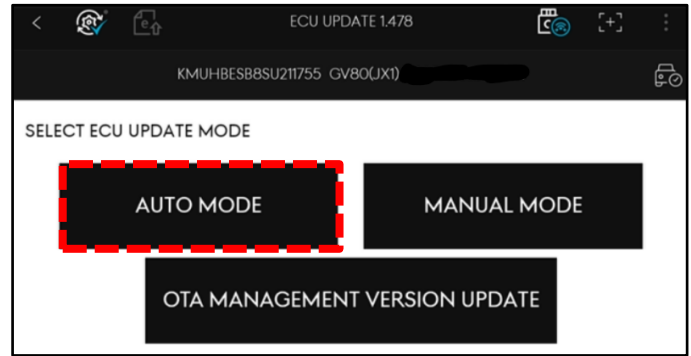
1. Perform the ECU update in **Auto Mode**.

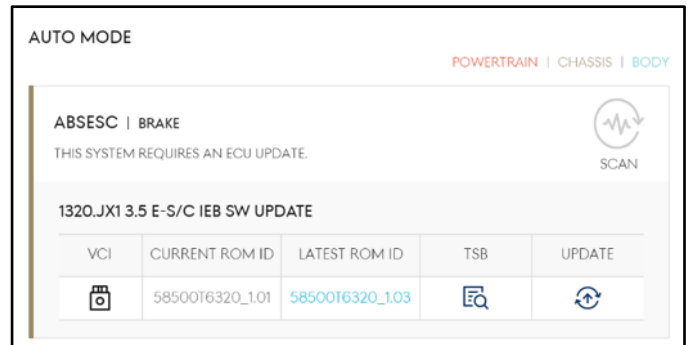
2. Verify the ROM ID by selecting the **ABSESC** system to scan the vehicle's current ROM ID.

Check the current ROM ID version and compare it to the ROM ID Information table before attempting to perform the software update.

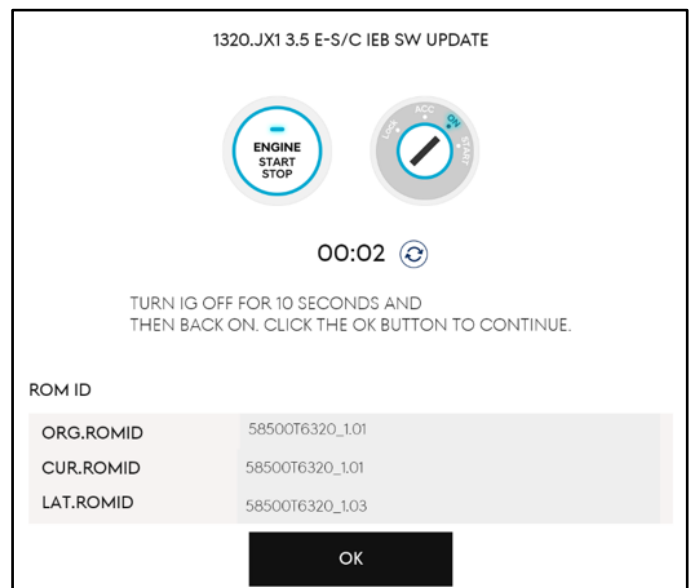
3. Once the ECU update is 100% complete, follow the prompts on the screen to cycle the ignition **OFF** for at least **10 seconds** to reset the control unit (certain models may take up to **30 seconds**).

Use the **Refresh** button to reset the timer.

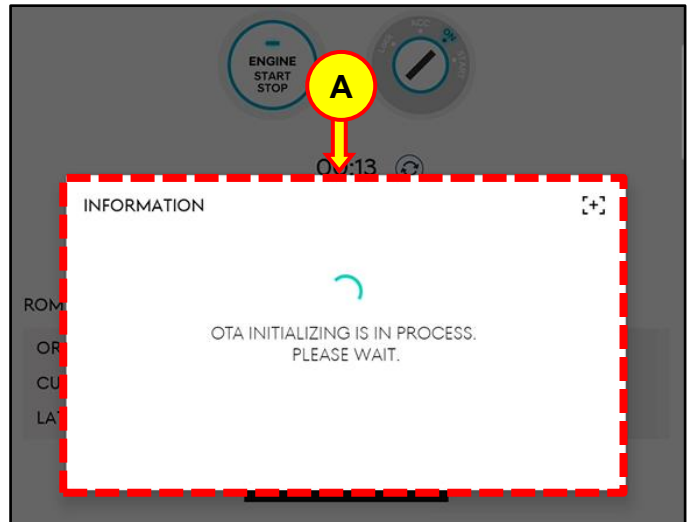
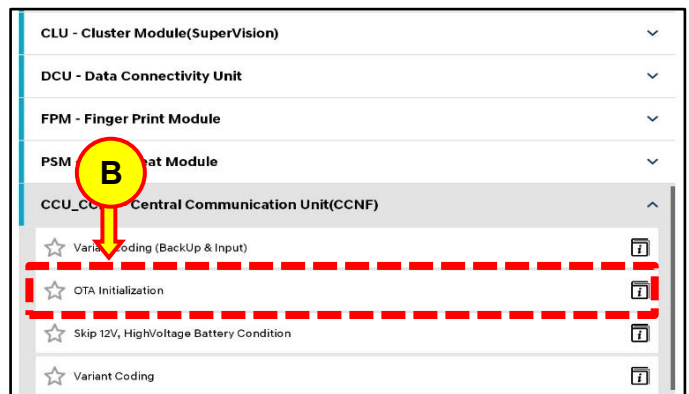
4. OTA initialization (A) should perform automatically:
- If OTA initialization performs automatically, then proceed with the service procedure.
  - If the OTA initialization process fails, complete it manually under:  
**S/W Management > CCU\_CCNF - Central Communication Unit (CCNF) > OTA Initialization (B).**

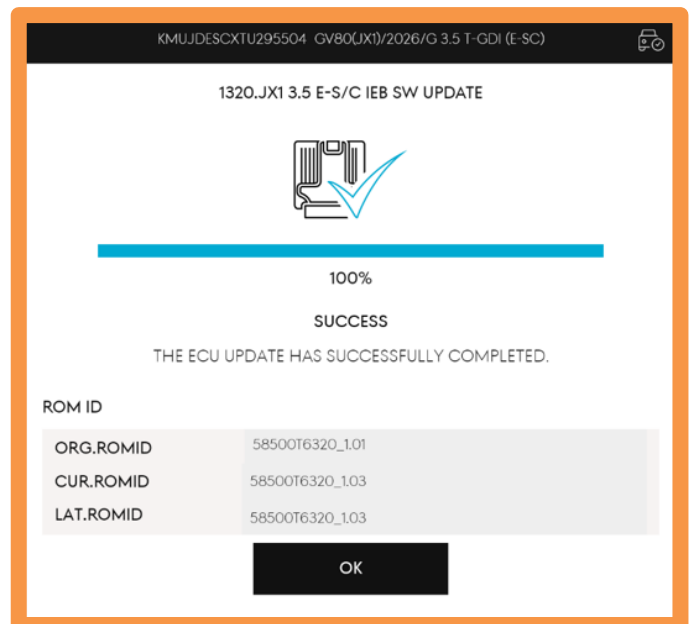
Using the tablet or GDS screen capture function, take a screenshot of the ECU upgrade "Success" result screen.

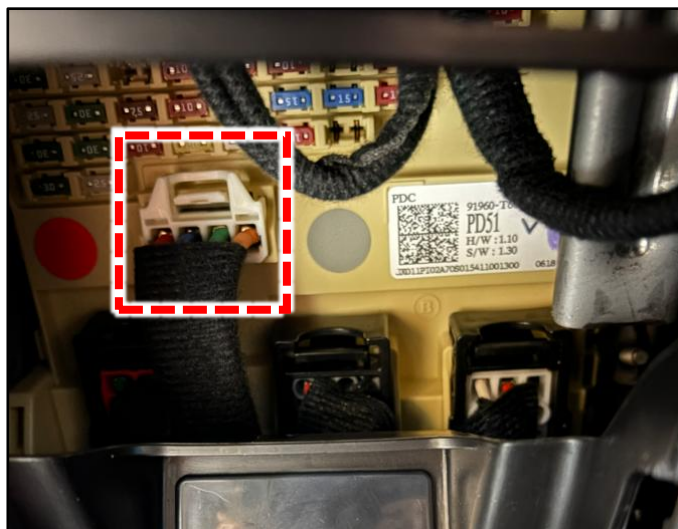
6. Remove the power connector from the in-cabin fuse box for at least **5 seconds**, then reconnect it.

Alternatively, disconnect the negative (–) **12V** battery terminal, wait at least **5 seconds**, then reconnect it.

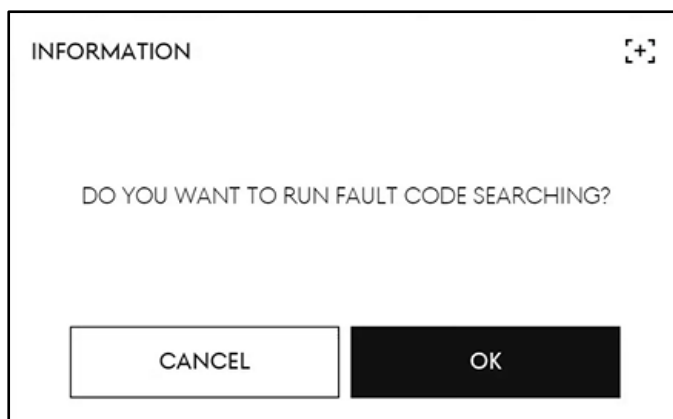
7. Perform an **All Systems Fault Code** search and erase DTC history that had incidentally occurred from the ECU update.

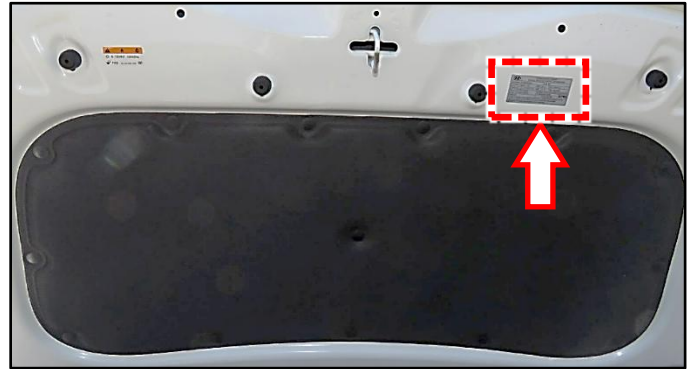
Be sure to clean the mounting surface to ensure proper label adhesion.

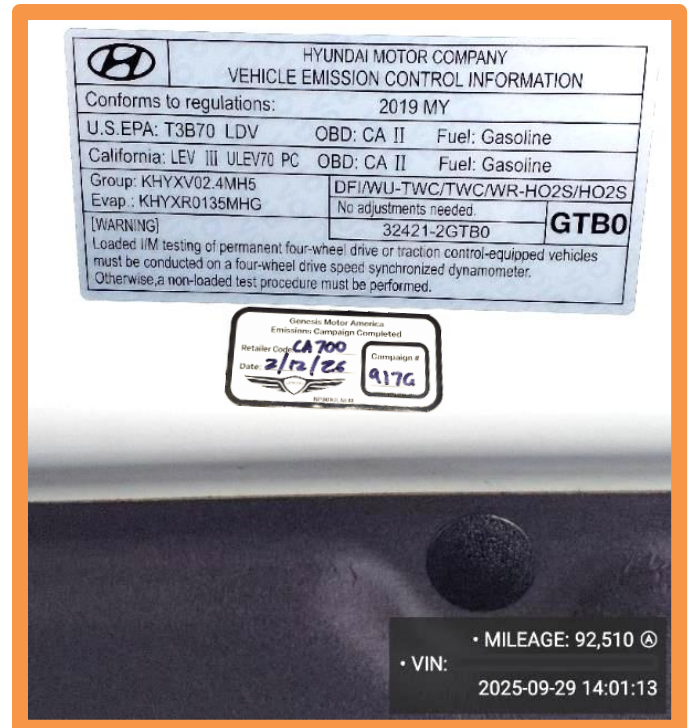
Using the STUI camera function, take a photo of the emissions label attached to the vehicle.

**NOTE:** If the STUI camera function is **NOT** used, write the last 6 digits of the VIN and date of repair on a piece of paper to include in the photo.
