# ESC Warning Lamp and ECU Replacement

## TSB-54-104-WST

Vehicles equipped with mBSP braking and ESC that show repeated DTC 1810/02 and a yellow ESC warning lamp (ESC disabled) have a longitudinal acceleration fault.

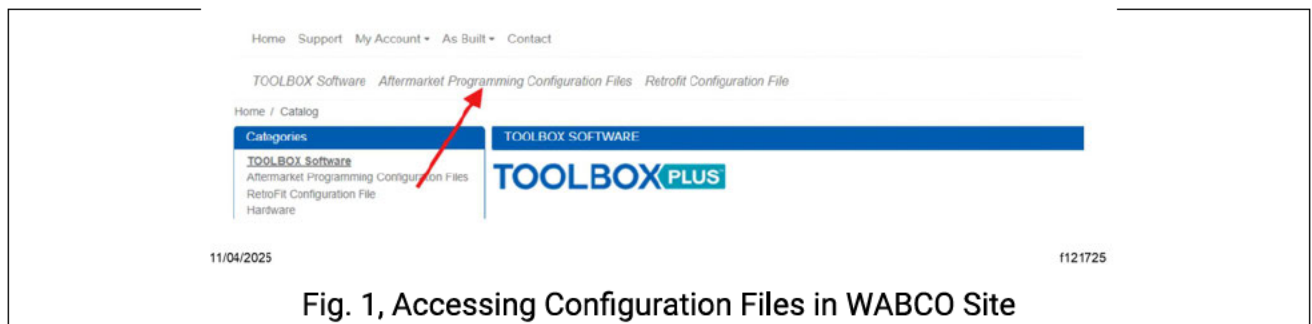
1. ☐ Go to the <https://wabco.snapon.com/Login.aspx>.
2. ☐ Login to the WABCO page.
3. ☐ Select 'Aftermarket Programming Configuration File.' See Fig. 1 and Fig. 2.
