HYUNDAI Technical Service Bulletin	GROUP CAMPAIGN	NUMBER 26-01-016H-1
	DATE MARCH 2026	MODEL(S) SANTA FE HYBRID (MX5A HEV)
SUBJECT: FPM SOFTWARE UPDATE (LIMITED COVERAGE CAMPAIGN LA6A)

Description: Certain Santa Fe Hybrid (MX5A HEV) vehicles may experience a discharged battery condition due to the Fingerprint Module (FPM) not entering 'SLEEP' mode when the ignition is turned off. This bulletin provides instructions to perform a software update with revised logic for the FPM.

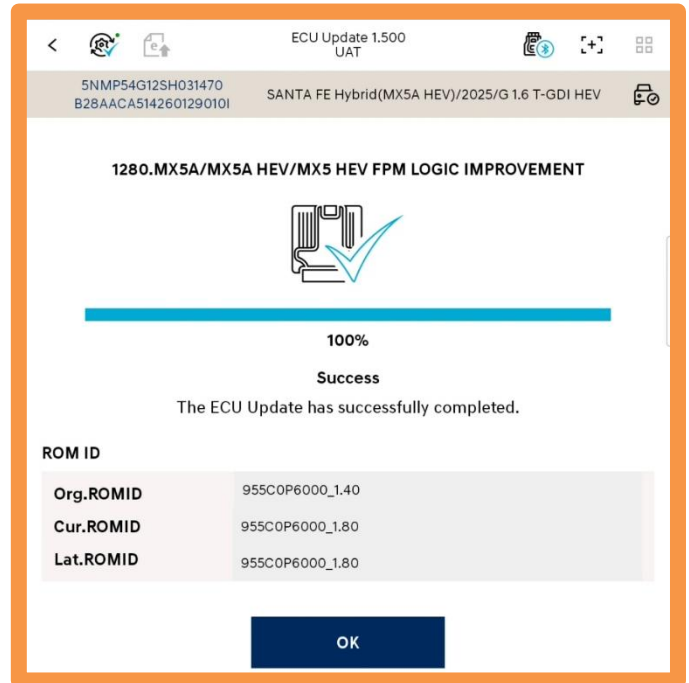
Using the tablet or GDS screen capture function, take a screenshot of the ECU update "Success" result screen.

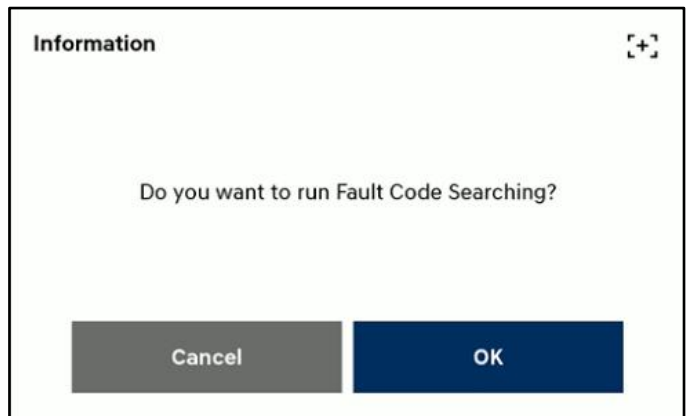
6. Perform an **All Systems Fault Code** search and erase DTC history that had incidentally occurred from the ECU update.
