# Technical Service Bulletin

GROUP <b>CAMPAIGN</b>	NUMBER <b>26-01-028H</b>
DATE <b>MARCH 2026</b>	MODEL(S) <b>SANTA CRUZ (NXT)</b>

**SUBJECT:** TCU SOFTWARE UPDATE FOR 8DCT HIGH PRESSURE ELECTRIC OIL PUMP (LIMITED COVERAGE CAMPAIGN LA12)

**Description:** Certain Santa Cruz (NXT) vehicles equipped with 8-speed dual clutch transmissions (8DCT) may set one of the high pressure electric oil pump (HP EOP) DTCs listed below. This bulletin provides the service procedure to update the Transmission Control Unit (TCU) with improved logic to address these DTCs and enhance operation of the 8DCT.

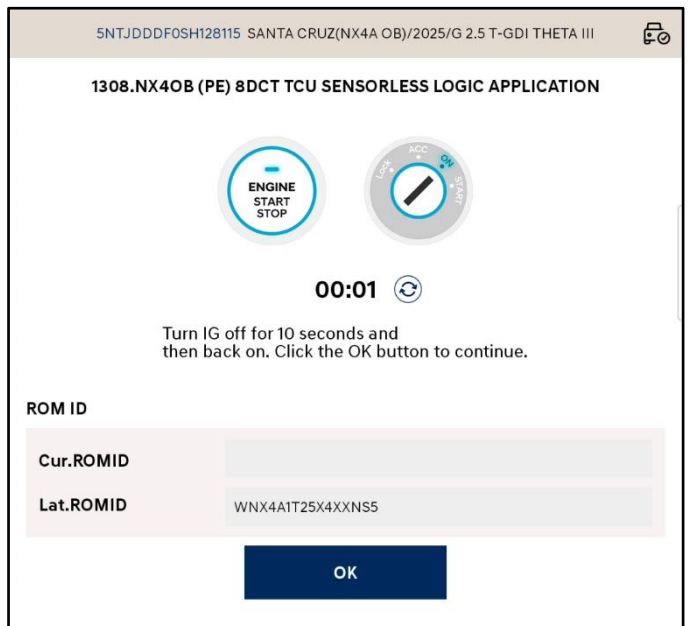
3. After the ECU update process shows 100% complete, follow the prompts on the screen to cycle the ignition **OFF** for at least **10 seconds** to reset the control unit (certain models may take up to **30 seconds**).

Use the **Refresh** button to reset the timer.

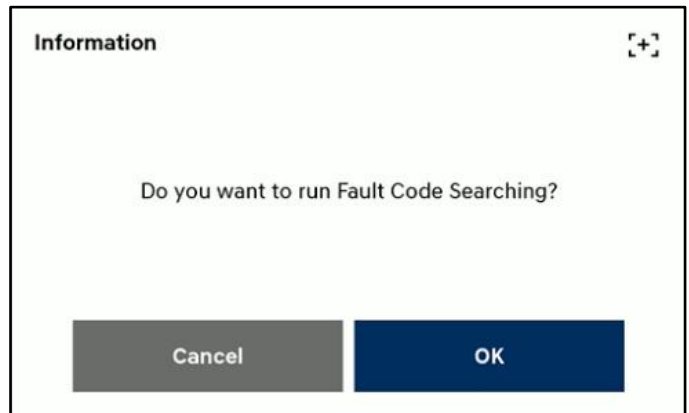
5.

Perform an **All Systems Fault Code** search and erase DTC history that had incidentally occurred from the ECU update.
