TECHNICAL SERVICE BULLETIN

DCU COMMUNICATION LOGIC IMPROVEMENT

This bulletin provides the procedure to upgrade the Data Connectivity Unit (DCU) system software on some 2025-2026MY vehicles listed in the table below. Kia has identified that Connected Car Services (CCS) functionality may intermittently fail due to temporary DCU communication issues. This condition can impact convenience and connectivity features by causing the Remote Start and Remote Climate functions to become inoperative, prevent vehicle status updates in the Kia Access app, and interrupt connected navigation routing services. To resolve this, follow the procedure outlined in this publication to install updated DCU software. Refer to [SST081](#) for software upgrade instructions using the Kia Diagnostic System (KDS) tablet with either the VCI-III or VCI-II with ECI Connector, and confirm the Upgrade Event Number/Name, ROM ID information, and Manual Mode passwords (if applicable) for the relevant vehicle.

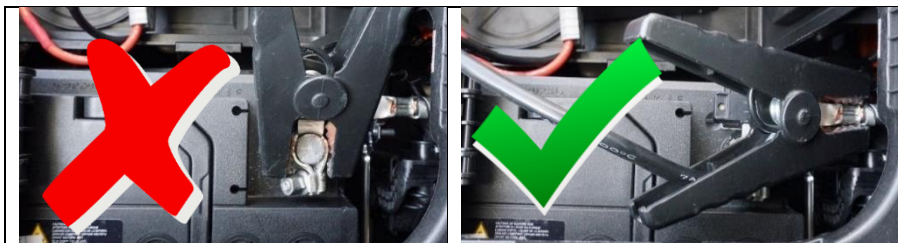
[Connect the negative \(-\) terminal to the battery as shown below.](#)

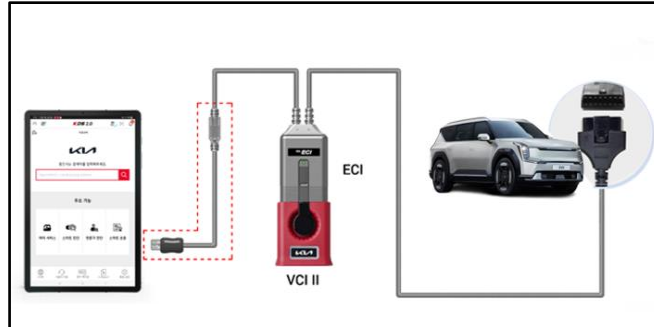
1. Connect the ECI DLC connector to the OBD-II connector, located under the driver's side of the instrument panel.
2. Connect the ECI USB -C connector to the KDS tablet.
3. Connect the VCI II to the ECI OBD-II connector.

Perform the update by connecting an additional ECI Connector to the VCI-II or by using a VCI-III Connector since the DCU upgrade uses ethernet for vehicle communication. The ECI Connector and VCI-III must be connected to the diagnostic terminal with a USB wired cable and the KDS tablet's IP must be set.

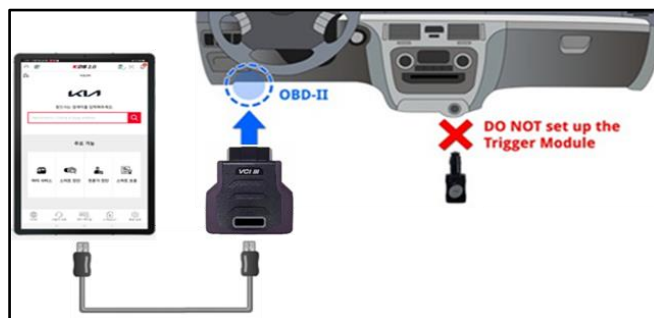
Using KDS + VCI-III Connection

1. Connect the VCI III USB-C connector to the KDS tablet.
2. Connect the VCI III to the OBD-II connector of the vehicle.
