SERVICE INFORMATION BULLETIN

APPLICABILITY:	All Models	NUMBER:	10-105-25R
SUBJECT:	New Procedure and Fail Code for First-Time Undetected A/C Refrigerant Leaks	DATE:	05/01/25
		REVISED:	03/26/26

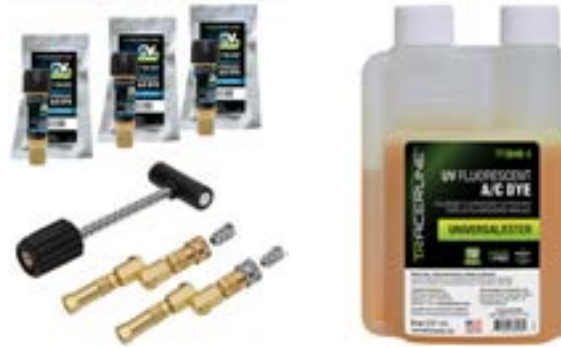
Subaru of America requires the use of Traceline dyes to assist in diagnosing refrigerant leak concerns. Traceline TP3840 can be sourced from many local auto parts suppliers. Traceline TP9815 and the required tools can be purchased at www.subaruretailersolutions.com.
