Technical product information

Topic	MIB3 Telecom Infotainment MMI becoming stuck on the 'initialisation/loading' screen Bentayga Series 23MY
Market area	Bentley: worldwide (2WBE), China 796 VW Import Comp. Ltd (Vico), Beijing (6796)
Brand	Bentley
Transaction No.	2079175/5
Level	EH
Status	Released for publishing
Release date	March 23 2026

MIB3 Telecom Infotainment MMI becoming stuck on the 'initialisation/loading' screen |
Bentayga Series | 23MY

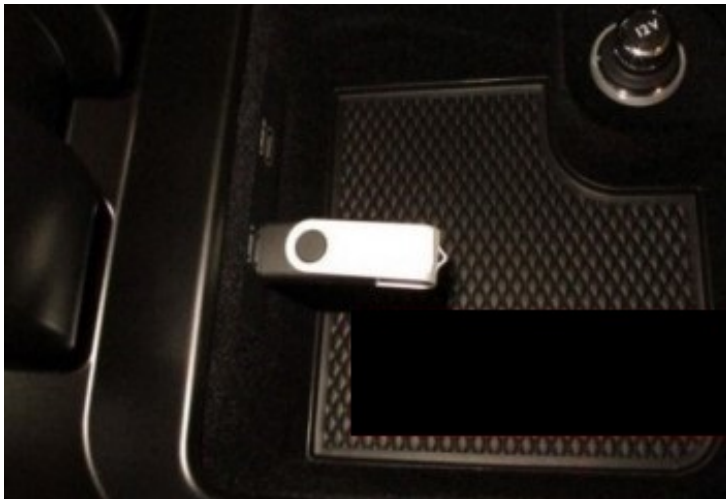
Figure 1

13. Insert the USB update stick with the instrument cluster software from **table 2** into the USB 1 socket (Figure 1).

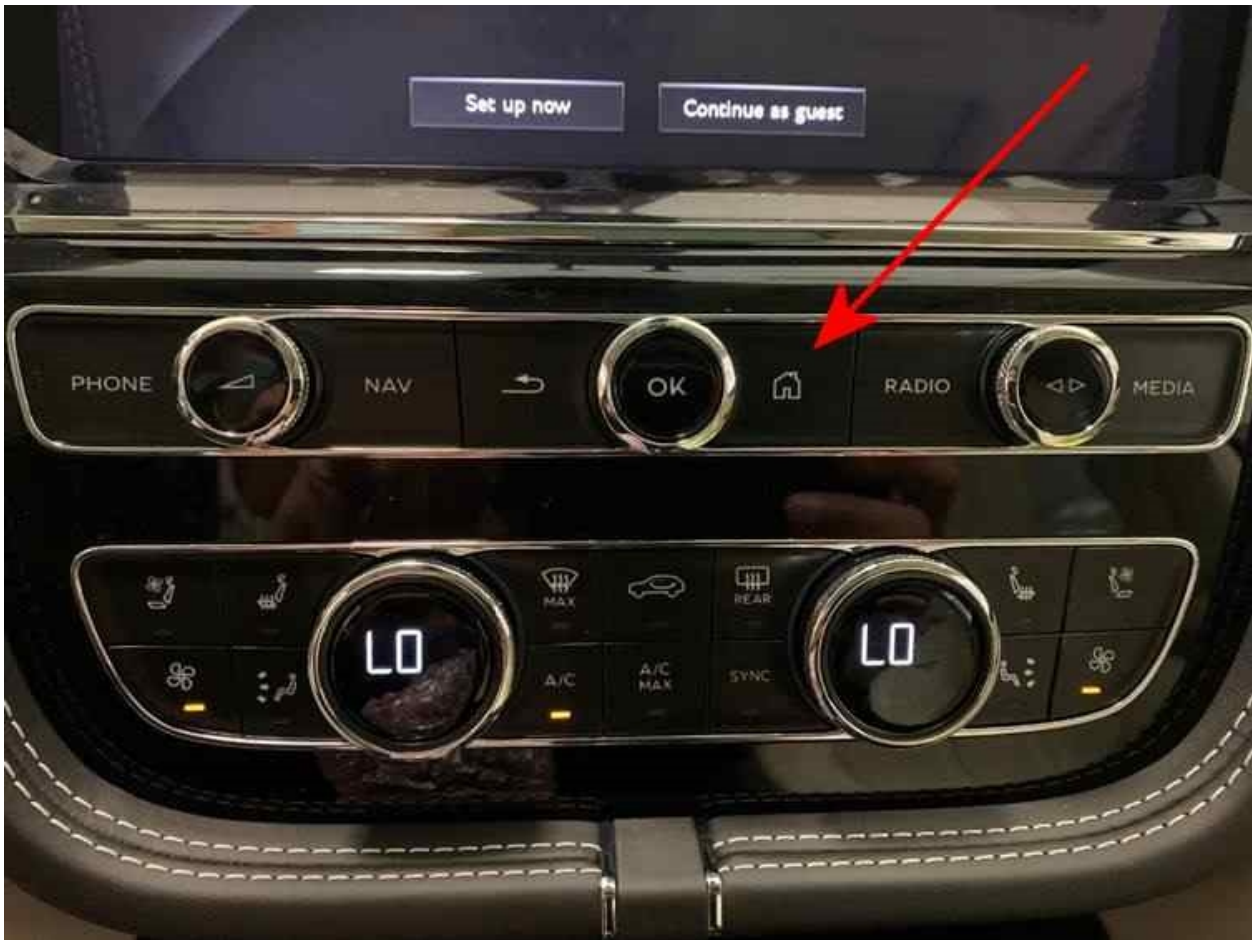
Figure 2

- Press the home screen button (Figure 2)

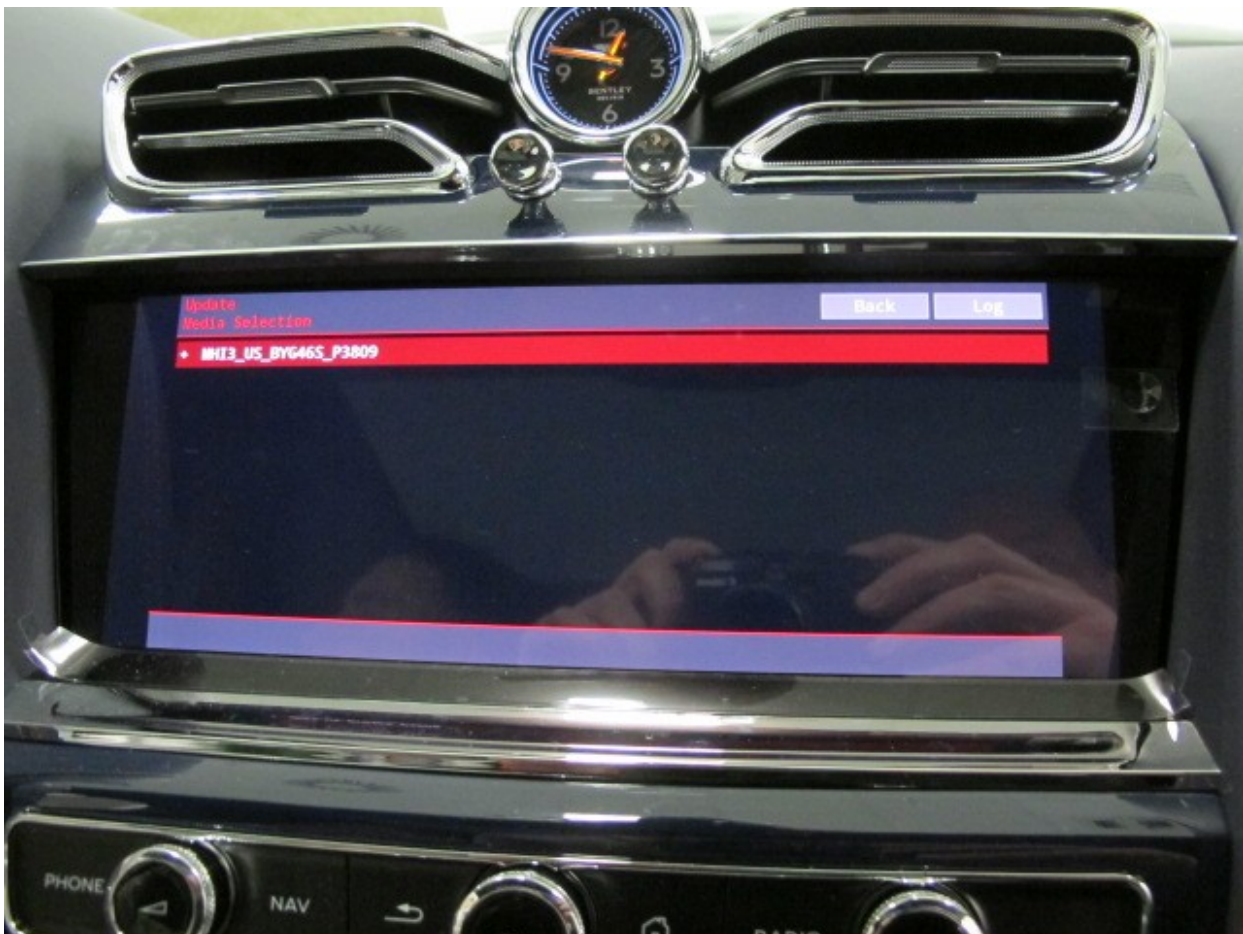
Figure 5

14. Select the suggested update. (Figure 5)

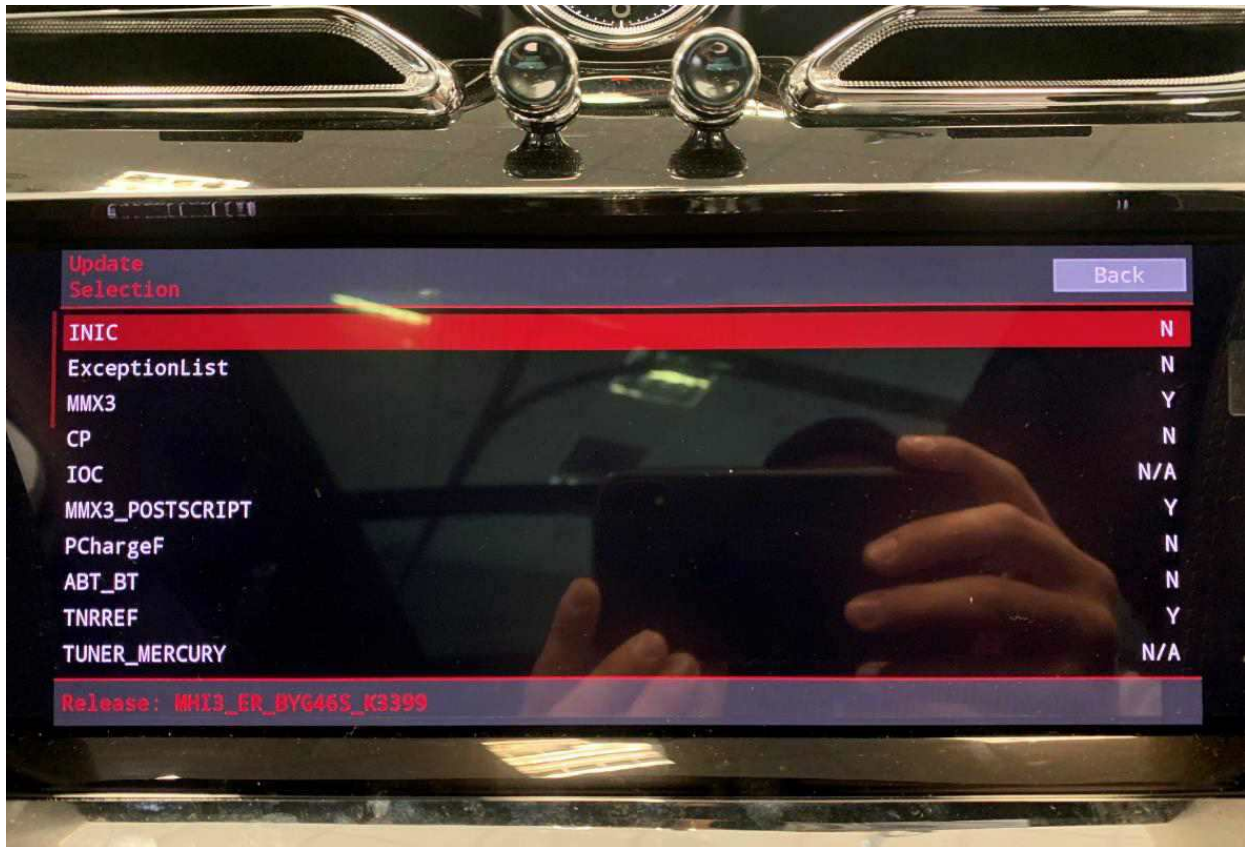
Figure 6

15. A summary of the proposed changes will then appear (Figure 6), scroll down and select 'Start update' (Figure 7)

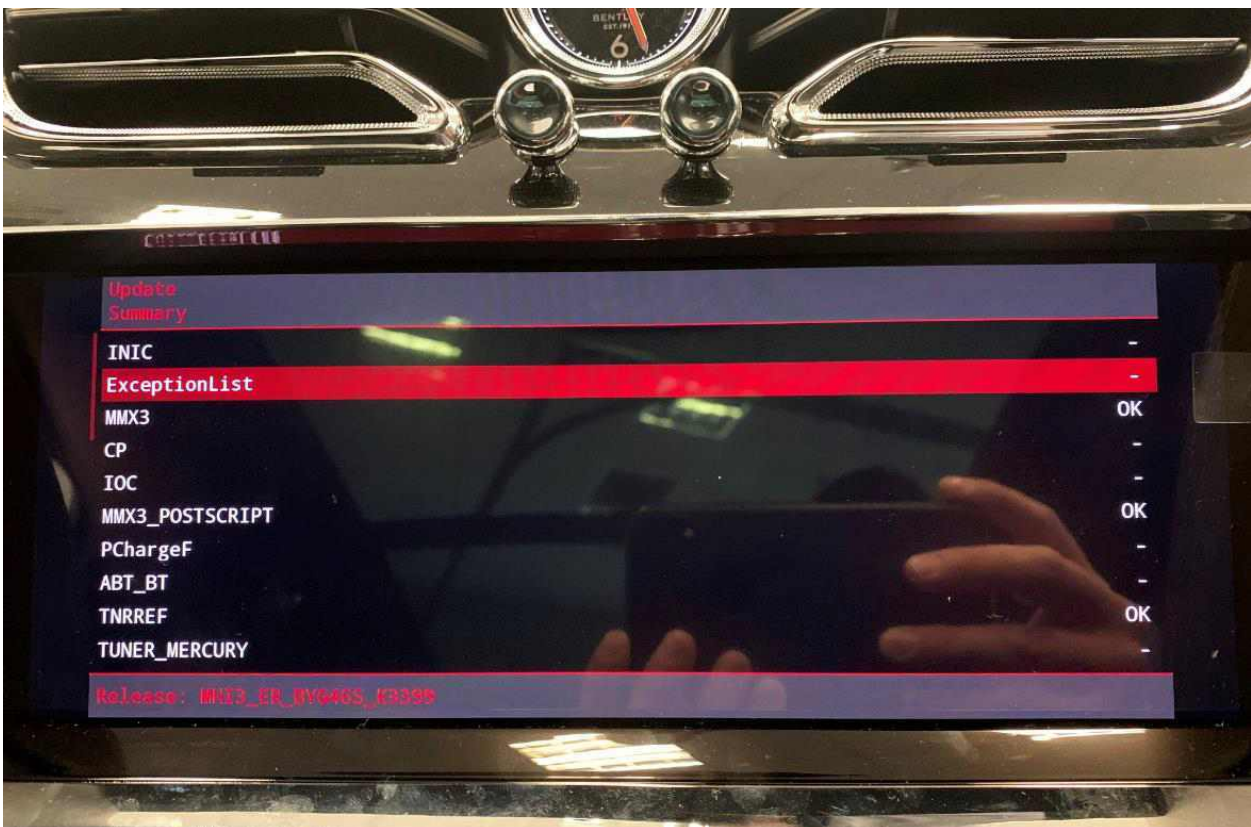
Figure 10

18. Once the update is complete a summary screen will be displayed. (Figure 10) Scroll down and press 'Resume' (Figure 11)

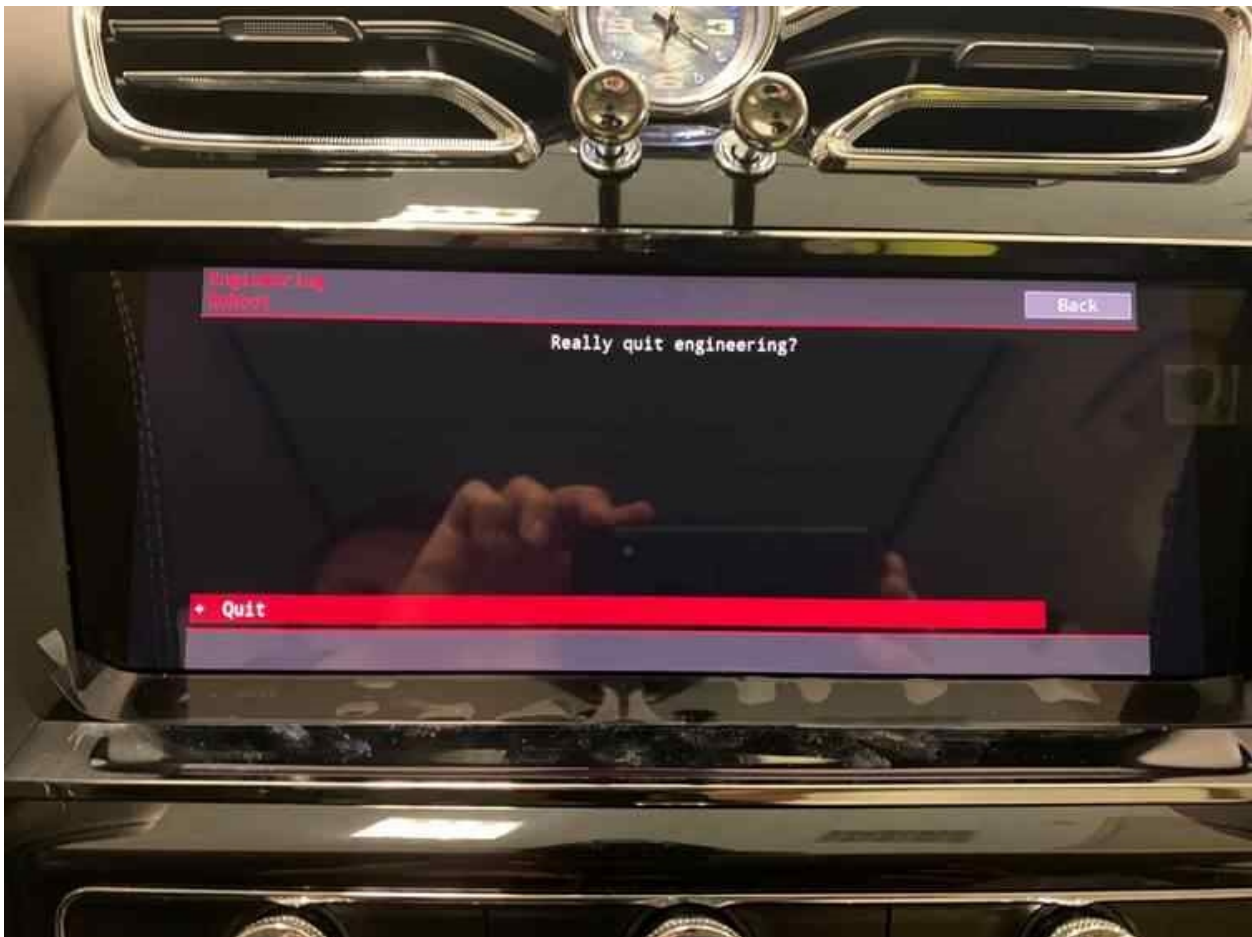
Figure 12

19. On the next screen select 'Quit' (Figure 12), the system will then reboot. Once the home screen is displayed, remove the USB update stick and carry out an ignition cycle.

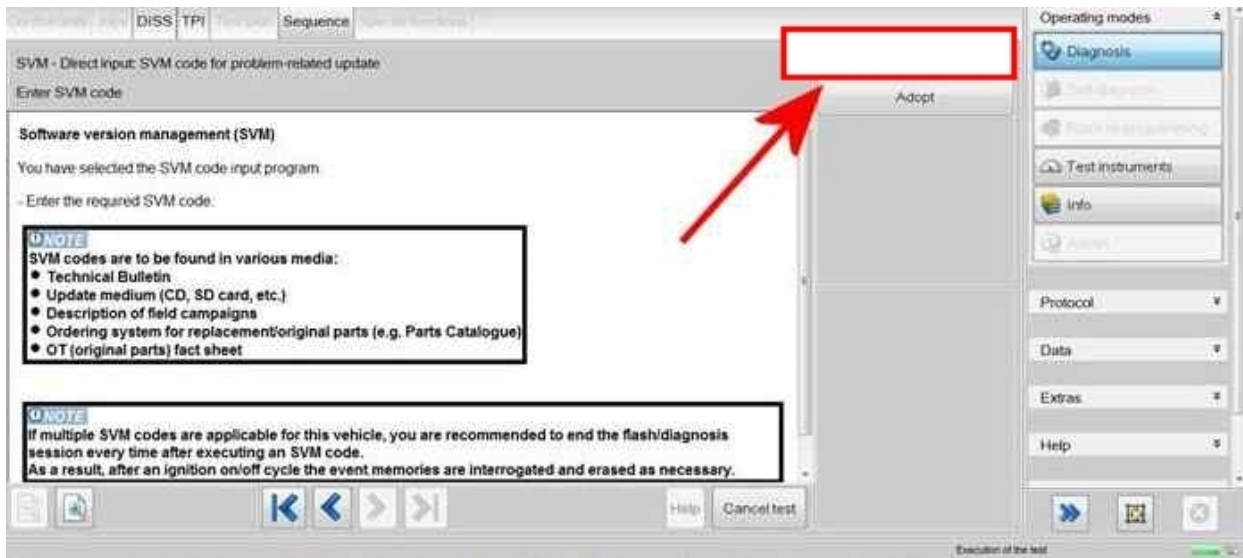
Figure 14

22. Navigate to 'SVM – Code Input' and enter the SVM Code and select adopt (Figure 14)

- If the vehicle is any variant of a Bentayga SWB, enter the SVM Code: 4V0CLUST37S2
- If the vehicle is any variant of a Bentayga EWB, enter the SVM Code: 4V1CLUST37S2

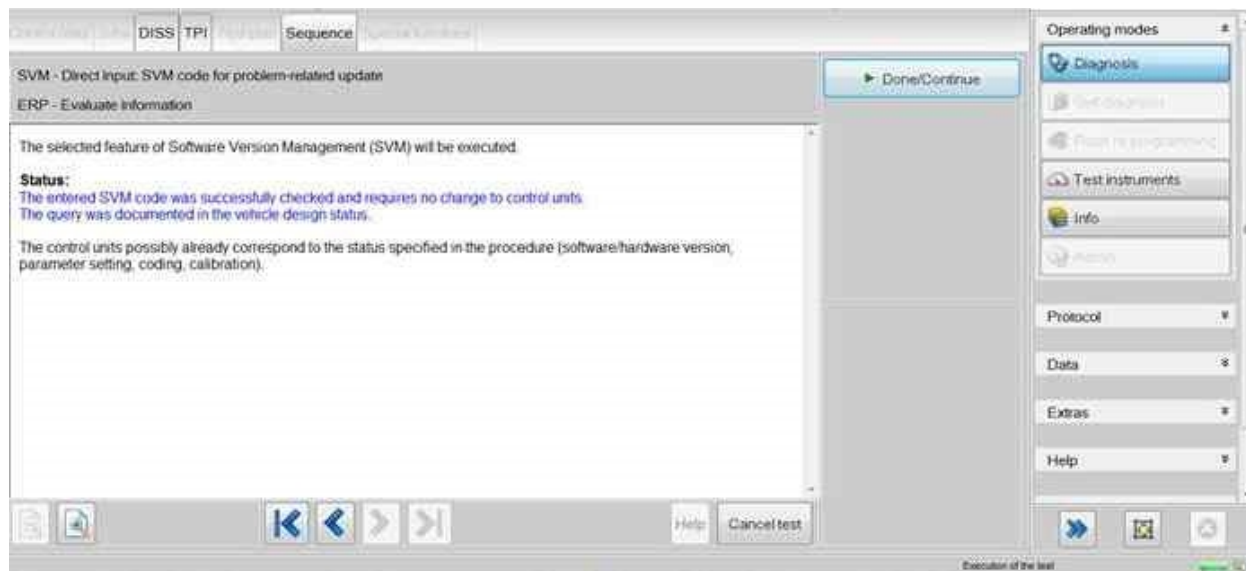
Figure 16

24. Once complete a summary screen will appear (Figure 16), this confirms successful completion - Follow any on screen prompts until program end
