Special Field Action 24L10

- What is the issue?** Documentation in your owner manual incorrectly states that your vehicle can be recreationally flat towed. You cannot recreationally flat tow your vehicle with all wheels on the ground because damage to the powertrain may occur.

- What will Lincoln and your retailer do?** **Software is available to repair your vehicle.** Lincoln has authorized your retailer to update the digital owner's manual in your vehicle free of charge. This Special Field Action will be in effect until March 31, 2027, regardless of miles.

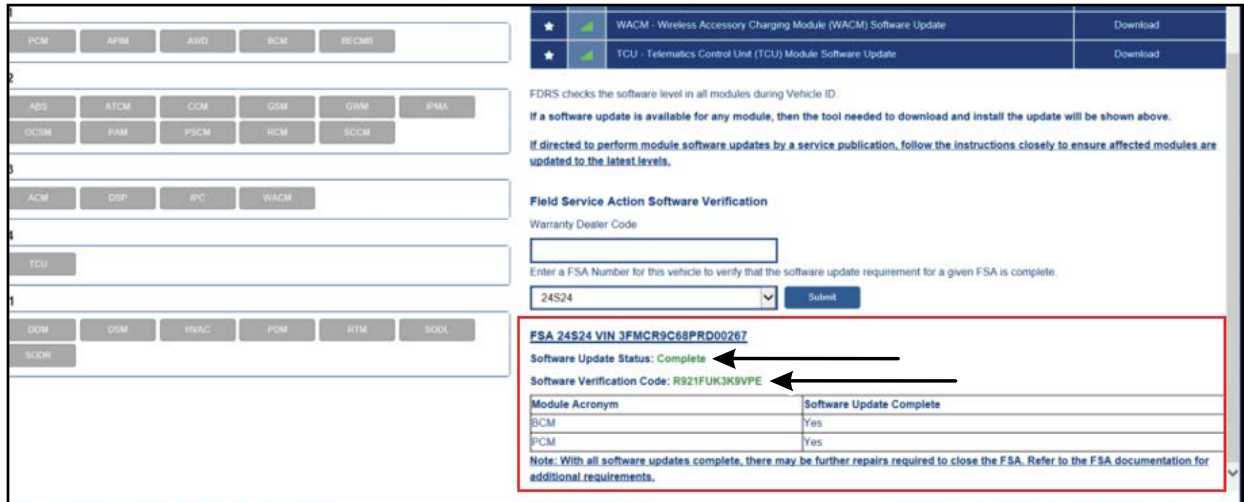
**FIGURE 2**

7. Does the FDRS Field Service Action Software Verification Status display a **Complete** status?  
See Figure 2.

- Yes** - This completes this FSA.
- No** - Proceed to Step 8.

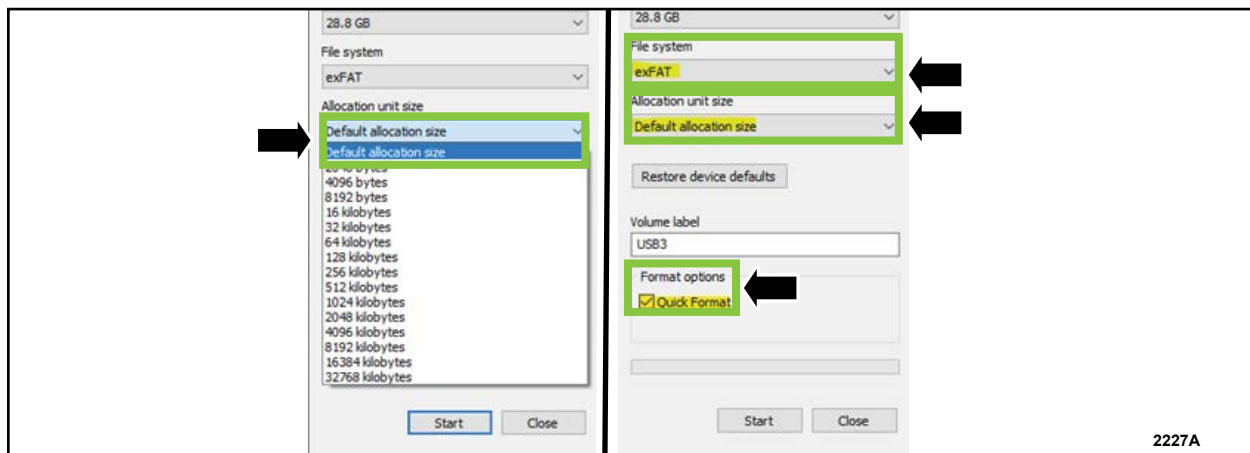
FIGURE 3

**NOTE:** A 64GB or larger USB flash drive is required for APIM, TCU, and GWM software updates. USB 3.0 or higher is recommended. Make sure the USB flash drive being used is formatted correctly. To see the available drives, hold down the Windows icon keyboard key and press the E keyboard key. Right click on the USB flash drive and select Properties. If File System under the General tab is not exFAT, the drive must be formatted.

- To format the USB flash drive:
  - a. Right click on the USB flash drive.
  - b. Select Format, select exFAT for the File System.
  - c. Select Default Allocation Size for the Allocation Unit Size.
  - d. De-selecting Quick Format is not necessary and will result in a lengthier operation.
