TECHNICAL INSTRUCTIONS
FOR
SPECIAL SERVICE CAMPAIGN 26TC02
REPROGRAMMING FOR PARKING ASSIST ECU
CERTAIN 2023 - 2024 SEQUOIA

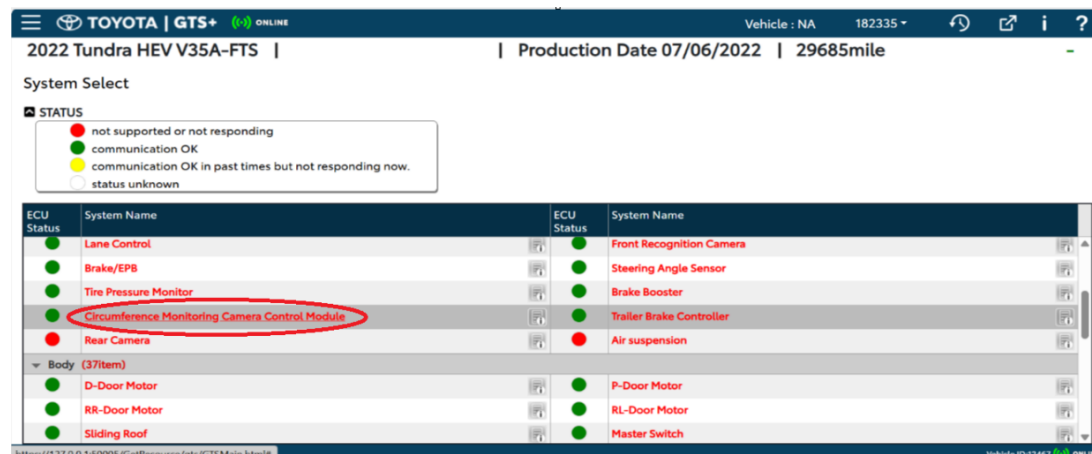
5. SELECT SYSTEM CHECK ON TOP LEFT CORNER & ACCESS CIRCUMFERENCE MONITORING CAMERA MODULE FROM THE LIST.

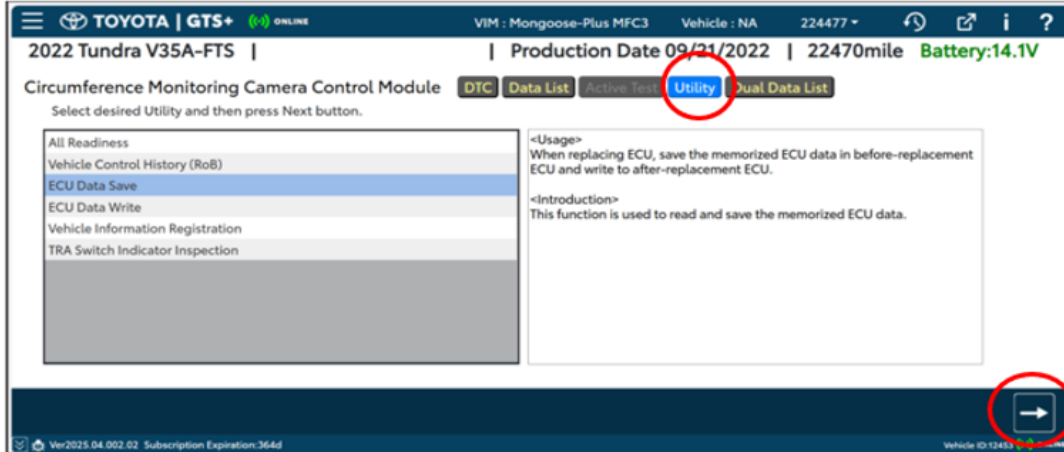
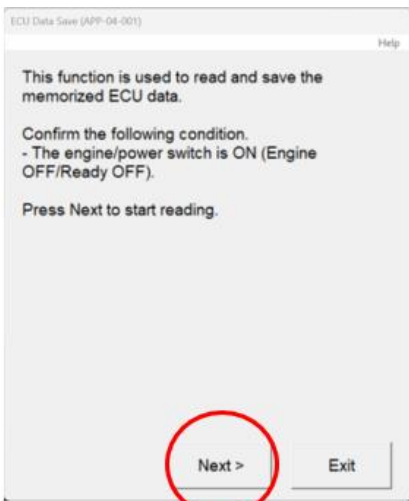
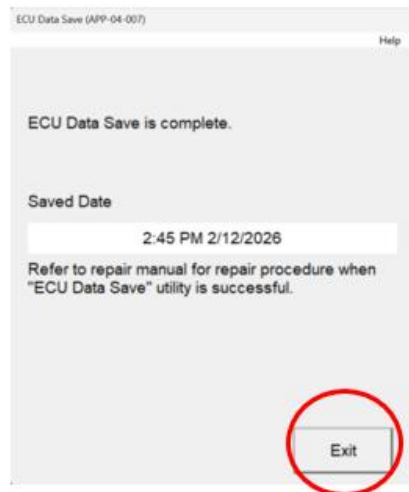
6. SELECT UTILITY & ECU DATA SAVE (This will generate a vehicle specific file saved in the background that will be used during the data write process)

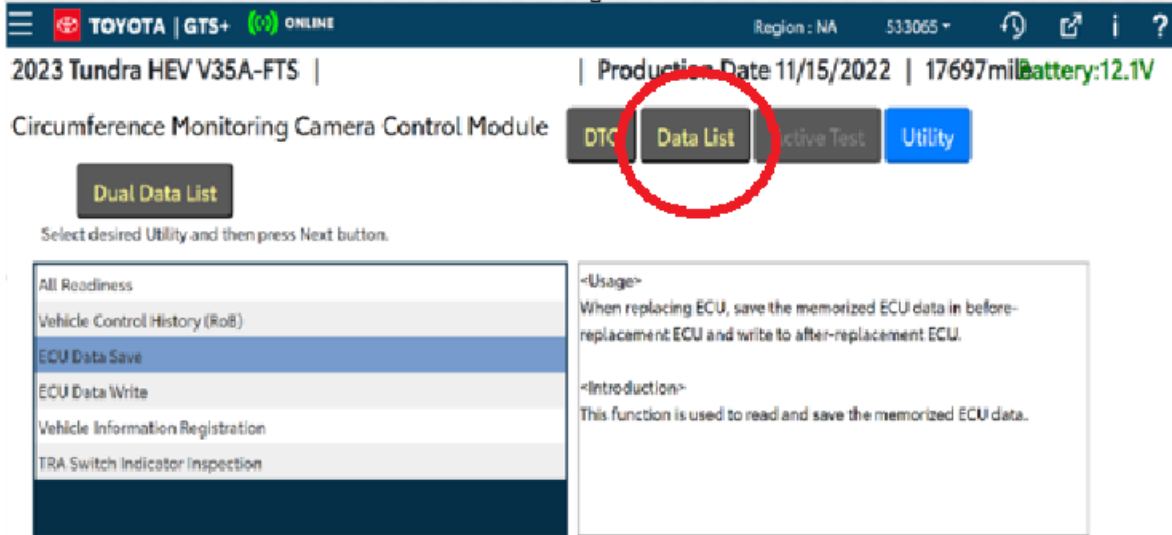
7. SELECT DATA LIST & TAKE A SCREENSHOT OF THE VALUES FROM THE DATA LIST TABLE TO INPUT LATER IN SECTION VIII STEP 8

***Note: If Aux camera is not on this list you will have to enter "Without" in Section VIII Step 7**

*We will be using the values from this data list table that were recorded at Section VI Step 7

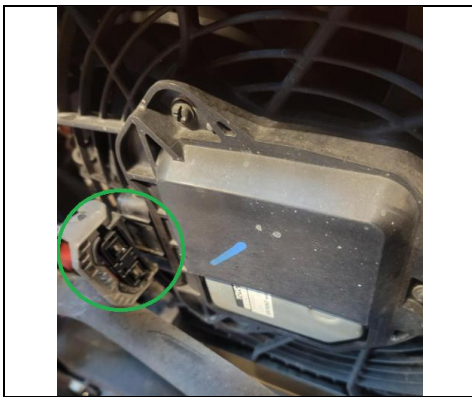
2. FOR HYBRID VEHICLES DISABLE THE ELECTRIC RADIATOR FAN BY UNPLUGGING THE CONNECTOR.

1. DISCONNECT THE DCA-8000
2. RECONNECT THE ELECTRIC RADIATOR FAN (HYBRID VEHICLES)

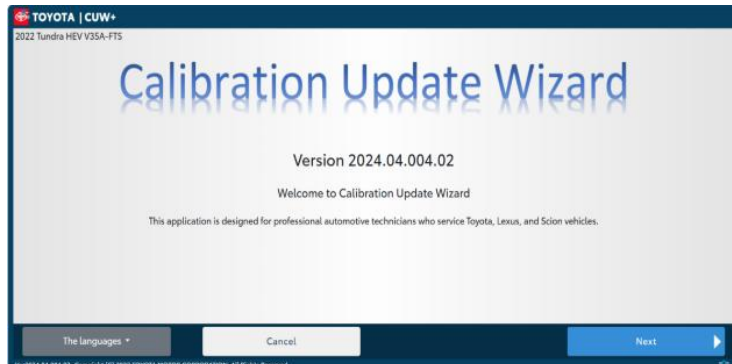
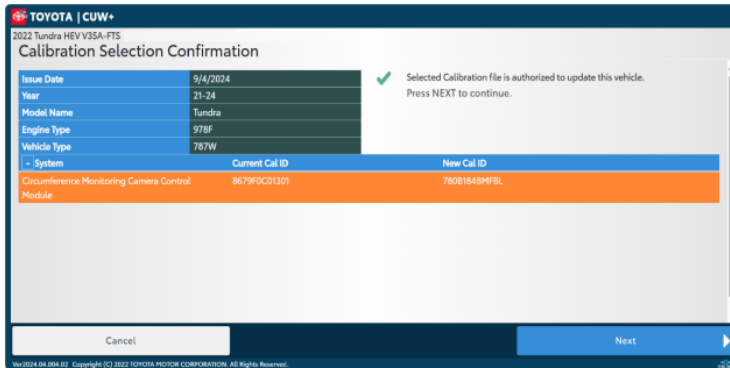
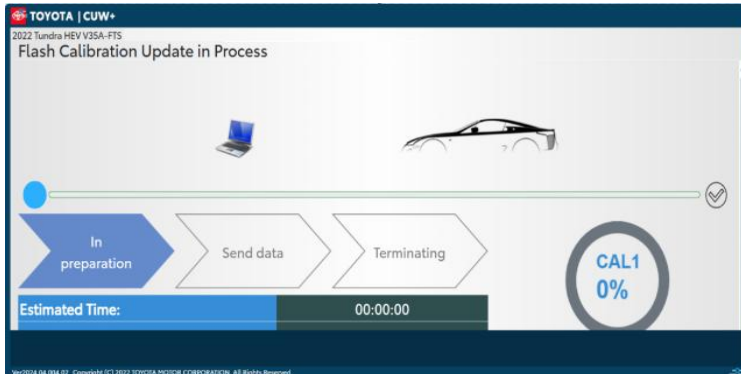
2. REFLASH THE PARKING ASSIST ECU USING FILE [660BS16BMFBL](#) (T-0162-24.cuw 12MB)

- a) Once the wizard loads, please follow instructions on screen.

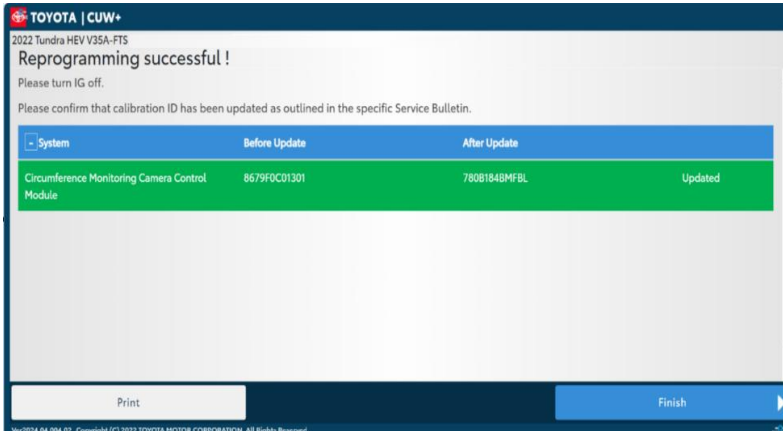
4. SELECT “FINISH” ONCE COMPLETED

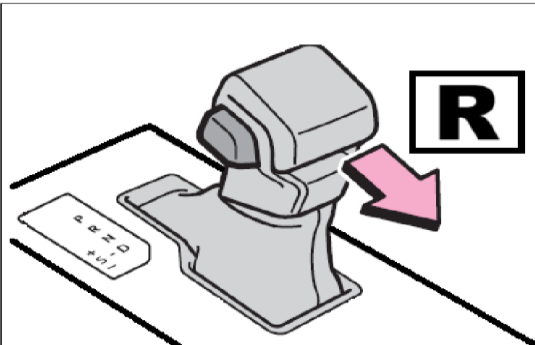
b) Put the gear selector in Reverse and back on Park for “CHK” to turn into “OK”.

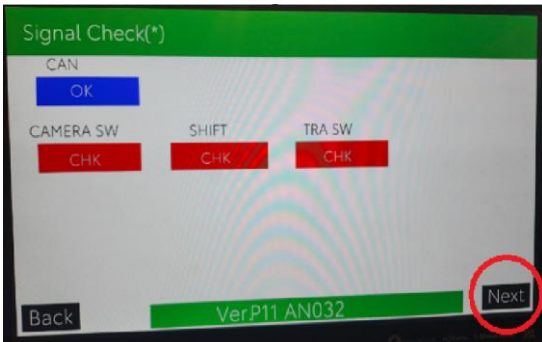
d) Once all checks are complete on the signal check screen select “Next” to end procedure on the Vehicle screen.
