BCM and ECM Reflash Sequence

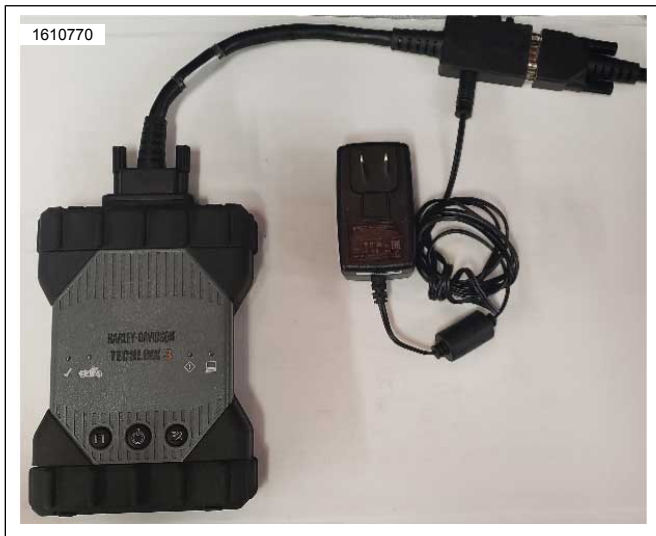
Figure 1. External Power Adapter

1. Connect battery tender directly to vehicle battery (not through battery tender lead).
 - a. Verify battery is fully charged before proceeding.
2. Connect external power to TL-3 appropriate power supply providing at least:
 - a. 12Voltage (V)
 - b. 1.2Amperes (A)

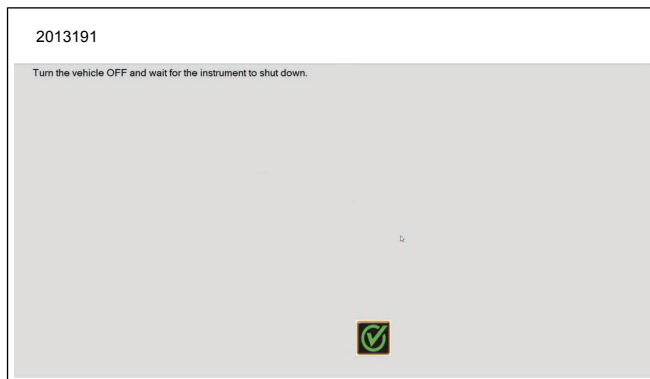
Figure 3. Power OFF Vehicle

An additional **ignition cycle** will be required and is part of the on-screen directions.
