## BCM and ECM Reflash Sequence

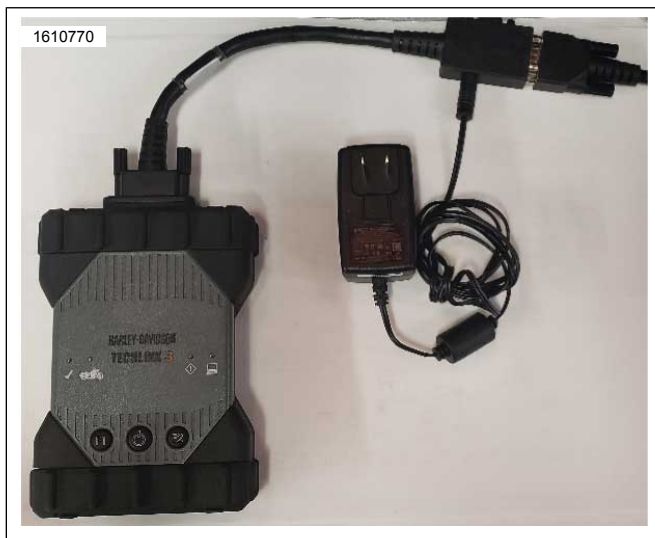
Figure 1. External Power Adapter

1. Connect battery tender directly to vehicle battery (not through battery tender lead).
  - a. Verify battery is fully charged before proceeding.
2. Connect external power to TL-3 appropriate power supply providing at least:
  - a. 12Voltage (V)
  - b. 1.2Amperes (A)

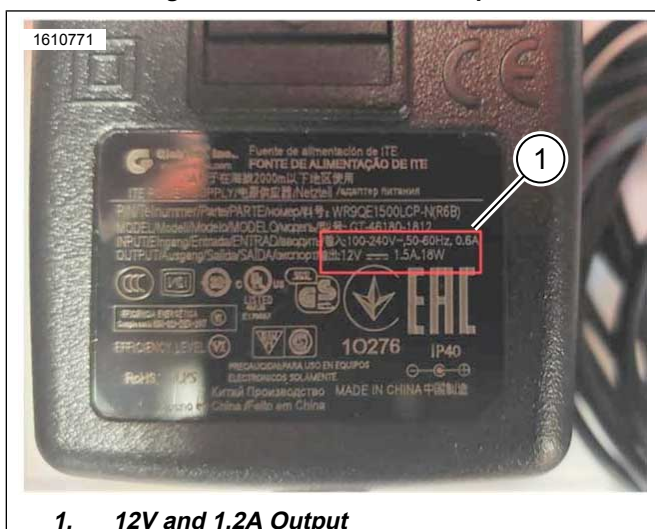
1. 12V and 1.2A Output

Figure 2. 12V and 1.2A Output

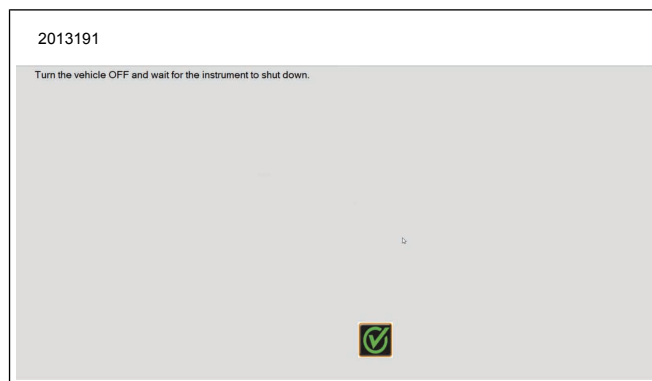
Figure 3. Power OFF Vehicle

An additional **ignition cycle** will be required and is part of the on-screen directions.

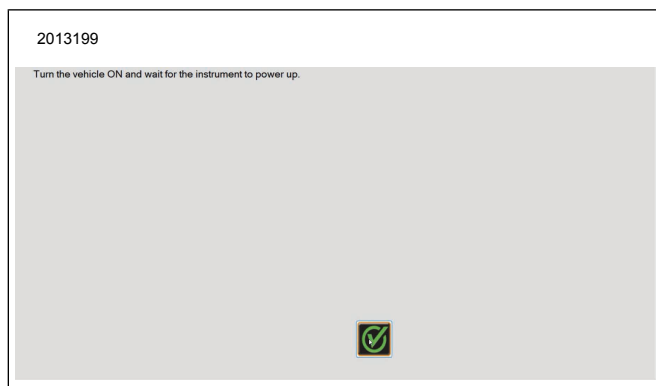
**Figure 4. Power ON Vehicle**
