Subject: N262547330 - Service Update
Telematic Control Module Reprogramming

Models: 2025-2026 Buick Enclave
2025 Cadillac CELESTIQ
2025-2026 Cadillac CT5
2024-2026 Cadillac LYRIQ
2025-2026 Cadillac OPTIQ
2026 Cadillac VISTIQ
2024-2025 Cadillac XT4
2024-2026 Chevrolet Blazer EV
2025-2026 Chevrolet BrightDrop 400
2025-2026 Chevrolet BrightDrop 600
2026 Chevrolet Corvette
2025-2026 Chevrolet Equinox
2024-2026 Chevrolet Equinox EV
2025-2026 Chevrolet Silverado EV
2025-2026 Chevrolet Traverse
2025-2026 GMC Acadia
2025-2026 GMC Sierra EV
2025-2026 GMC Terrain

N262547330 Telematic Control Module Reprogramming

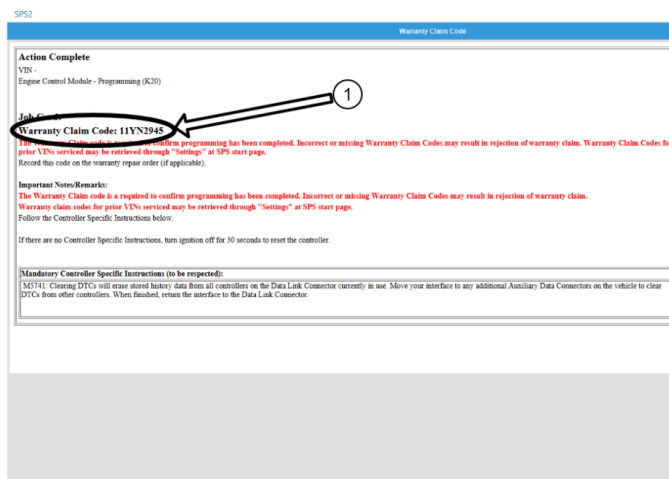
7001097

Important: To avoid warranty transaction rejections, you **MUST** record the warranty claim code provided on the Warranty Claim Code (WCC) screen shown above on the job card. Refer to callout 1 above for the location of the WCC on the screen.
