GROUP	MODEL
ELE	2027MY Telluride (LQ2a, LQ2 HEV)
NUMBER	DATE
421	April 2026

TECHNICAL SERVICE BULLETIN

SERVICE ACTION: DOOR HANDLE DISCHARGE LOGIC IMPROVEMENT (SA646)

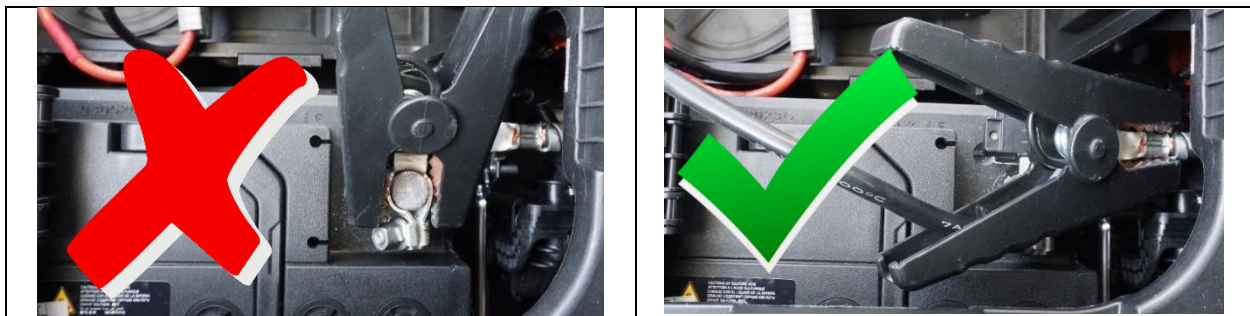
[Connect the negative \(-\) terminal to the battery as shown below.](#)

- Confirm a fully charged battery (12.3 volts or higher is necessary) is used or utilize a fully charged jump starter box connected to the battery.
- **Ensure the KDS GDS is sufficiently charged at 60% or higher prior to reflash.**
- All ECU upgrades must be performed with the ignition set to the 'ON' position unless otherwise stated.
- **Damaged VCI II units should not be used and promptly replaced.**
- Be careful not to disconnect the VCI-II connected to the vehicle during the ECU upgrade procedure.
- **DO NOT start the engine during ECU upgrade.**
- DO NOT turn the ignition key 'OFF' or interrupt the power supply during ECU upgrade.
- **When the ECU upgrade is completed, turn the ignition 'OFF' and wait 10 seconds before starting the engine.**
- ONLY use approved ECU upgrade software designated for the correct application.

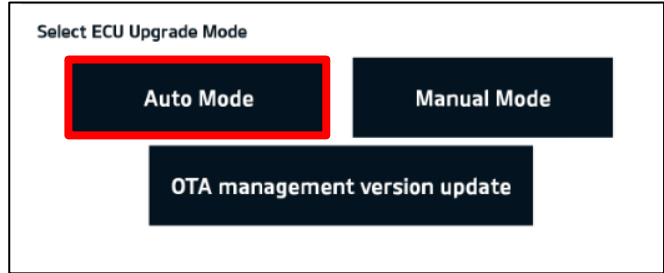
The required software must be installed by selecting the **'Auto Mode'** ECU Upgrade option.

Note: In some cases, the 'Manual Mode' installation option may be required ONLY if the 'Auto Mode' function fails or is otherwise noted above.

If the automatic upgrade fails, turn the ignition 'OFF' for about 10 seconds then place it back in the 'ON' position to reset the control unit BEFORE performing the manual upgrade.

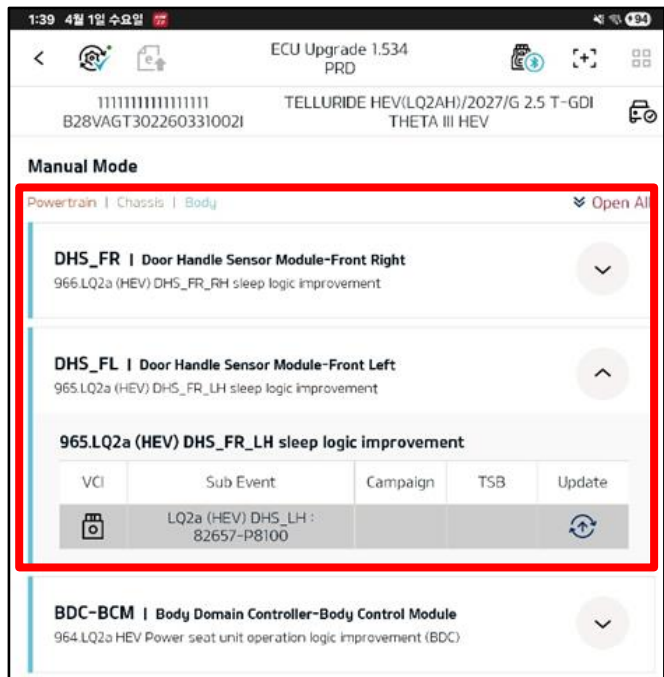
Select the applicable **'DHS_FR_LH'** and **'DHS_FR_RH'** system module and the Event Group.

- 965. LQ2a (HEV) DHS_FR_LH sleep logic improvement
- AND**
- 966. LQ2a (HEV) DHS_FR_RH sleep logic improvement

Verify the affected vehicle Calibration Identification of the applicable ECU ROM ID and reference the Information Table on page 3 as necessary.
