GROUP	MODEL
ELE	2022-2024MY EV6 (CV1)
NUMBER	DATE
420	April 2026

TECHNICAL SERVICE BULLETIN

ICCU INSPECTION/REPLACEMENT (WTY044)

This bulletin provides information associated with the 'Warranty Extension Program' (WTY044) to inspect and, if necessary, replace the Integrated Charging Control Unit (ICCU) and/or the ICCU Fuse on 2022-2024MY EV6 (CV1) vehicles produced from November 17, 2021 through July 22, 2024. The affected vehicles may exhibit difficulty or inability to charge the subject vehicles using Level 1 or Level 2 AC charging and/or inability to use the Vehicle-to-Load (V2L) function, and/or display of the "Check electric vehicle system" warning message. The warranty coverage for repairs related to the ICCU with above symptoms will be extended from 10 years / 100,000 miles to 15 years / 180,000 miles, whichever comes first, starting from the date the vehicle was first put into service. Follow the procedure outlined in this publication to inspect and, if necessary, replace the ICCU and/or ICCU Fuse on the applicable vehicle.

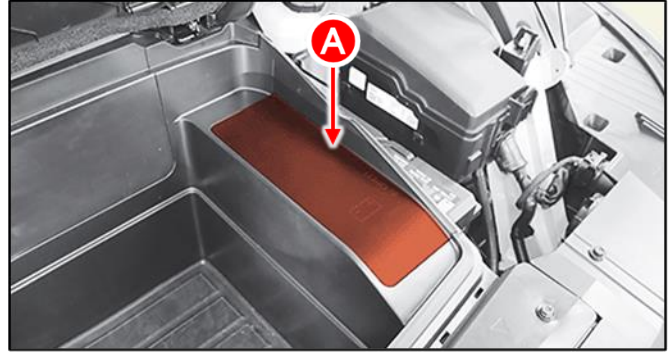
- 1a. Open the hood and open the auxiliary battery (12V) service cover and fuse (A).

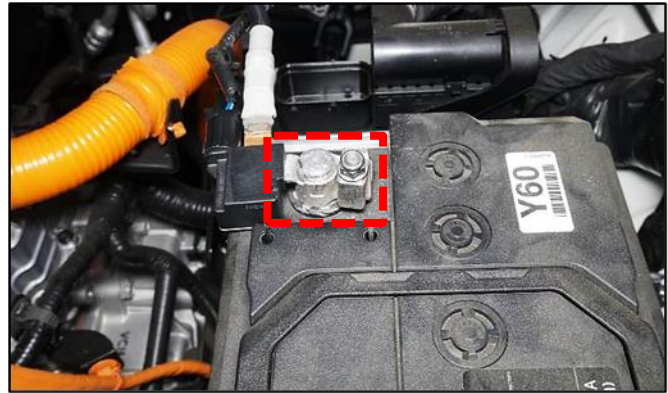
- 1b. Open the hood and disconnect the battery negative (-) post cable.

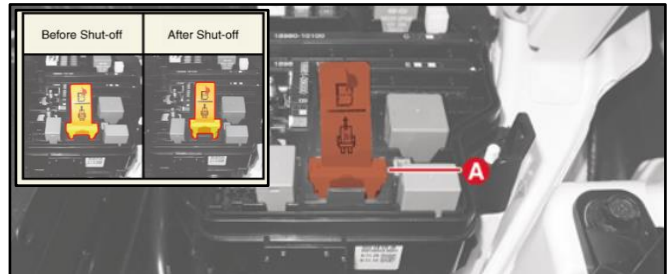
2. Perform the 'High Voltage Shut-Off Procedure' by referring to "Body Electrical System → High Voltage Shut-Off Procedures → High Voltage Shut-Off Procedures (Steps 1 - 4 Only)" in the applicable Shop Manual on KGIS.

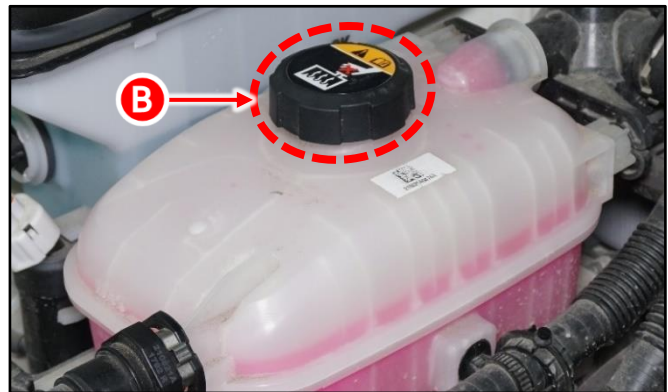
3. Open the coolant reservoir tank pressure cap (B) to release pressure.

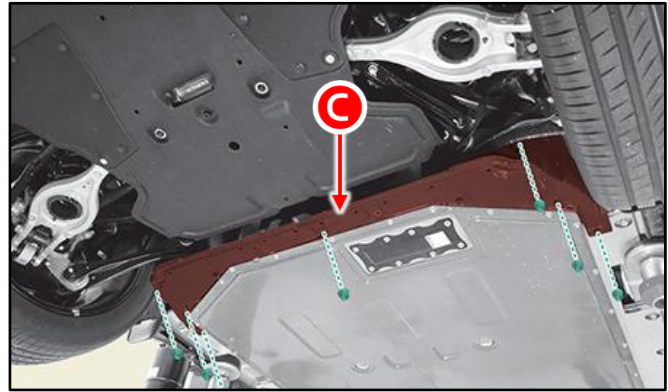
4. Remove the rear under cover (C).

Tightening torque for nuts:
5.8 - 8.7 lb.ft (7.8 - 11.8 N.m)

Note: Long Range model shown for reference use only.
Standard range will appear different.

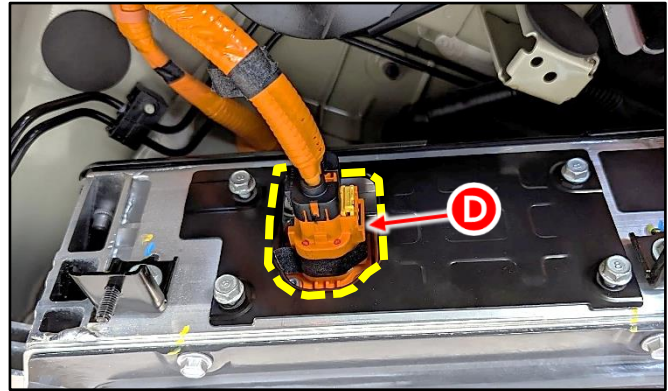
5. Disconnect the ICCU Connector (D).

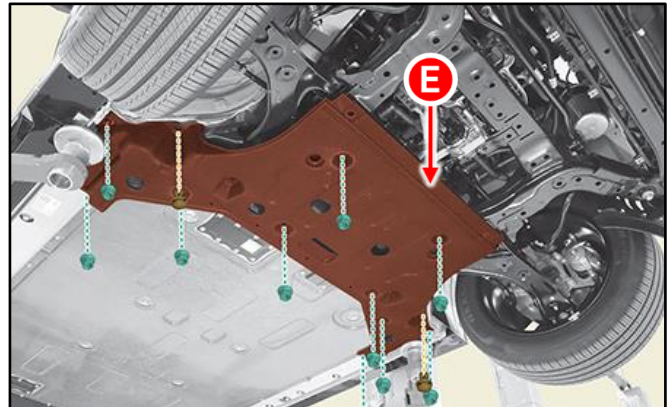
6. Remove the front rear under cover (E).

Note: The front under cover does not need to be removed. Image shown for reference only.

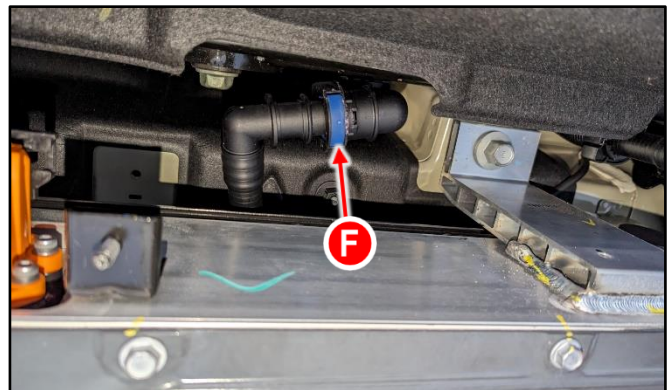
Front of Battery

7. Disconnect the blue rear coolant hose connector (F).

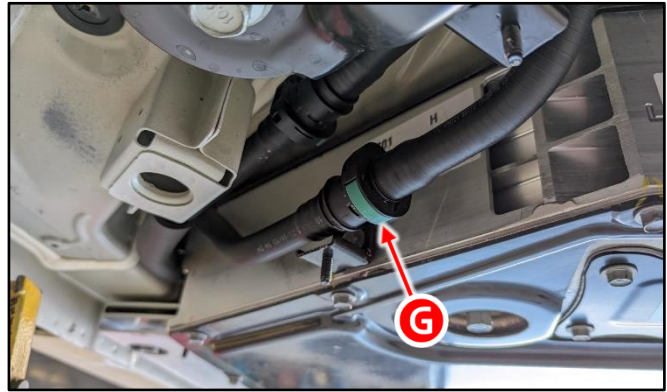
Rear of Battery

- 8a. Disconnect the front coolant **green** hose connector (G).

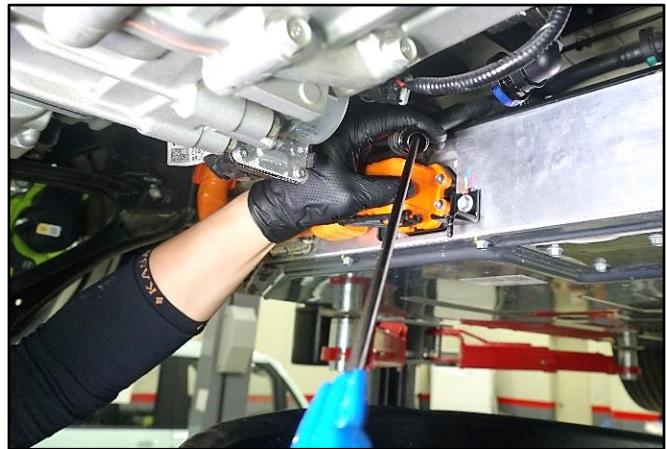
Front Right Side of Battery

- 8b. Using shop air, blow out the ICCU coolant from the **blue** rear disconnected coolant hose (F).

Wearing a rubber glove, create a tight seal using hand when blowing into the **blue** hose connector end.

Note: Use a drain pan to collect the coolant fluid from the front disconnected hose.

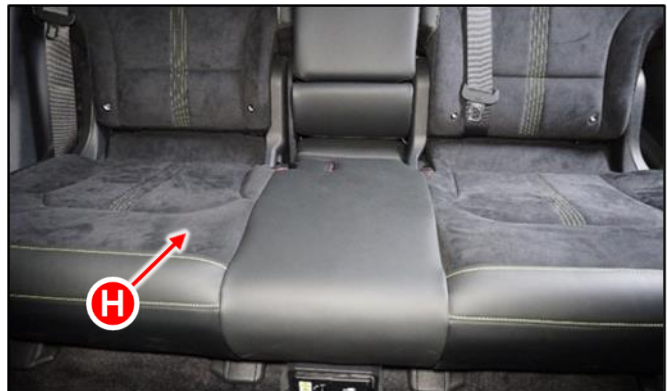
- 9. Remove the rear seat assembly (H) by referring to "Body Interior and Exterior → Rear Seat Assembly → Removal and Installation" in the applicable Shop Manual on KGIS.

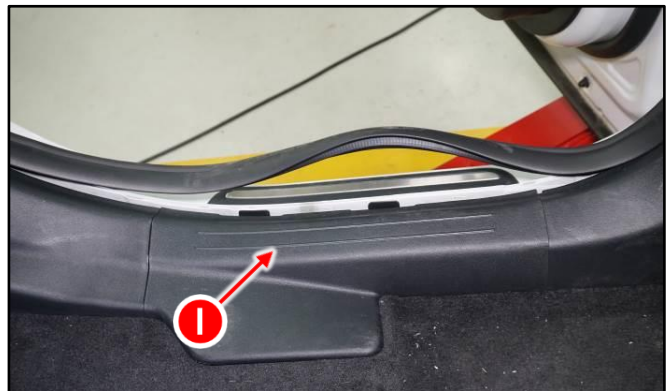
- 10. Remove the left (LH) and right (RH) side rear door scuff trim (I).

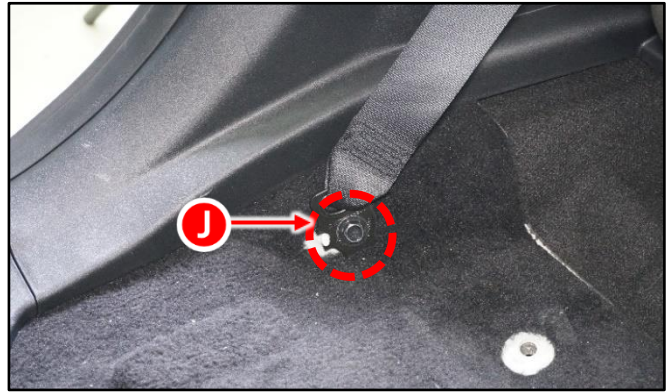
11. Remove **both** (LH and RH) the rear seat belt lower anchor retaining bolts (J).

Tightening torque for bolt (J):
29.7 - 44.1 lb.ft (40.2 - 59.8 N.m)

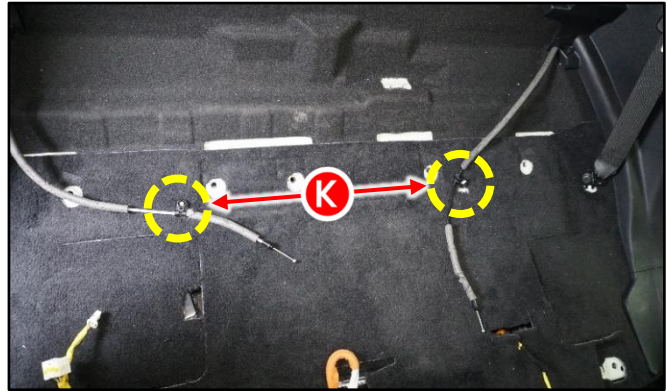
12. Detach the two (2) folding lever cables (K) from the floor carpet.

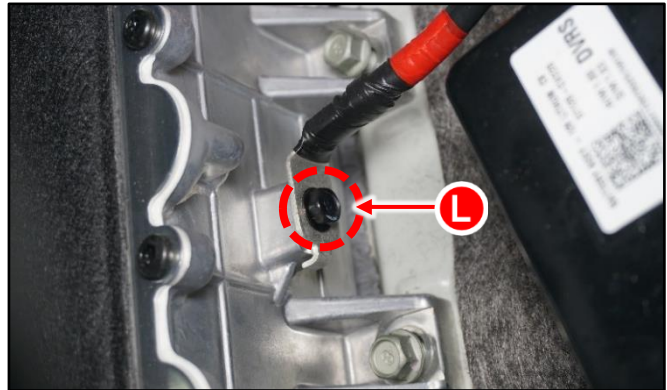
13. Disconnect the LDC cable by loosening the retaining bolt (L).

Tightening torque for bolt (L):
5.8 - 7.2 lb.ft (7.8 - 9.8 N.m)

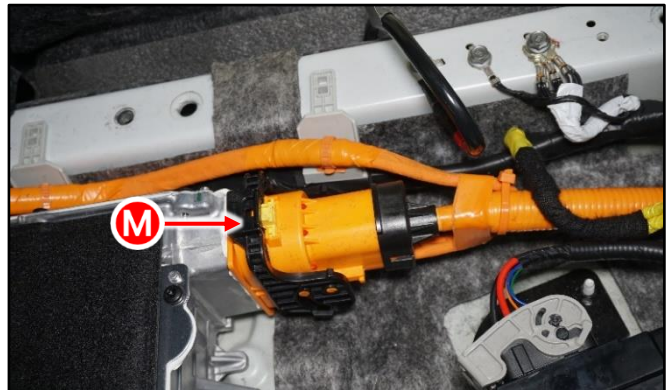
14. Disconnect the combo charge inlet wire harness connector (M).

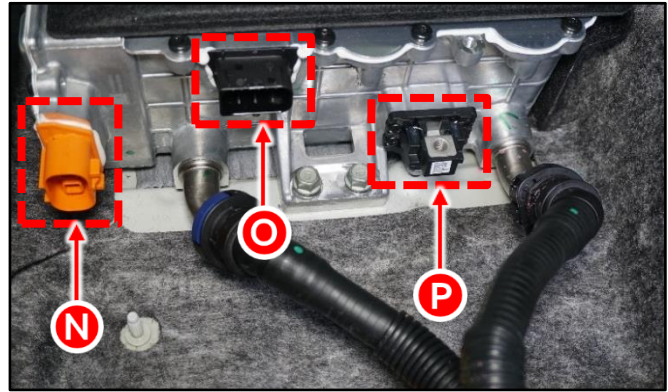
15a. Disconnect the following:

- HV power connector (N)
- ICCU connector (O)
- LDC positive (+) cable (P)

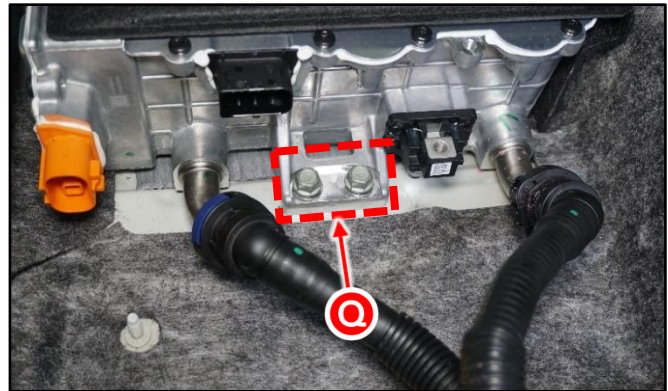
15b. Remove the two (2) ICCU assembly retaining bolts (Q).

Tightening torque for bolts (Q):
5.8 - 8.7 lb.ft (7.8 - 11.8 N.m)

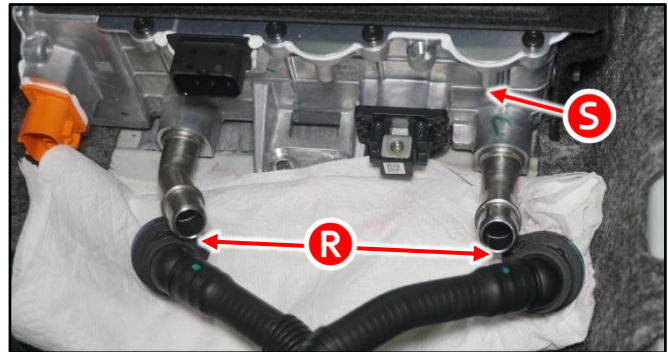
15c. Disconnect the two (2) ICCU coolant hoses (R) from the ICCU assembly (S).

Note: Place an absorbing towel to collect any remaining coolant fluid residue when detaching the coolant hoses.

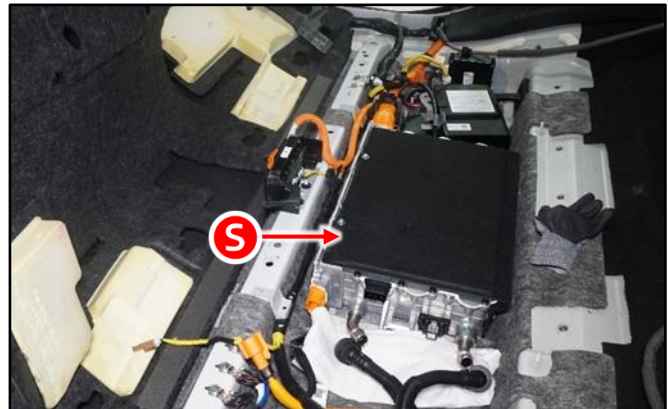
16. Replace the ICCU assembly (S) with a new part in the reverse order of removal.

Note: If ICCU Fuse Replacement is required, proceed to and complete steps for 'ICCU Fuse Replacement Procedure' on page 9 FIRST, then complete steps 17 - 18 below.

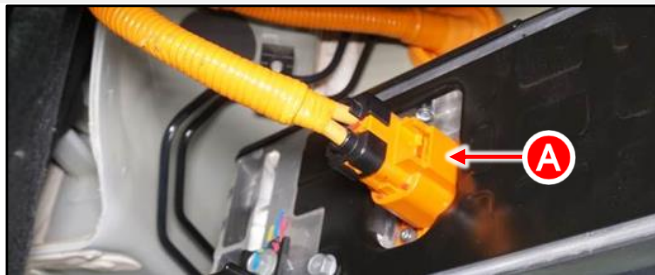
1. Disconnect the ICCU power cable (A) .

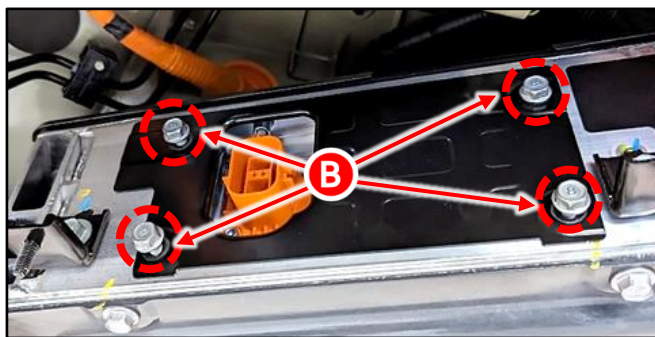
2. Remove the four (4) ICCU fuse service cover retaining bolts (B).

Tightening torque for bolts (B):
5.8 - 8.7 lb.ft (7.8 - 11.8 N.m)

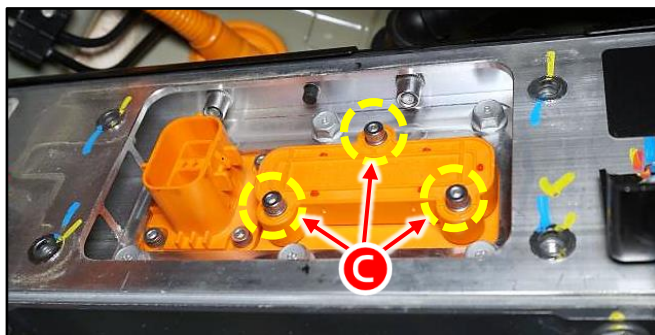
3. Remove the three (3) ICCU fuse cover retaining bolts (C).

Tightening torque for T3 hex bolts (B):
22.6 - 29.5 lb.in (2.5 - 3.3 N.m)

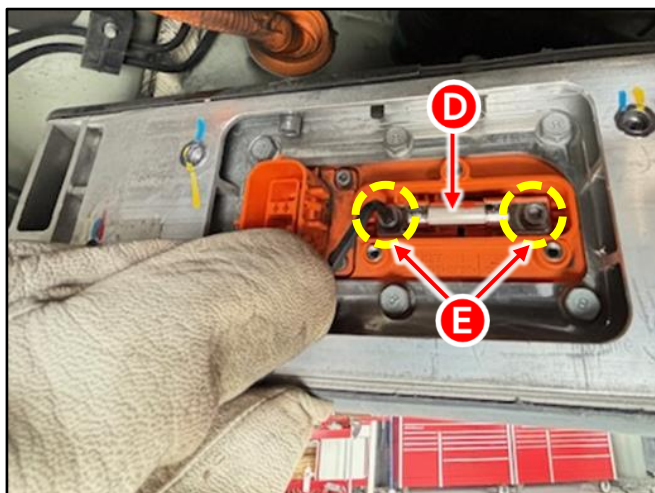
4. Carefully and gently remove the two (2) ICCU fuse (D) retaining allen head bolts (E) using a hand tool and replace the ICCU fuse (D) with a new part.

Tightening torque for T5 hex bolts (E):
39.1 -47.7 lb.in (3.3 - 4.0 N.m)

DO NOT use a power tool to remove these bolts. There are two (2) securing nuts inside the battery. If the nuts fall inside the battery, additional time will be required to extract them.
