UPDATED April 10, 2026 – STANDALONE PROCEDURE IS BELOW. The repair is a software update OR a check to make sure the software is at the current level with an ODR upload.

Module to be reprogrammed or checked to make sure it is at the current level:

- 1. PT_GWU**

2025MY - CX-50 Hybrid System Failure DTC P2530

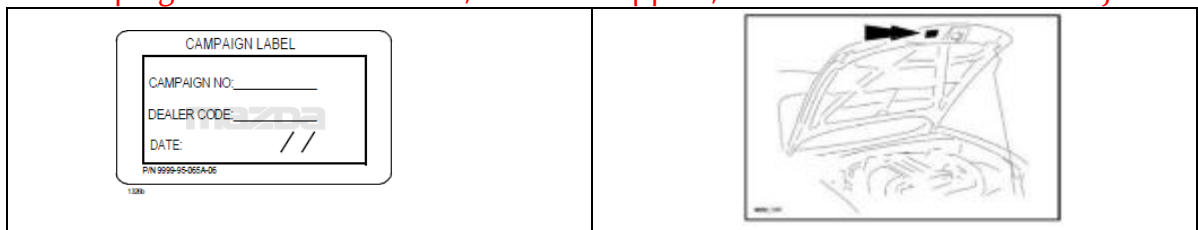
eMDCS - Warranty Vehicle Inquiry Results

2. If the vehicle is in the range above and SSPEO is in OPEN status in eMDCS, proceed to Step 3. If the vehicle does not have an OPEN SSPEO status, return the vehicle to the customer or inventory.
3. Perform an eMDCS Warranty Vehicle Inquiry and inspect the vehicle for a Campaign Label with SSPEO attached to the vehicle’s hood, driver door or firewall.

NOTE: Always be sure to verify the campaign number as the vehicle may have multiple campaign labels on the hood, radiator support, and firewall or driver door jamb.

If eMDCS displays:	Campaign Label is:	Action to perform:
If no repair date is displayed on the line with CAMPAIGN SSPE0, the campaign has not been completed on this vehicle	Present	Fill out Dealer Recall Help on OneMazda contact or the Mazda Warranty Department at warrantydept@mazdausa.com to review vehicle history.
	Not present	Proceed to "REPAIR PROCEDURE".
If repair date is displayed for CAMPAIGN SSPE0, is "CLOSED"	Present	Return vehicle to inventory or customer.
	Not present	Complete a label and apply to vehicle's hood with repair date and dealer code from eMDCS Warranty Inquiry.
CAMPAIGN SSPE0 is not displayed	See Action	The vehicle is not affected by the SSP

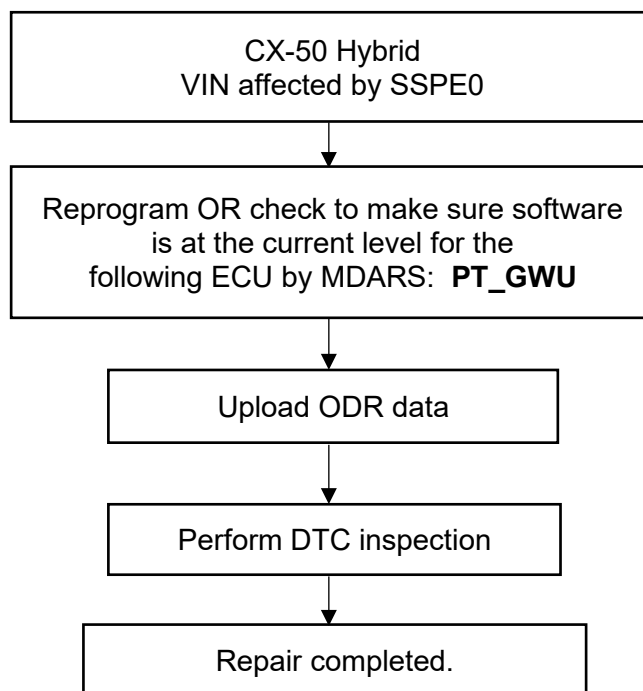
Section A: Flow Chart: NOTE: This Flow Chart needs to be followed strictly and the CAUTIONS must be read before proceeding

CAUTIONS: DTC P2530:12 IS NOT REQUIRED TO BE PRESENT TO COMPLETE THIS REPAIR. Always check for an aftermarket device connected to the DLC port and remove before proceeding with connection.

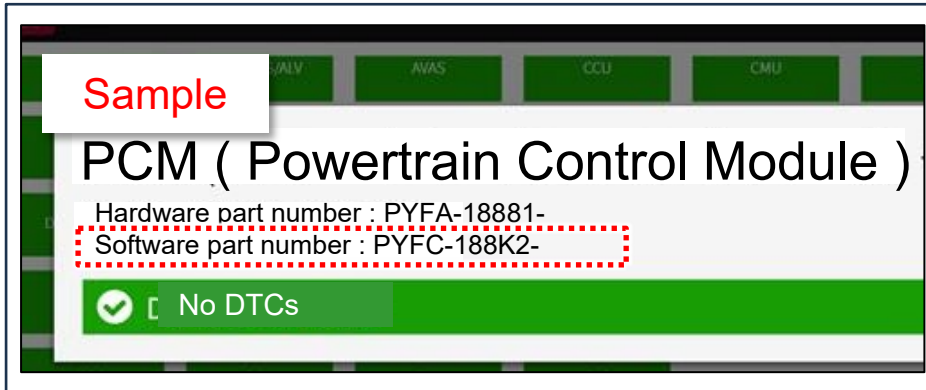
1. Check the file version of each ECU listed in the countermeasure repair procedure. Compare the software version of each ECU with the software version in the repair procedure.
 - a. If the vehicle software version is newer, do not perform reprogramming.
 - b. If the vehicle software version is older, perform reprogramming.

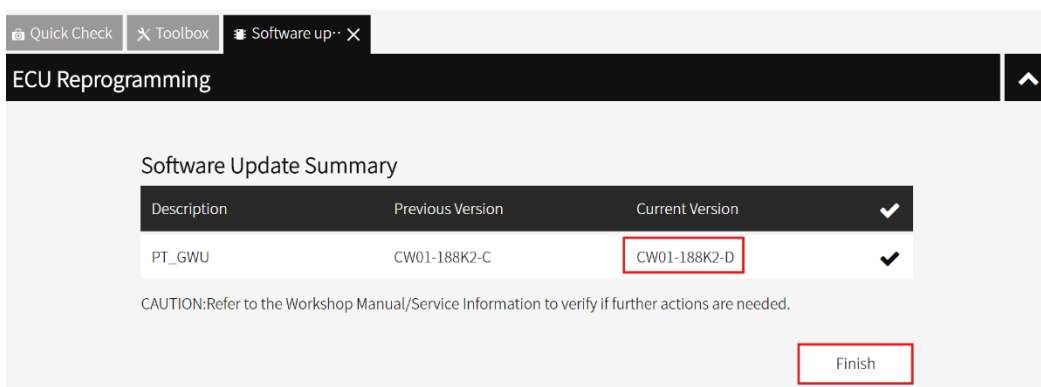
3. Confirm the current and new software versions, click "Next". If the software is at the current level, do not stop repairing and continue with all remaining steps including Uploading ODR data and Campaign Label Installation.
4. Wait for the download and click "Next".

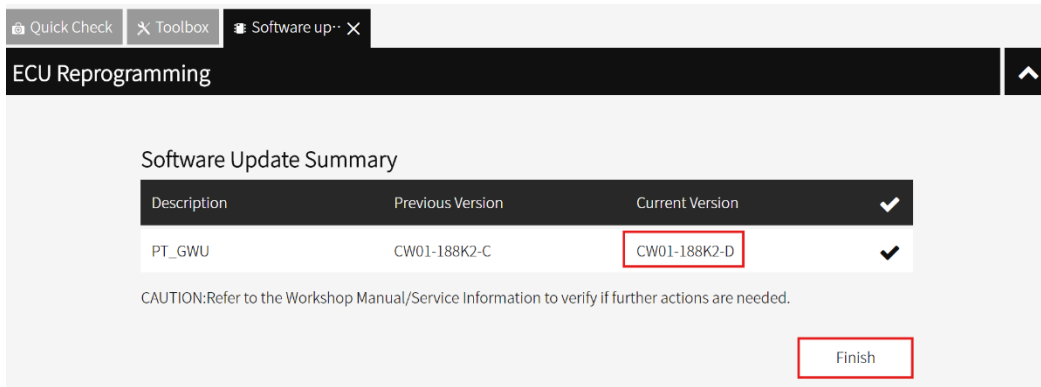
Example

5. After completion of software update, the previous and current software version are shown.
 - Check current version at "Calibration File information below".
 - Then, click on "Finish" to exit the ECU reprogramming.

Model	Module	Target ECU (hardware #)	Target ECU NEW Software file # (or latest version)	Reprogramming Time (min.)
CX-50 HYBRID	PT_GWU	CW01-67GMX-	CW01-188K2-D	3

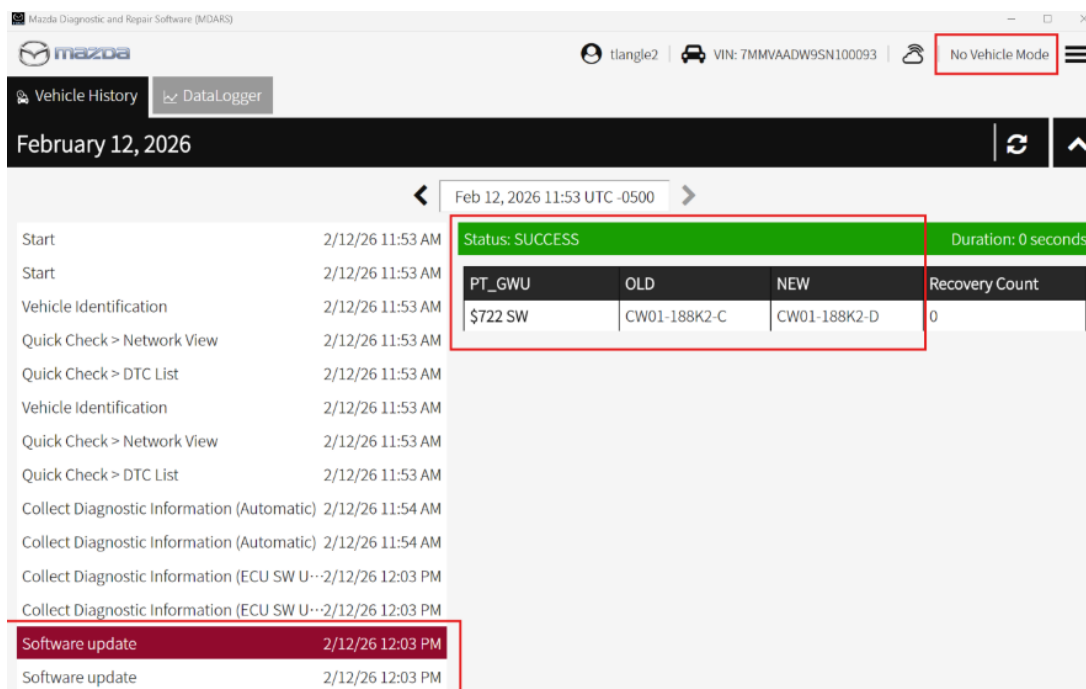
There must be a "Software Update" entry in MDARS for the PT_GWU. If you do not have an entry for PT_GWU, go back to step 1 of the repair.

PT_GWU module is updated (or check to make sure software is at current level) – this is only an example

6. Check to make sure PT_GWU module was updated OR at the current level.

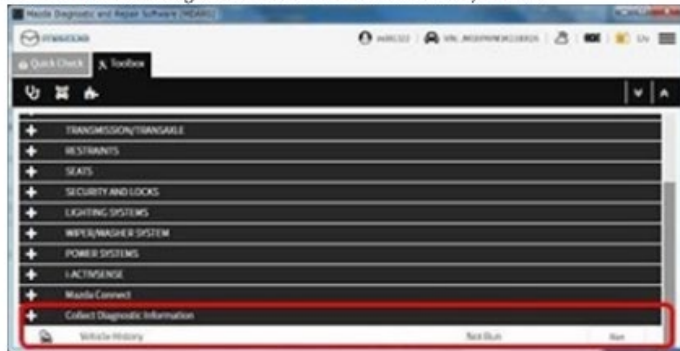
1. Toolbox → Collect Diagnostic Information → Vehicle History → "Run"

- 1) Check and erase DTC by using MDARS.
- 2) Confirm all DTCs were erased.
