<b>Release Date</b>	04/01/2026	<b>Technical Service Bulletin</b>	
<b>93N6 UPDATE</b> <b>Software Update for Battery Modules Control Unit –</b> <b>(High-Voltage Battery Warranty)</b>

<b>This Update has been proactively released to prevent the following condition(s) from occurring in the vehicle:</b>	
<b>Criteria</b>	<b>Technical Background</b>
S1	A software update is necessary on Audi e-tron vehicles manufactured within a specific period. The battery system of an electric vehicle consists of a large number of individual battery cells. These cells have the same capacity and slightly different cell voltages. Without a balancing function, the capacity of the entire system would align itself with the capacity of the weakest cell. In addition, individual cells could be overloaded and age more rapidly. The efficiency of the balancing function may be affected by a possible error in the cell voltage measurement. This software update optimizes the function of the control unit with respect to balancing and stabilizes the cell voltage measurement.

<b>Criteria</b>	<b>Remedy</b>
S1	Update of the battery modules control units and, if necessary, further control units in the system will be update

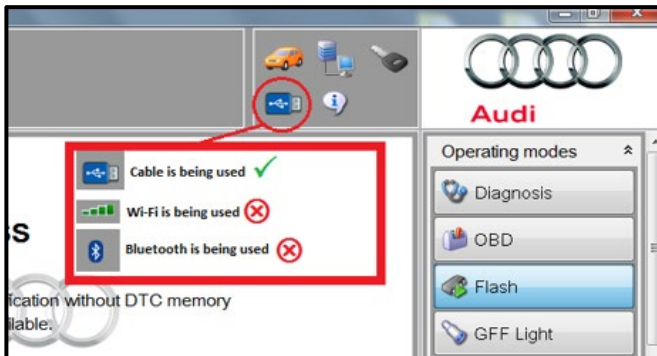
- Connect the VAS6150X/VAS6160X Diagnostic Tester to the vehicle.
- Start the ODIS program.
- Confirm that scan tool is communicating with the diagnostic head by USB cable.
  - If the Bluetooth or WiFi symbol is shown, then disconnect the diagnostic head from the vehicle and reconnect the USB cable to the diagnostic head and then reattach to the vehicle.

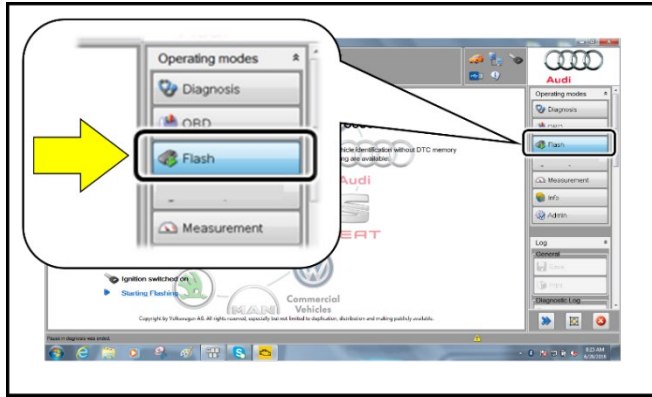
- From the home screen of the scan tool highlight “Flash” <1>.
- Follow the on-screen prompts.

Operating mode “Flash” must be used. Performing this software update using “Diagnosis” (Guided Fault Finding) could result in non-payment of the claim.

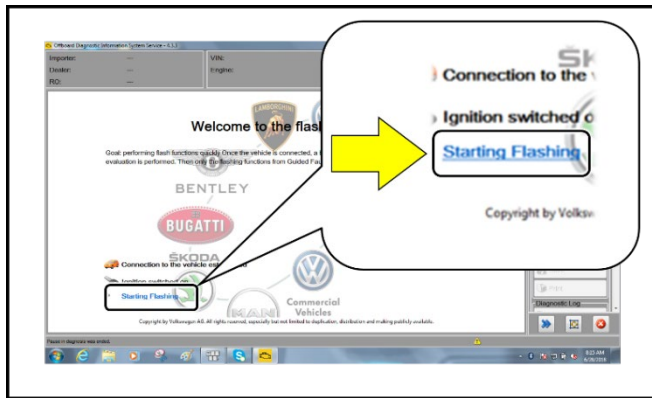
- Select “Starting Flashing” and follow the on-screen prompts.

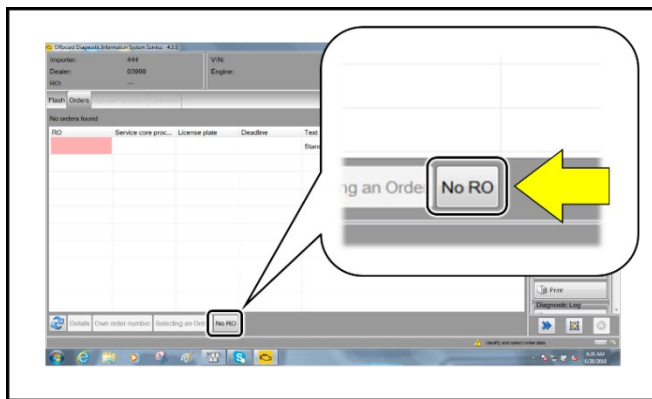
- Select “No RO”.

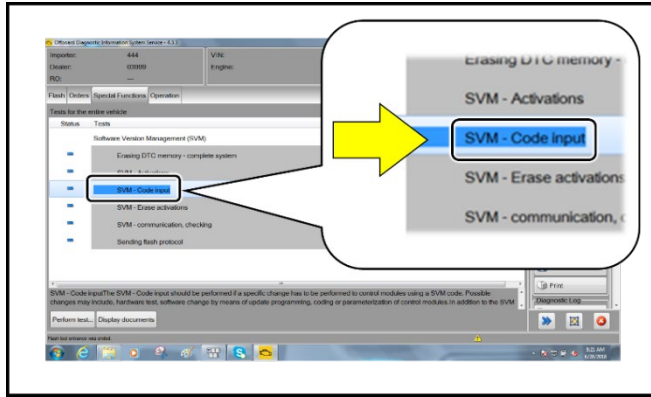
- Highlight “SVM – Code Input”.

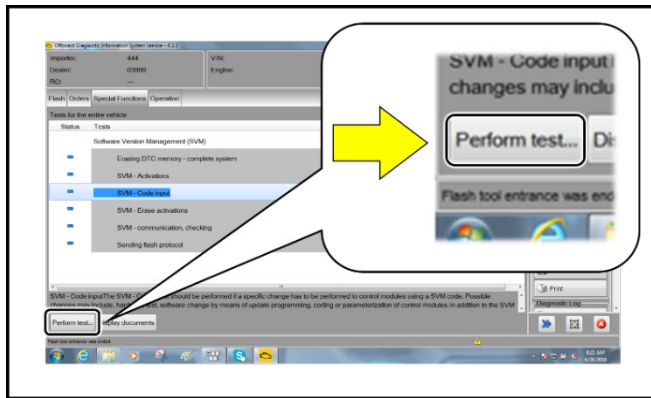
- Select “Perform test”.

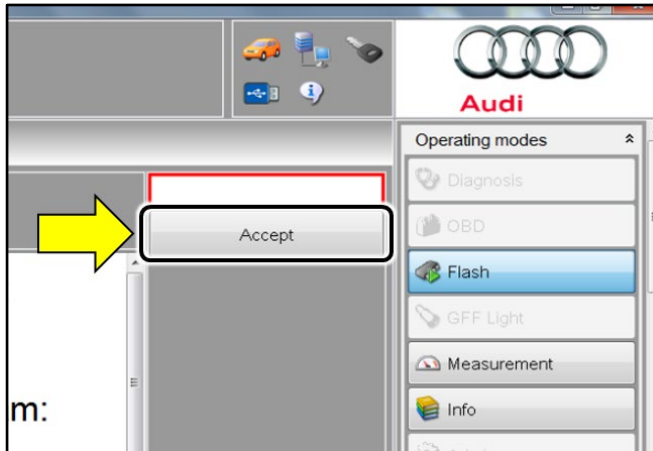
**SVM code**

**93N6A268**

- Enter the corrective action code (SVM code) as listed above.
- Select "Accept" <arrow>.
- Follow the on-screen prompts.

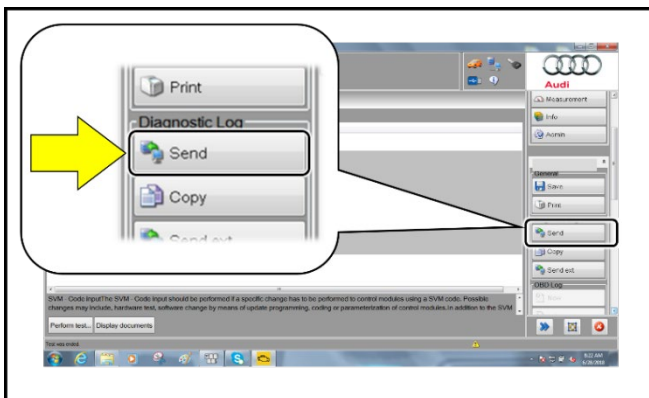
- After receiving confirmation that the flash completed successfully, select "Send" <arrow> to send the diagnostic protocol online.
- Follow the on-screen prompts.

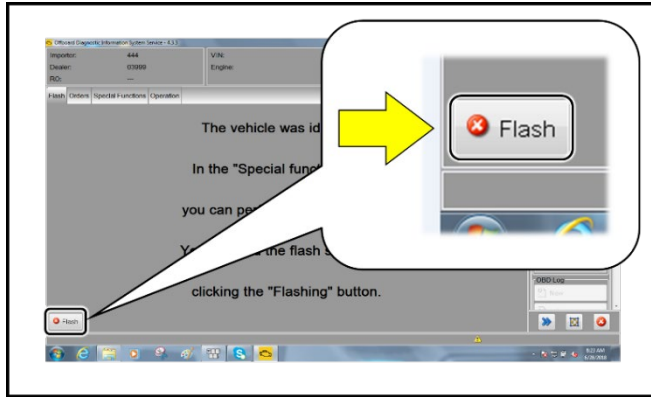
- Click "Flash" <arrow> to exit the flash session.
- Various event memory entries may be generated after the flashing procedure on some vehicles. Put the vehicle in a corresponding bus sleep mode after performing the update in order to clear the faults.
- To put the vehicle in bus sleep mode, disconnect the diagnostic tester, remove the key from the vehicle and lock the vehicle with the remote for 6 minutes.
