Service Engineering Operations  
Customer Service Division

**SUBJECT:** **NEW VEHICLE DELIVERY HOLD - Emissions Recall 25E08 – Supplement #1**  
Certain *2016 – 2019 Model Year Lincoln MKT, 2016 Model Year MKS, and 2017 - 2020 Model Year Continental Vehicles with 3.7L Engines*  
Powertrain Control Module (PCM) Reprogramming

**REF.** **NEW VEHICLE DELIVERY HOLD - Emissions Recall 25E08**  
Dated December 12, 2025

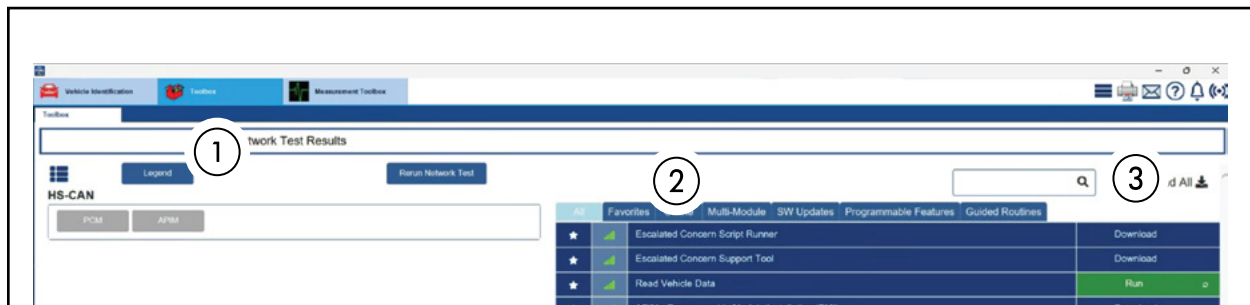
FIGURE 1

6. Select **Toolbox** (1) tab. See Figure 1.

7. Select **All**. See Figure 1.

8. Select **Read Vehicle Data** (2) and then **Run** (3). See Figure 1.

**NOTE:** Steps 4-7 (Read VIN from Vehicle) and Step 8 (Read Vehicle Data) MUST be completed prior to performing Steps 9-13. Failure to complete Steps 5-8 will result in a "Not Complete" or "An Error Occurred" from the Software Update Status Screen.
