WSJO – Update to Software Network VR28.13 (Workshop Campaign)

Model Line: **Macan Electric (XAB)**

Concerns: **Software update (software network VR28.13 SQ4)**

Information: **Software optimizations are available for various control units for the Macan Electric.**

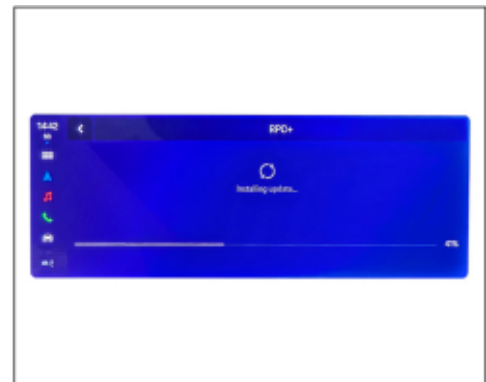
If Wi-Fi coverage is insufficient, the connection between the Porsche Tester and VCI can be interrupted (battery charge indicator at the top right inactive on the Tester display). The vehicle will, nevertheless, continue programming **independently**. In the meantime, no entry may be made on the Porsche Tester, and the programming must not be restarted. In this case, the update progress can still be checked in the vehicle in the front display and control panel (R238) by going to the **"Messages" (RPC+)** tile.

Update progress on central display

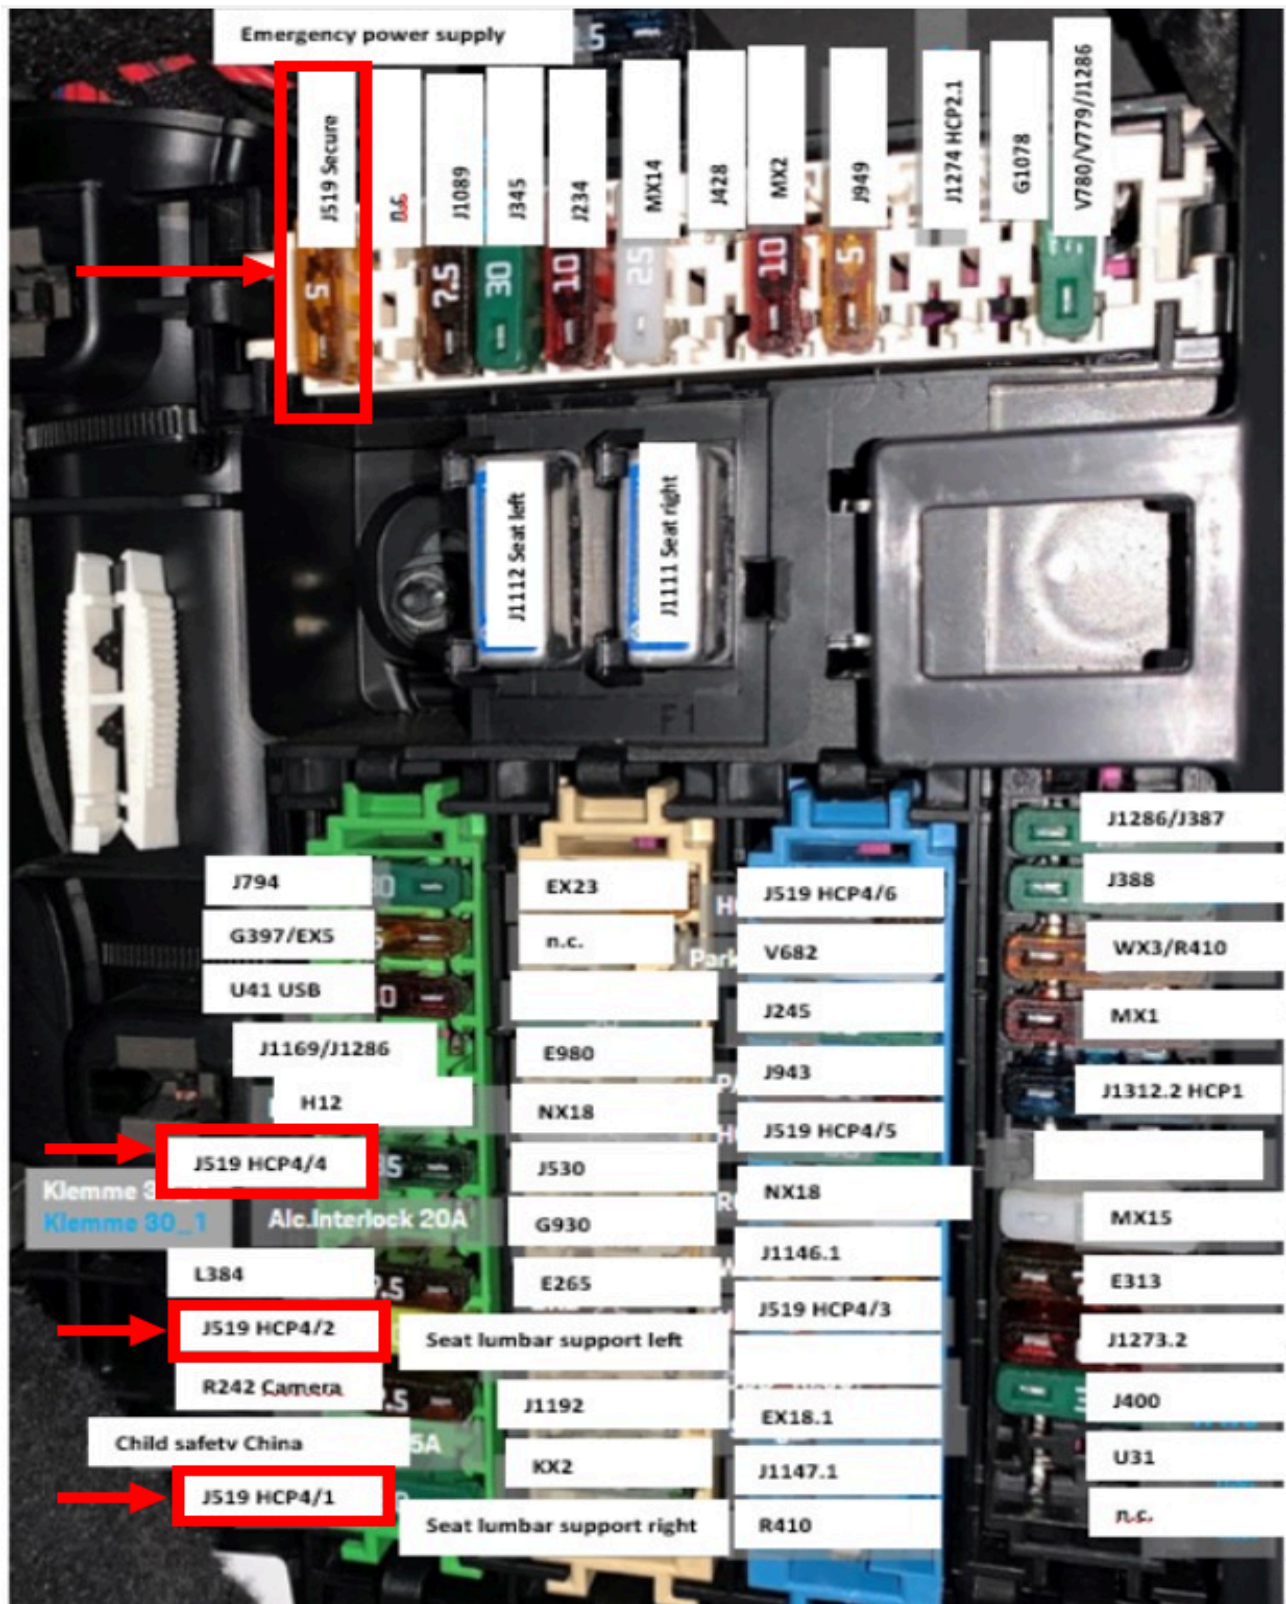
<p>HCP4 body electronics main control device (J519) reports programming and coding errors in the results view</p>	<p>The affected control unit was not successfully programmed and coded</p>	<p>Vehicle</p>	<p>Do not perform an ignition change! This results in the destruction of the control unit.</p> <p>Fuses</p> <ul style="list-style-type: none"> ▪ J519 HCP4/1 ▪ J519 HCP4/2 ▪ J519 HCP4/4 ▪ J519 Secure <p>Pull, wait 30 seconds and plug it back in correctly.</p> <p>The fuses have different parameters and must be reinserted at exactly the same</p>

<p>location; for the correct fuse positions, see: ⇒ <i>Fuse positions</i></p> <p>Select "Special function" in the additional menu</p> <p>Enter campaign code: HCP4_ERROR_KD2 and follow the Tester instructions</p> <ul style="list-style-type: none">▪ Please note! HCP4 is therefore programmed, but not coded – do not perform an ignition change!▪ After successful programming of the control unit in the integration test, re-start using the 'Campaign' function (F5) (if not available, start the 'Repair' function with (F8))▪ After this has been performed successfully, continue with work step 4
--	--	---
