HYUNDAI Technical Service Bulletin

26-01-041H

TUCSON (NX4A)

**CCU SOFTWARE UPDATE FOR OTA INITIALIZATION
(LIMITED COVERAGE CAMPAIGN LA21)**

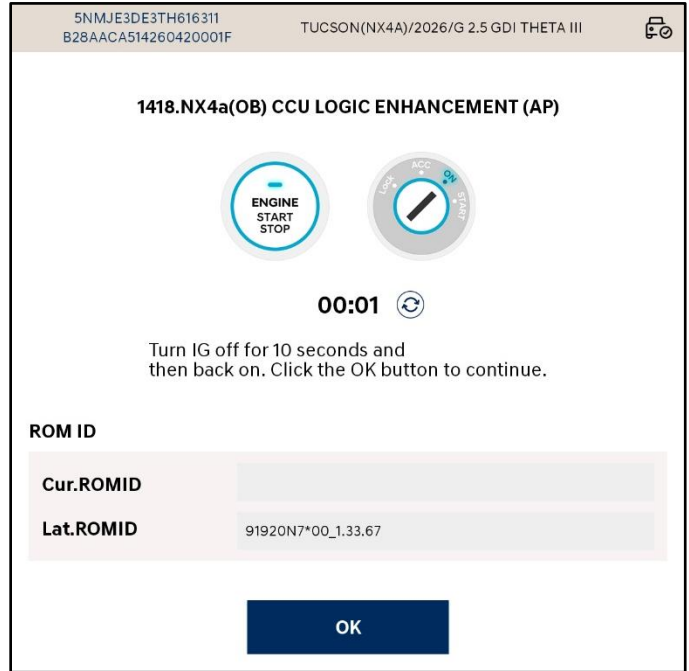
- After the ECU update process shows 100% complete, follow the prompts on the screen to cycle the ignition **OFF** for at least **10 seconds** to reset the control unit (certain models may take up to **30 seconds**).

Use the **Refresh** button to reset the timer.

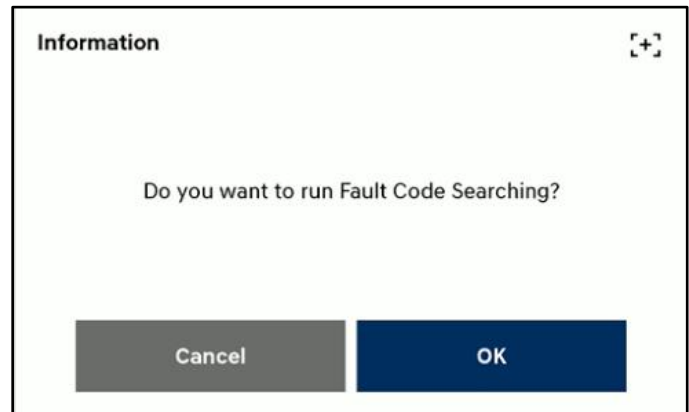
6. Perform an **All Systems Fault Code** search and erase DTC history that had incidentally occurred from the ECU update.

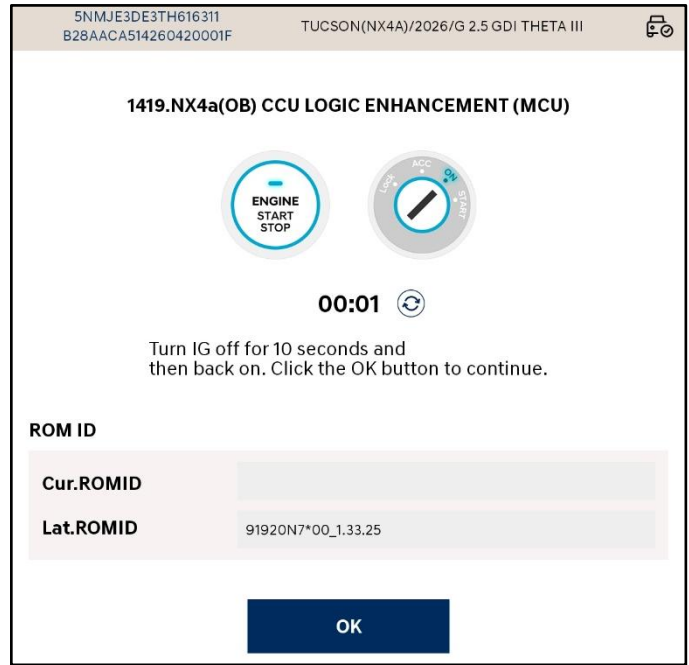
- After the ECU update process shows 100% complete, follow the prompts on the screen to cycle the ignition **OFF** for at least **10 seconds** to reset the control unit (certain models may take up to **30 seconds**).

Use the **Refresh** button to reset the timer.

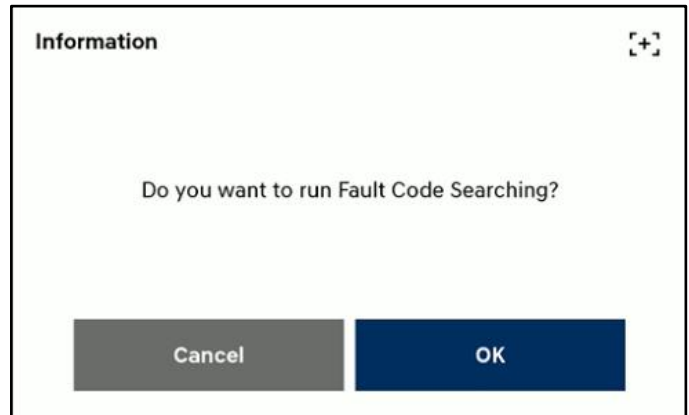
6. Perform an **All Systems Fault Code** search and erase DTC history that had incidentally occurred from the ECU update.
