Technical Service Bulletin (TSB)
Replace K1 Clutch / Input Shaft Assembly

| REFERENCE: | TSB: 21-039-26 GROUP: 21 - Transmission and Transfer Case | Date: | May 8, 2026 | REVISION: | 21-051-24 |
| CAUSE: | K1 clutch manufacturing issue that results in a loss of torque transfer for lower gears 1, 2, 3 and 4. | | | | |

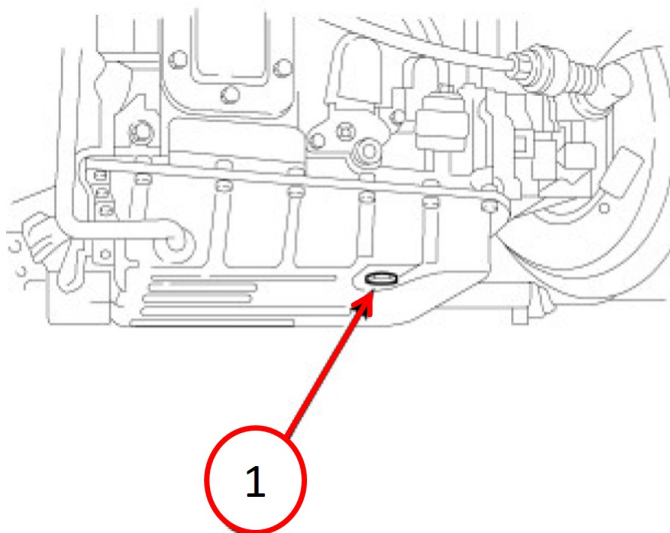
5. Remove oil pan drain plug [Fig. 1](#) and drain fluid from transmission pan. **DISCARD** the drain plug gasket.

Fig. 1
Oil Pan Drain Plug

1 - Transmission Oil Drain Plug

35. Using a **NEW** gasket, install the transmission oil pan drain plug [Fig. 1](#).

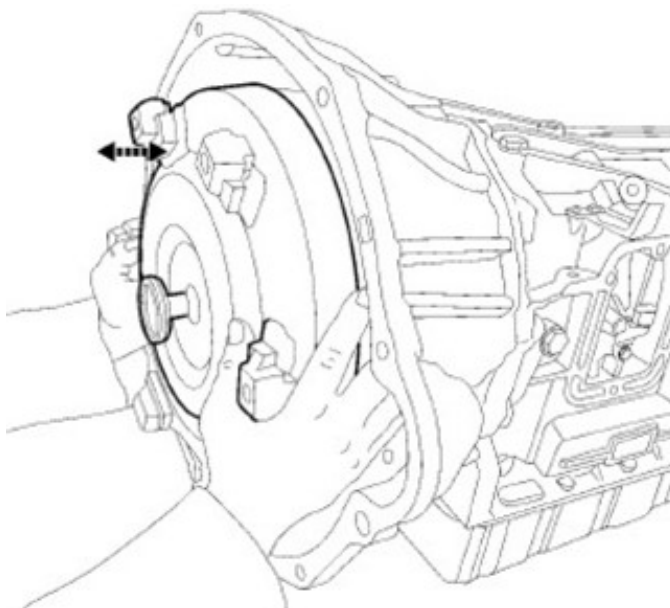
6. Remove the torque converter from the transmission [Fig. 2](#).

Fig. 2
Removing Torque Converter

33. Install the torque converter onto the input shaft while applying inward pressure and rotating back and forth at the same time in order to align the input shaft splines and the two teeth on the oil pump drive gear [Fig. 2](#).

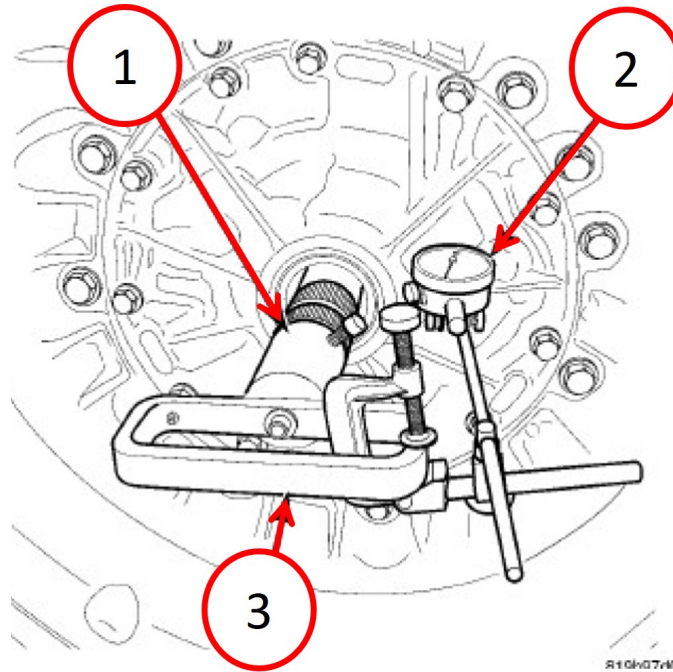
NOTE: Gear train end play is a critical pre-disassembly check to help determine the condition of the transmission. An end play reading greater than specification (larger gap) indicates that a bearing or thrust plate is either missing, worn or has disintegrated, in which case there will be debris found in the transmission oil pan.

- Using special tools Adapter Socket, End Play 8266-22 and the handle from End-Play Tool Set 8266B and Dial Indicator C-3339A, measure and record the input shaft end-play [Fig. 3](#).

Fig. 3
Recording The Input Shaft End-Play

- 1 - 8266-22
- 2 - 8266B
- 3 - C-3339A

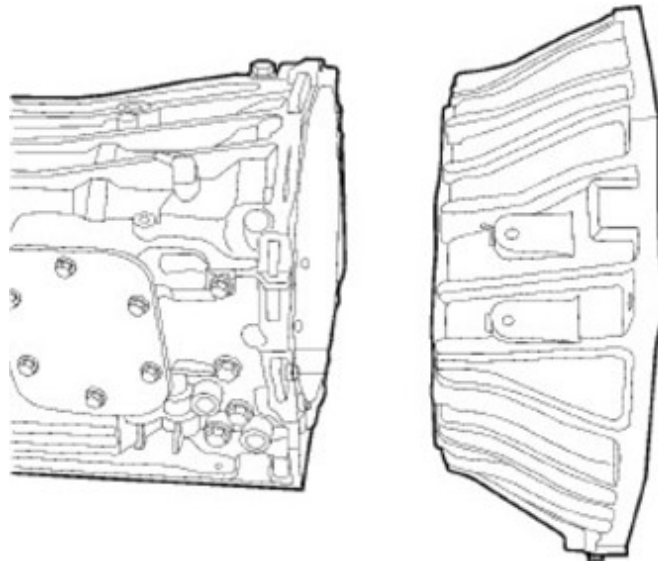
- Remove the bolts securing the torque converter housing to the transmission case and remove the housing [Fig. 4](#).

Fig. 4
Torque Converter Housing And Transmission Case

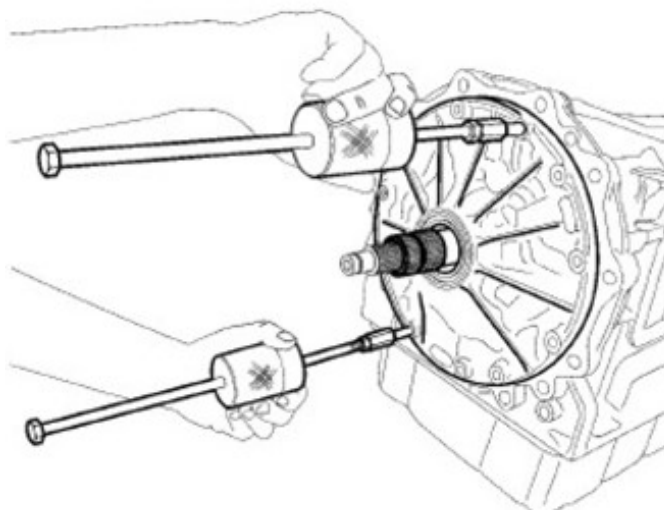
Fig. 5

9. Remove the bolts securing the oil pump to the transmission case and use Slide Hammers C-3752 with Adapters 9981 to remove the oil pump assembly from the transmission spline [Fig. 5](#).

Slide Hammers C-3752 And 9981 Adapters

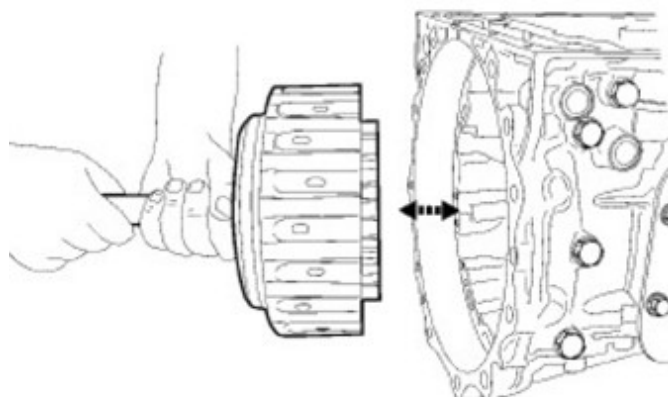
Fig. 6

10. Remove the input shaft assembly with the K1 and K2 clutch assemblies attached [Fig. 6](#).

NOTE: If the K1 snap ring has become dislodged, the K1 clutch assembly will not come out as a complete unit.

K1 And K2 Clutch Assemblies

21. Install the K2 clutch assembly and the K1 clutch/input shaft assembly into the transmission case [Fig. 6](#).

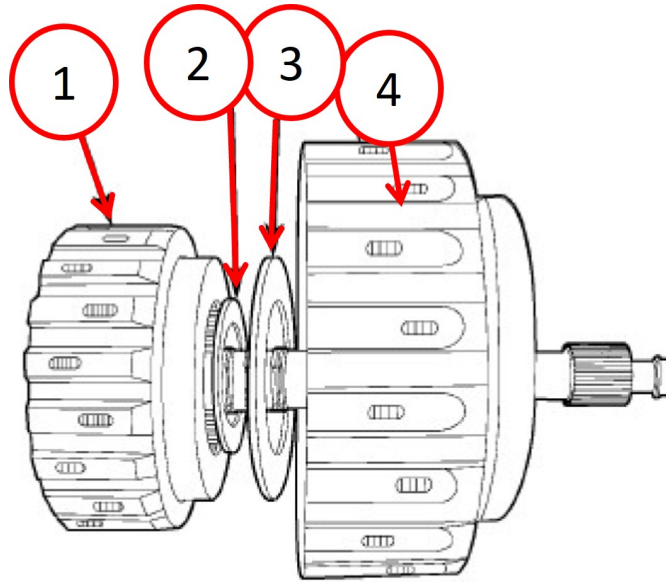
11. Remove the K2 clutch assembly and the selectable input shaft end-play thrust bearing number one and thrust washer from the K1 clutch/input shaft assembly [Fig. 7](#).

Fig. 7
K1 And K2 Clutch Assemblies

- 1 - K1 Clutch/Input Shaft Assembly
 - 2 - Thrust Bearing Number One
 - 3 - Thrust Washer
 - 4 - K2 Clutch Assembly
-

19. Install the K1 clutch hub and thrust bearing into the transmission case [Fig 10](#).
20. Apply trans jel or petroleum jelly onto the new input shaft seal rings and install the K2 clutch assembly onto the new K1 clutch/input shaft assembly with the original selectable input shaft end-play thrust bearing number one and thrust washer in place [Fig. 9](#).

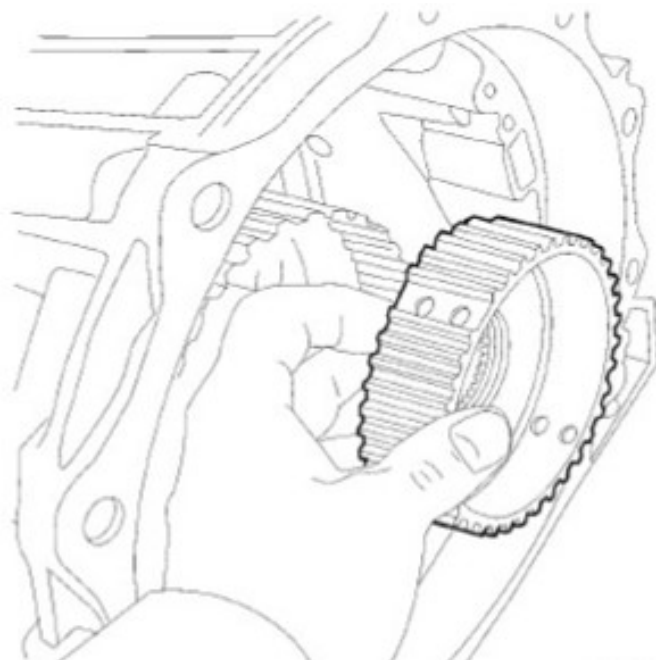
12. Remove and inspect the K1 clutch hub [Fig. 8](#) and [Fig. 9](#). **Replace only if needed.**

Fig. 8
K1 Clutch Hub

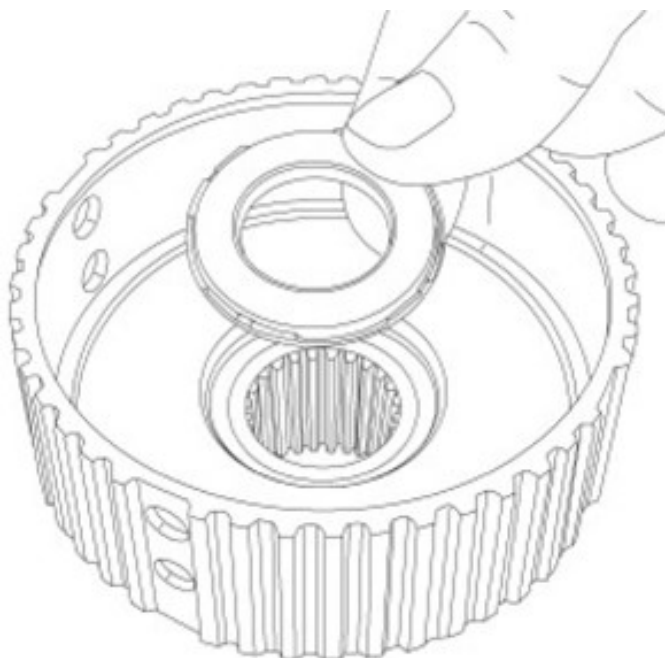
13. Remove and inspect the K1 thrust bearing number two [Fig 10](#). **Replace only if needed.**

Fig. 9
K1 Thrust Bearing Number Two

17. Install the K2 clutch hub into the transmission case [Fig. 11](#).
18. Lubricate with trans jel or petroleum jelly and install K1 thrust bearing number two into K1 Clutch Hub [Fig 10](#).

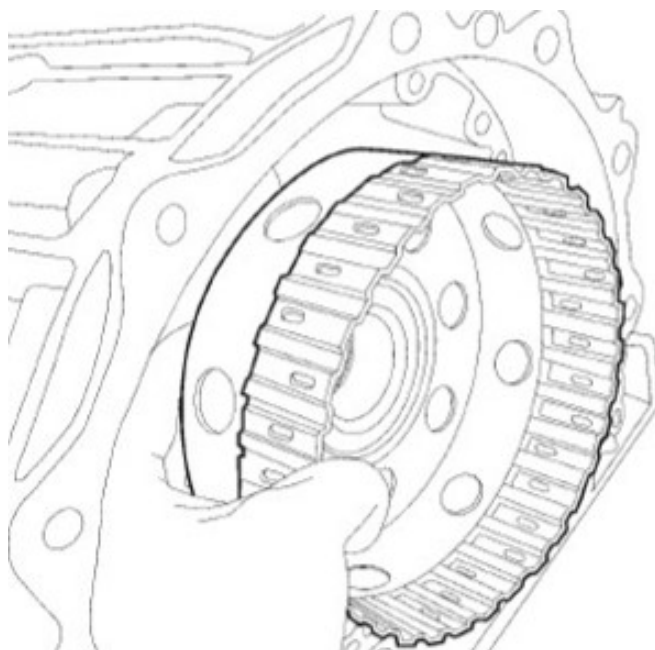
14. Remove and inspect the K2 clutch hub [Fig. 11](#). **Replace only if needed.**

Fig. 10
K2 Clutch Hub

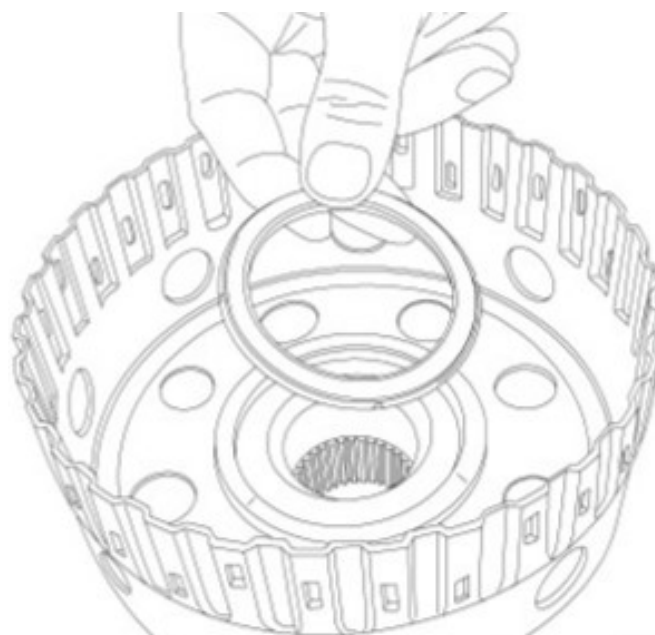
Fig. 11

16. Lubricate with trans jel or petroleum jelly and install K2 thrust bearing number three [Fig. 12](#).

K2 Hub Thrust Bearing Number Three

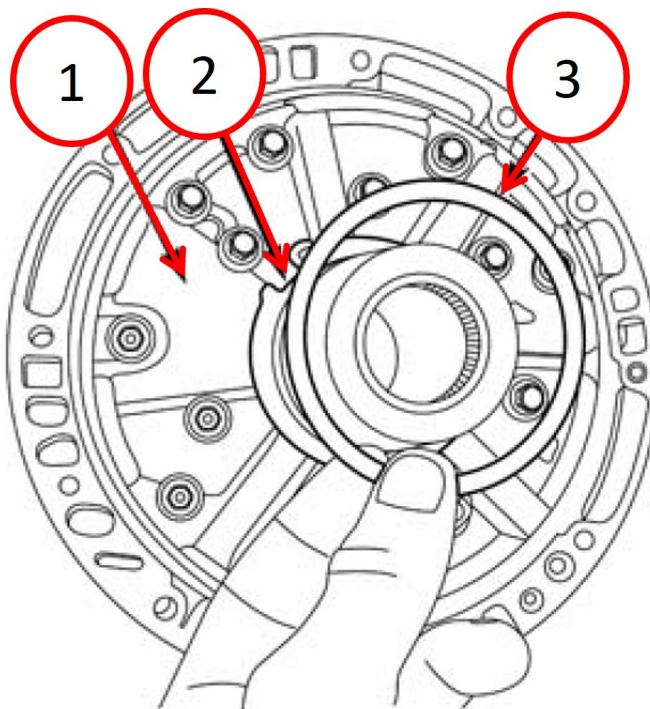
22. Lubricate with trans jel or petroleum jelly and install the nylon thrust washer onto the oil pump [Fig. 12](#).

NOTE: The nylon thrust washer is keyed to the oil pump [Fig. 12](#).

NOTE: Two pin punches inserted through the oil pump mounting holes will aid in the installation of the oil pump [Fig. 12](#).

Fig. 12
Oil Pump Assembly

- 1 - Oil Pump
- 2 - Nylon Thrust Washer
- 3 - Input Shaft Seal Ring

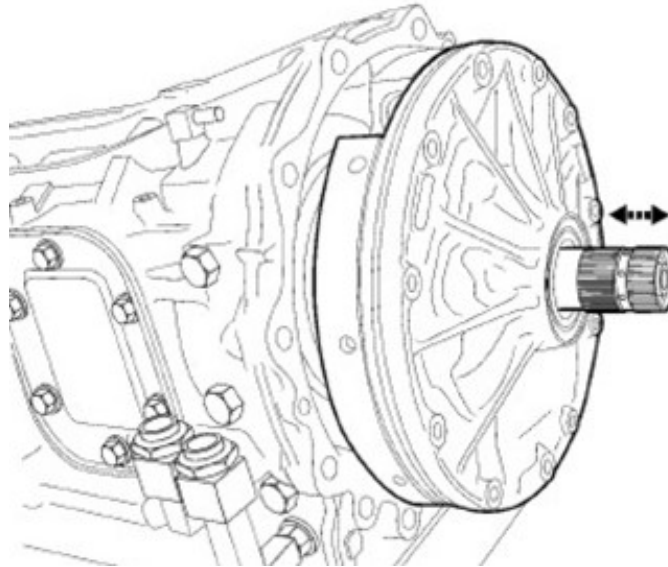
Fig. 13

24. Install the oil pump with a **NEW** gasket onto the transmission case [Fig. 13](#).

Oil Pump Assembly On Transmission Spline Shaft

25. Apply a light coating of MOPAR thread sealant onto the oil pump bolts and install the bolts. Tighten the bolts in a crisscross pattern to 21 N·m (15.5 ft. lbs.).
