SERVICE BULLETIN

APPLICABILITY: 2026MY Solterra **NUMBER:** 15-332-26
SUBJECT: Reprogramming File Availability for Optimization of Denso-Ten Infotainment Systems **DATE:** 04/30/26

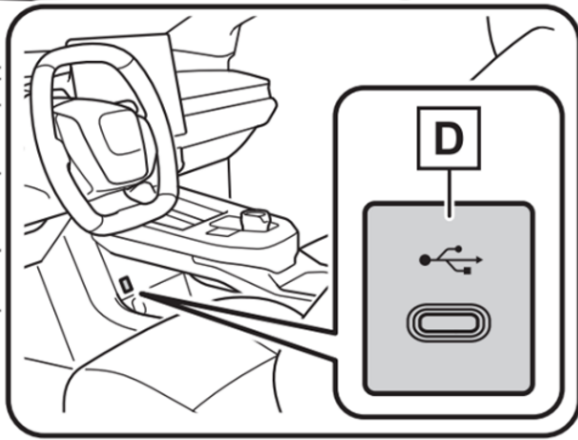
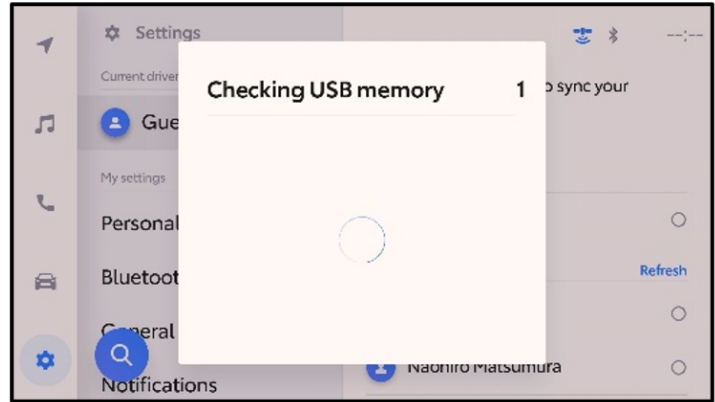
STEP 5: Insert the flash drive containing the correct software update into the vehicle’s leftside USB port marked with the USB (🔌) icon.

Note: A “Checking USB memory” message will display. This message can be displayed for up to 10 minutes.
