SERVICE BULLETIN

NUMBER: 02-193-24R

SUBJECT: Walnut Blast Cleaning Procedure for Carbon Deposit Removal to Address Engine Misfire DTCs, Black Smoke from the Exhaust, Lack of Power, Knocking (Ping) and / or Rough Idle Concerns

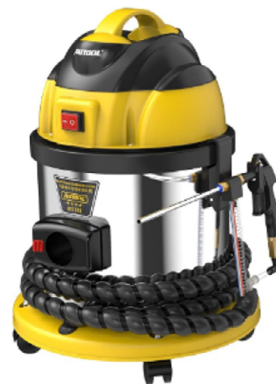
[AUTOOL HTS558](#)

WALNUT BLASTING MACHINE

An Autool HTS558 is shown in the example image to the right.

STEP 9: Prepare the walnut blasting machine (**AUTOOL HTS558**) with the necessary air supply. Always use NEW abrasive material when performing cleaning.

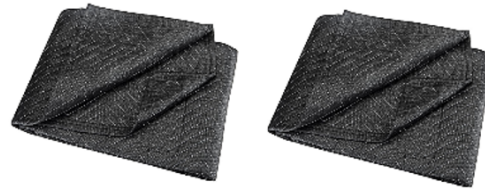
MOVING BLANKET

Size: 40in x 72in

Quantity: 2

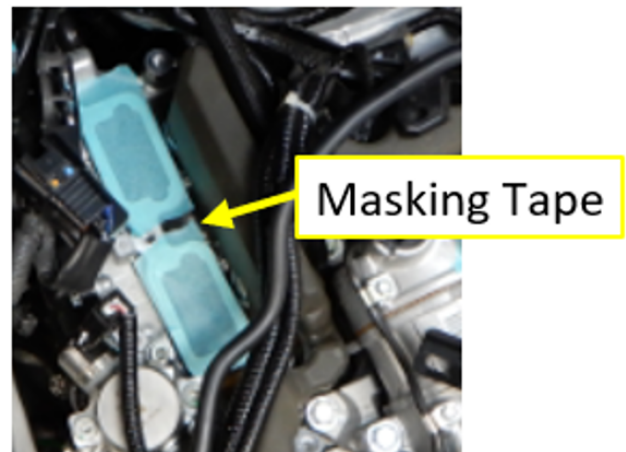
STEP 7: Seal the intake ports of cylinders #2 and #4 with masking tape. This will prevent any foreign material from entering.

CAUTION: Contamination or adhesion of foreign material such as walnut shell media inside the engine may cause starting failure and/or engine stalling.

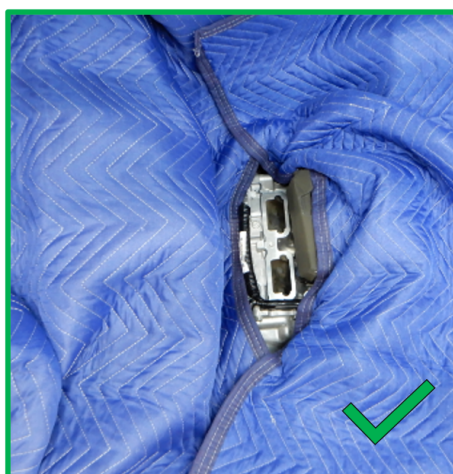
CAUTION: Confirm harness connections, fuels lines, and ALL other components are covered prior to cleaning.

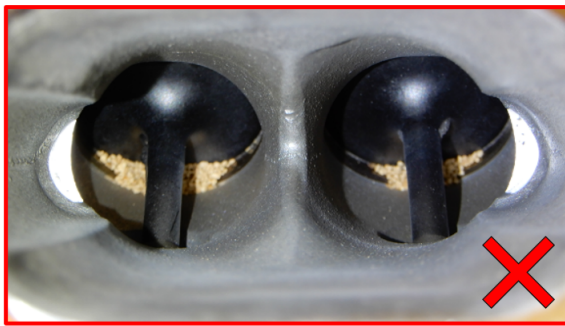
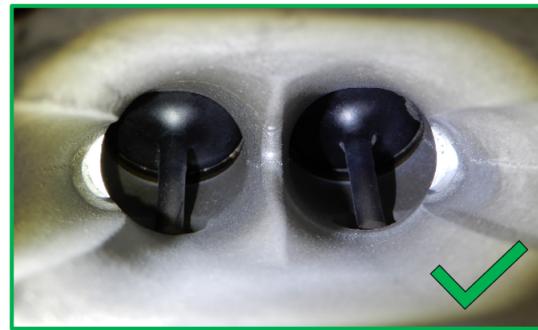
STEP 14: After cleaning is completed, remove any remaining abrasive material using the suction hose. Using a flashlight, inspect the ports and confirm there is no remaining material.

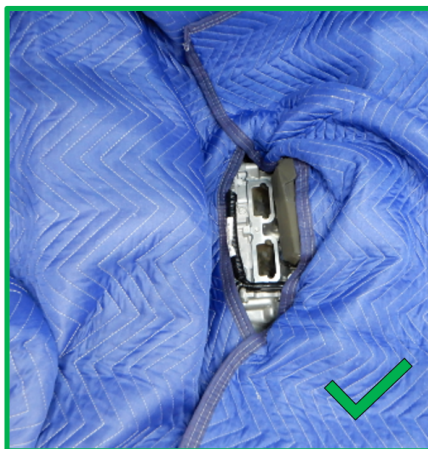
CAUTION: Confirm harness connections, fuels lines, and ALL other components are covered prior to cleaning.

STEP 20: Repeat the procedures outlined in Steps 9 through 15 on cylinders #2 and #4.

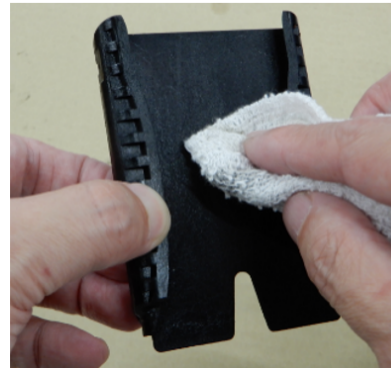
STEP 21: Clean the plate and stick portions of all the cylinder head plates using throttle plate cleaner. Dry the cylinder head plates with a clean shop towel. Confirm there is no cleaner remaining on the plates.

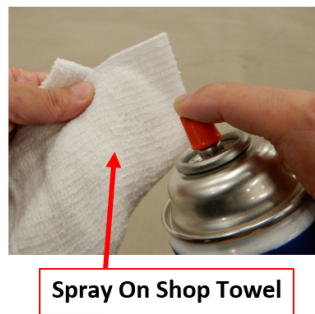
STEP 22: Clean the throttle body.

- A. Remove the throttle body from the intake manifold.
- B. Soak a shop towel in throttle plate cleaner.
- C. Wipe the throttle valve and bore inner surfaces from both the intake manifold and intake duct sides.
- D. Wipe the cleaned areas with a clean shop towel and confirm no throttle plate cleaner remains.

CAUTION: DO NOT open and close the throttle valve manually during cleaning. DO NOT deform or scratch the throttle valve/bore.
