# HYUNDAI

## Technical Service Bulletin

GROUP <b>CAMPAIGN</b>	NUMBER <b>26-01-046H</b>
DATE <b>MAY 2026</b>	MODEL(S) <b>IONIQ 5 (NEA EV)</b>

VCU SOFTWARE LOGIC IMPROVEMENT  
(LIMITED COVERAGE CAMPAIGN LA25)

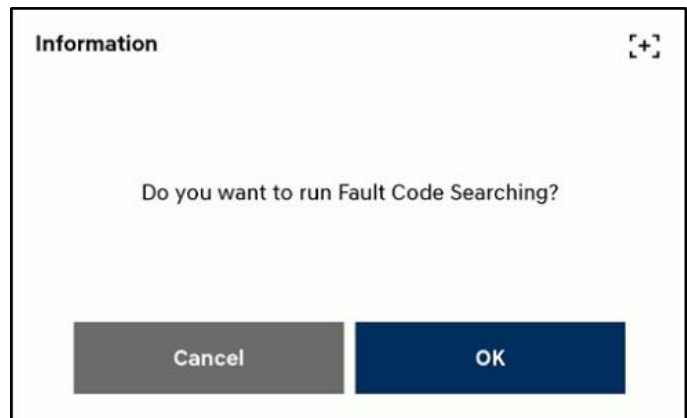
5. Perform an **All Systems Fault Code** search and erase DTC history that had incidentally occurred from the ECU update.
