# HYUNDAI

## Technical Service Bulletin

| GROUP<br><b>CAMPAIGN</b> | NUMBER<br><b>26-01-052H</b> |

**SUBJECT:** AC NOT TURNING OFF - ATCU SOFTWARE UPDATE  
(LIMITED COVERAGE CAMPAIGN LA30)

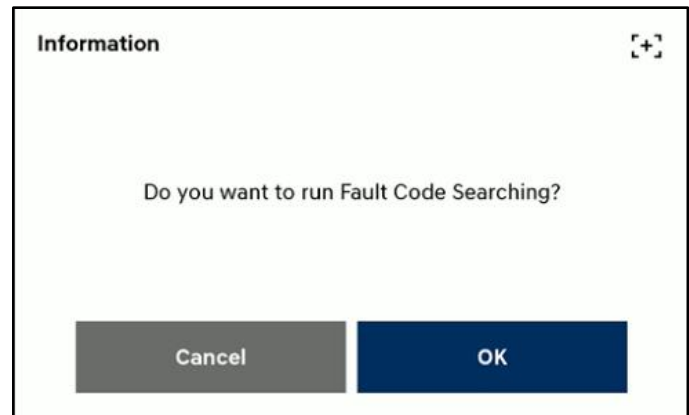
6. Perform an **All Systems Fault Code** search and erase DTC history that had incidentally occurred from the ECU update.
