## SERVICE BULLETIN

**NUMBER:** 15-311-23R

**SUBJECT:** FOTA (Firmware Over-The-Air) Reprogramming  
 for DENSO Gen 4.5 Audio Navigation Infotainment Systems via DCM

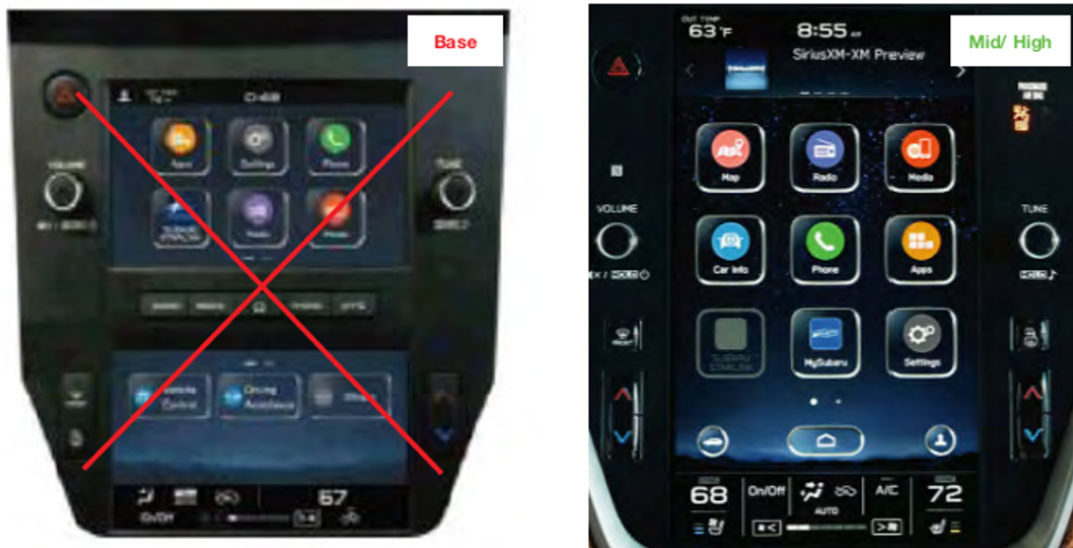
Reference photos of each system faceplate are supplied below:

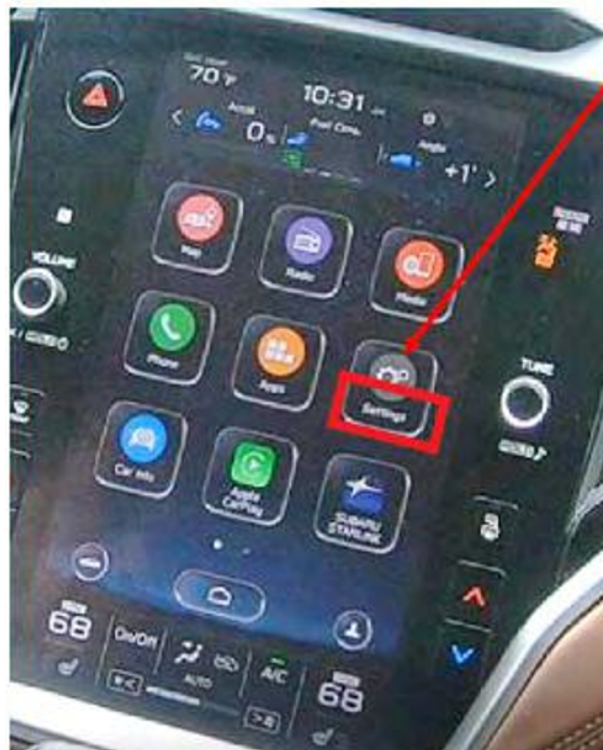
- 1) After starting the engine and system boot-up completes, from the HOME screen, touch the Settings button.

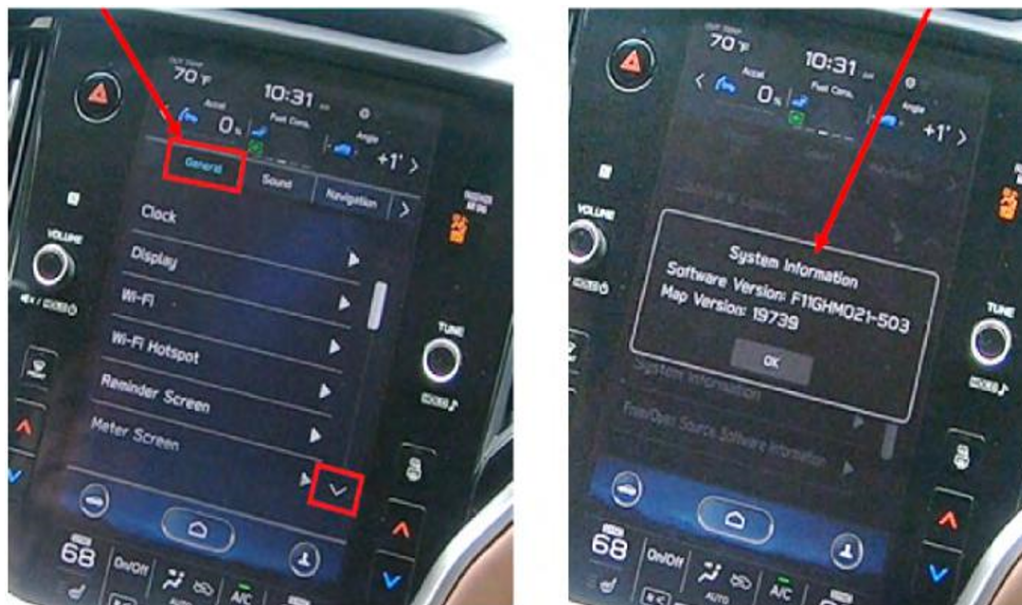
- 2) Press the **General** button. Use the down arrow to scroll to **System Information** then press to display the System Information / Version information.

Please note the last six digits of the software version (XXX-XXX) would determine an eligibility for the software update. If the the last six digits of the software version are not listed in the table below proceed to section “**FOTA REPROGRAMMING OVERVIEW**” below. Otherwise the unit already has the latest software version installed. No update is required at this time.

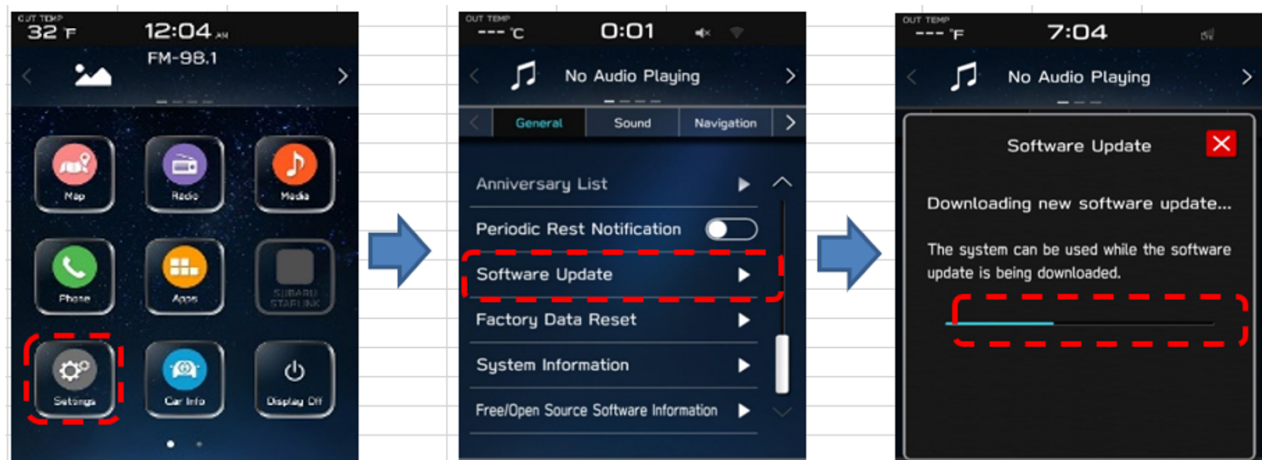
Downloading automatically starts and finishes. While the DCM is downloading the new software, all functions of Cockpit Control Unit remain available. The status of the downloading process can be checked using *Settings/General/Software update feature* as shown below.

Normally downloading takes 10-20 minutes depending on reception condition. Even if

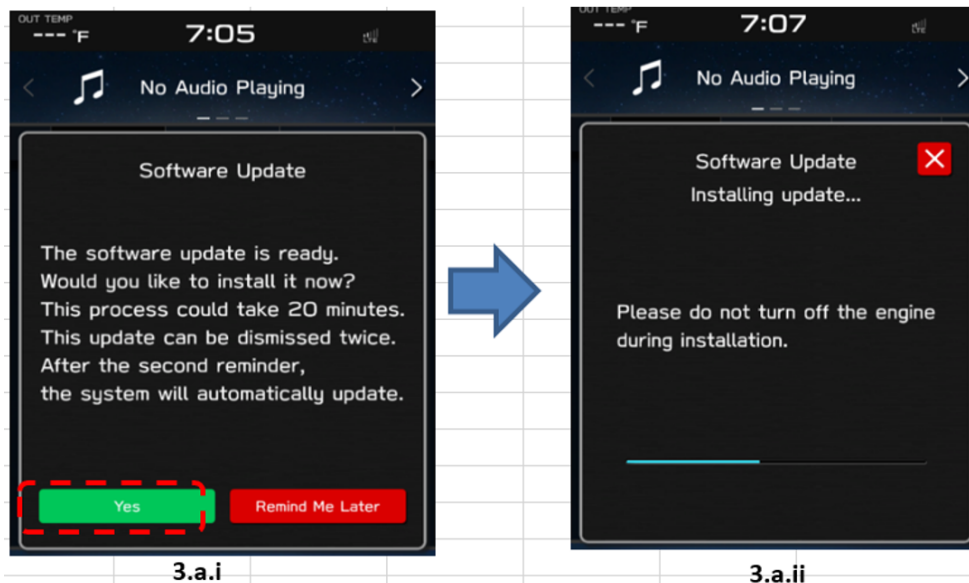
Notification screen is automatically displayed, after the background downloading has been successfully completed. This screen is displayed only while the vehicle is not in motion. Select “Yes” => Start installation. Once “Yes” is pressed, installation continues even if the

Customers can skip installation by selecting <Remind Me Later> up to two times. However, after skipping two times the installation starts automatically as soon as the Ignition Switch is turned ON without any notification. In that case the installation notification (3.a.i) is not displayed anymore. See below for more information.

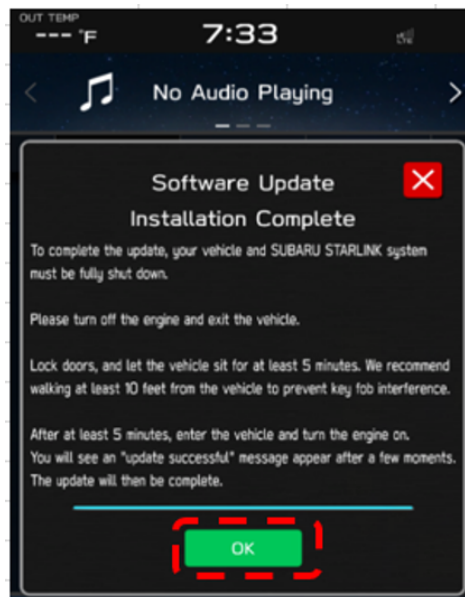
- If ignition Switch is turned OFF while 3.a.i screen is being displayed, the installation process is terminated. In that case the screen 3.a.ii pops up automatically the next time the Ignition Switch is turned on.
- If ignition Switch is turned OFF during 3.a.ii screen is being displayed, the installation process is terminated. In that case installation process automatically resumes without showing 3.a.ii next time the Ignition Switch is turned on.
- Activation: Wait until the installation is completed (Time required for installation: 15 minutes or less). After the first installation process is coming to an end and the pop-up screen shown below comes up, then press “OK.”

Switch the vehicle OFF, exit the vehicle, lock all doors including the rear gate (if equipped) and **move the key fob away from the vehicle at least 10 feet (3m) to enable affected systems to go to sleep. WAIT AT LEAST 5 MINUTES** prior to switching the vehicle ON to assure proper software activation.

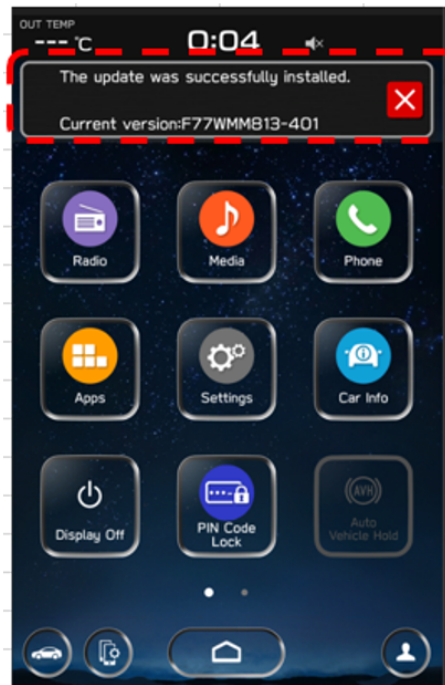
Pop-up screen shows up soon after the system completes to boot up. It confirms the software has been installed.

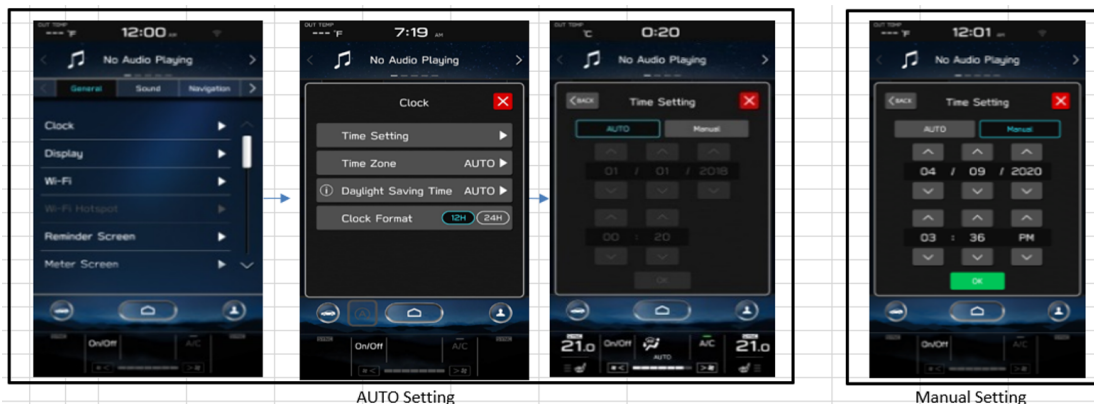
#### <Models with navigation system>

- Confirm GPS signal is received. Vehicle position on the map should match its location. If necessary, drive the vehicle to assure good reception.
- Check if Clock is set to “Auto”: Setting→”Clock”→”Time Setting” .
- Once the Navi receives the GPS signal the clock is adjusted automatically.
- If the GPS signal is not available, set the clock to “Manual Setting”.

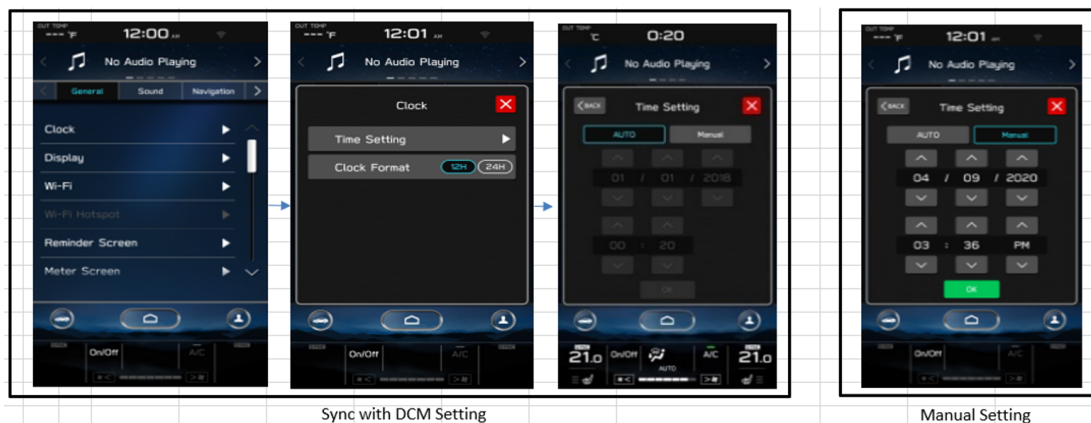
#### <Models without navigation system>

- Select “Setting”→”Clock”→”Time Setting” and check if the setting is “AUTO”. In case the clock is not adjusted correctly, set the clock in “Manual” setting.

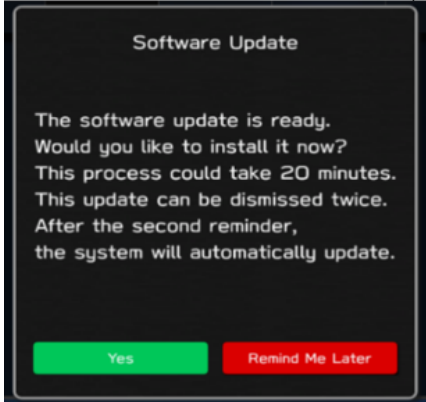
| No. | Applicability | Case Scenario (Trouble) | Causes | Check Points |
|---|---|---|---|---|
| 3-3 | | <p>Selected &lt;Remind Me Later&gt;, but next time IG ON 3.a.i screen is not displayed.</p> | DCM has lost connection to SUBARU server. After downloading was completed, DCM needs to connect with SUBARU server, before installing | Assure DCM has strong reception and reliable connection with the server, then turn ignition OFF and ON to repeat the test. |
