## IATSB004354v3

## Technical Service Bulletin

| <b>Title</b> | Electro-Hydraulic Power Steering (EHPS) Mapping Update | |
| <b>Affected Vehicle(s)</b> | Grenadier | PF00001 – PF009914<br>RF004651 – RF023496<br>SF000001 – SF030942 |

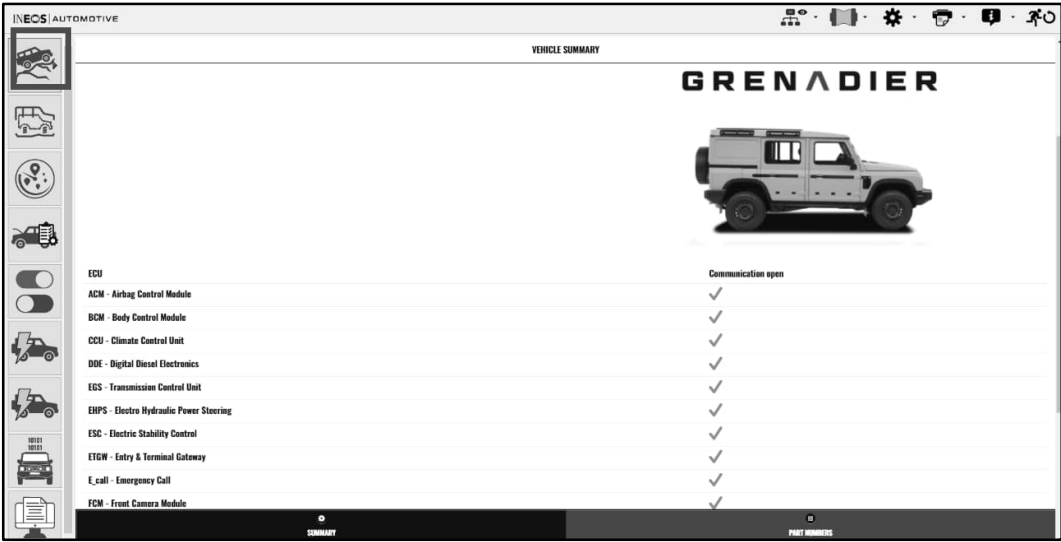
2.

- If an installed ECU is not listed as communicating, carry out a battery reset for 10 minutes.
- Ignore FCM, and other ECUs not installed as these will display as red crosses.

Within the 'Vehicle Summary' check all installed ECUs have an open communication displaying a green tick.

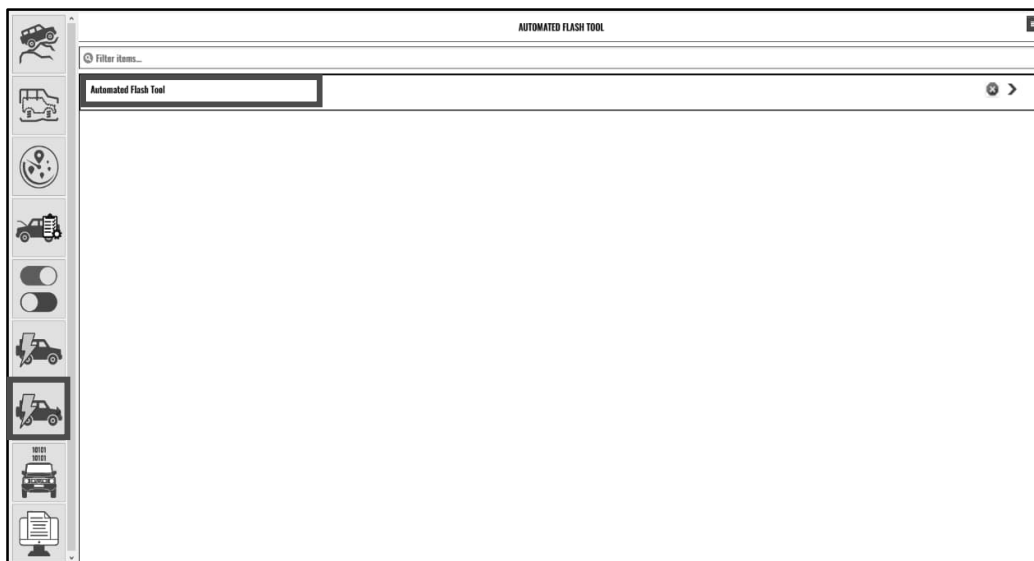
4.

- Select '**Automated Flash Tool**' tab.
- Select '**Automated Flash Tool**' action.

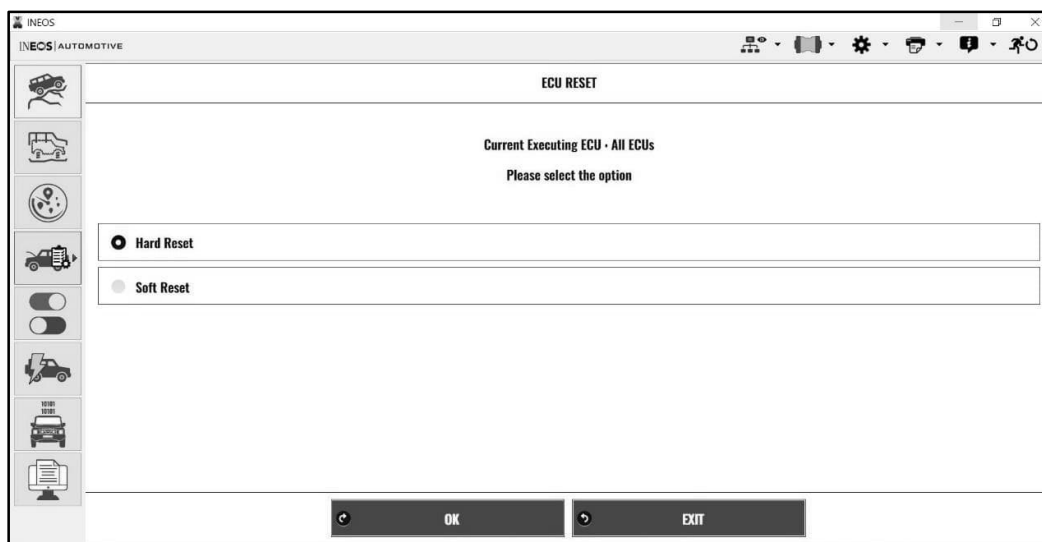
11.

- Select '**Hard Reset**'
- Select '**OK**'

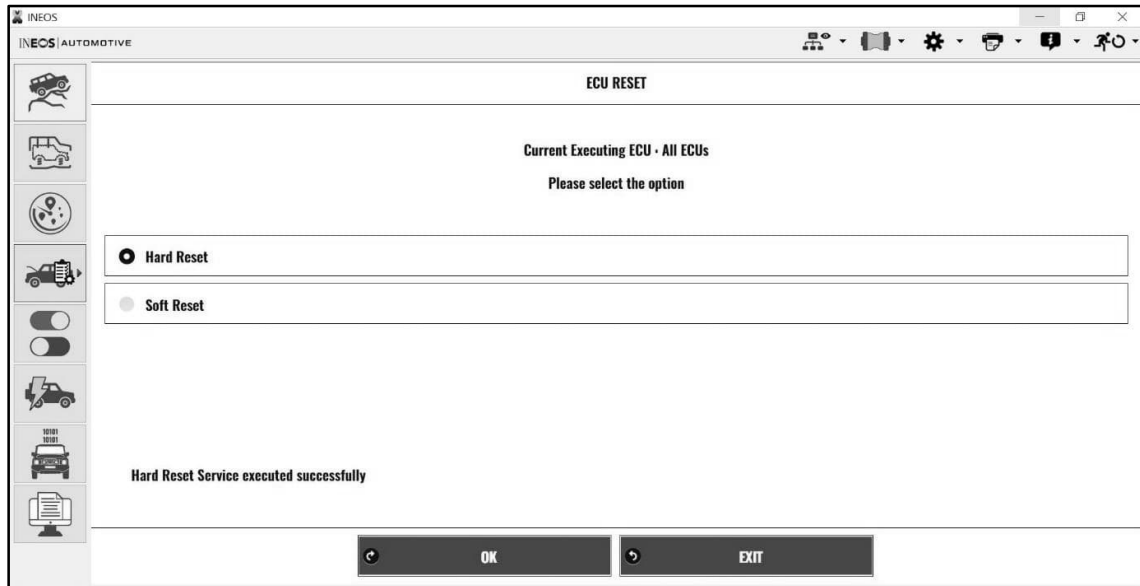
12.

- A message will appear to say if the '**Hard Reset**' has been successful.
- Disconnect the Grade X session.
