Title: eCE Bus and eMV Calibration Release Information

Applies To: eCE Bus and eMV

IC Bus® Electric CE Series and International® eMV™ Series VCU calibration release information:

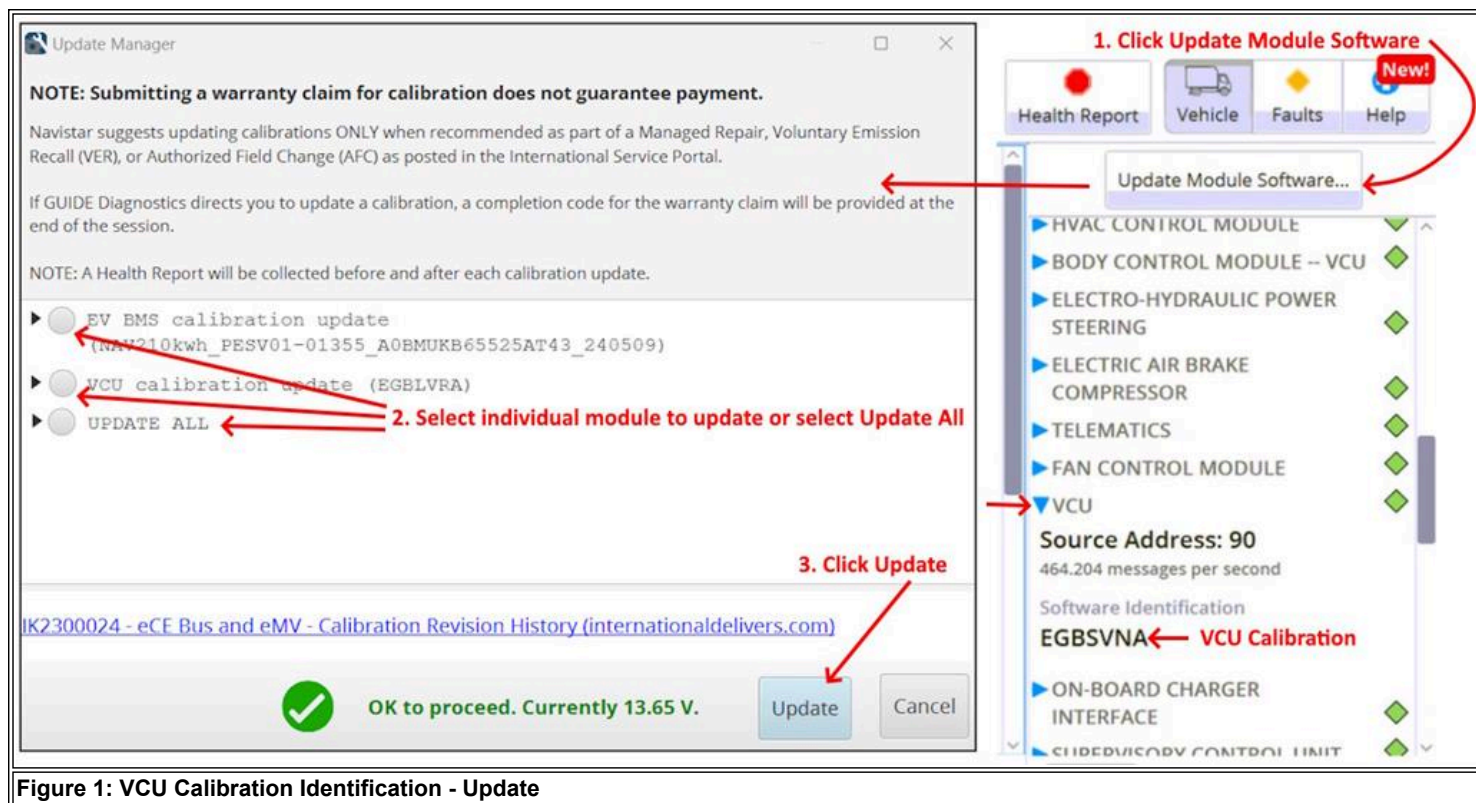
1. Connect with SDS with Key On
2. Right Vehicle Panel - the current VCU calibration ID can be viewed by expanding the VCU module.
3. If an updated calibration is available the Update Module Software Button at the top right panel will be available.
4. Click the Update Module Software button. Figure 1 item #1
5. Select the Calibration update: Figure 1 item #2
6. Click Update. Figure 1 item #3
7. Follow all on-screen instructions.
8. After updating the calibration, clear all fault codes and cycle the ignition key.
