Mitsubishi Motors North America, Inc.

## TECHNICAL SERVICE BULLETIN

### **ABNORMAL NOISE FROM DYNAMIC SOUND YAMAHA ULTIMATE 12 SPEAKERS AND INOPERATIVE ACV/RCV FUNCTION**

No: TSB-26-54-003

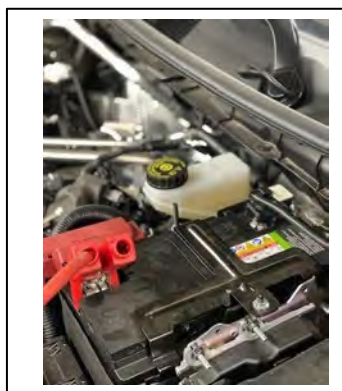
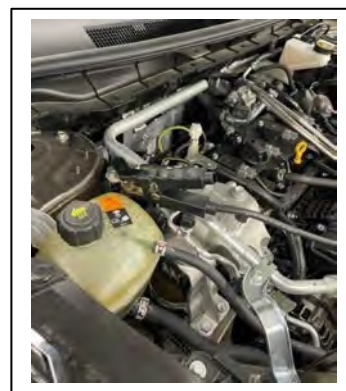
**NOTE:** Due to limited space in the engine compartment, it may be easiest to connect battery charger cable onto ground point.

Place the push-button switch in the "ON" position.

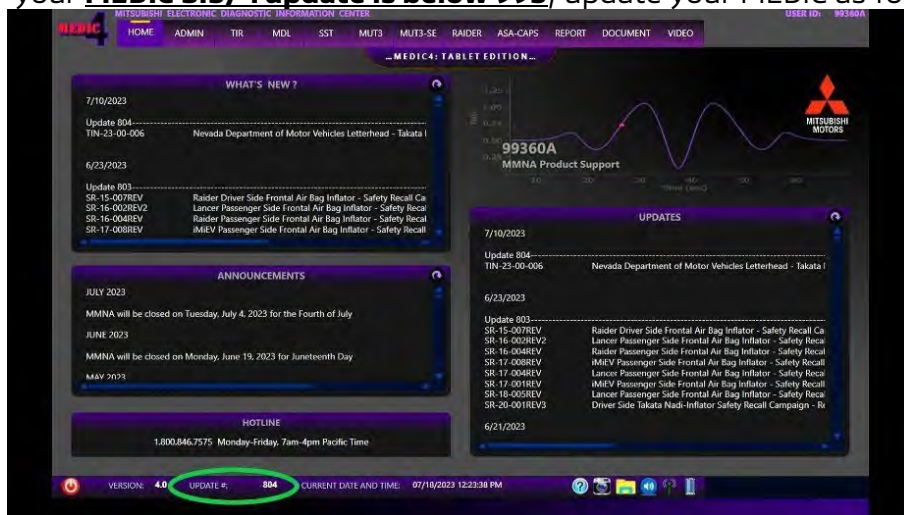
2. Verify the MEDIC 3.5/4 is at version 3.5 and at update **995** or higher.  
If your **MEDIC 3.5/4 update is at least 995**, continue with the Reprogramming Procedure. If your **MEDIC 3.5/4 update is below 995**, update your MEDIC as follows:

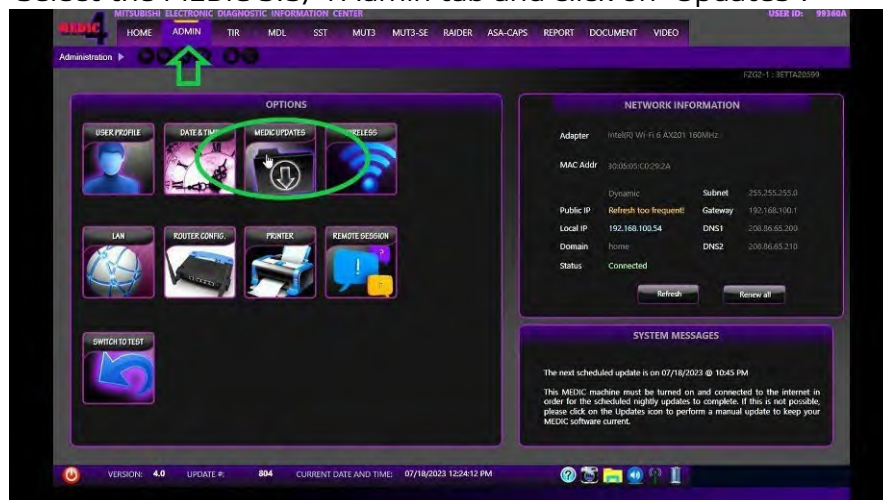
3. Select the MEDIC 3.5/4 Admin tab and click on "Updates".

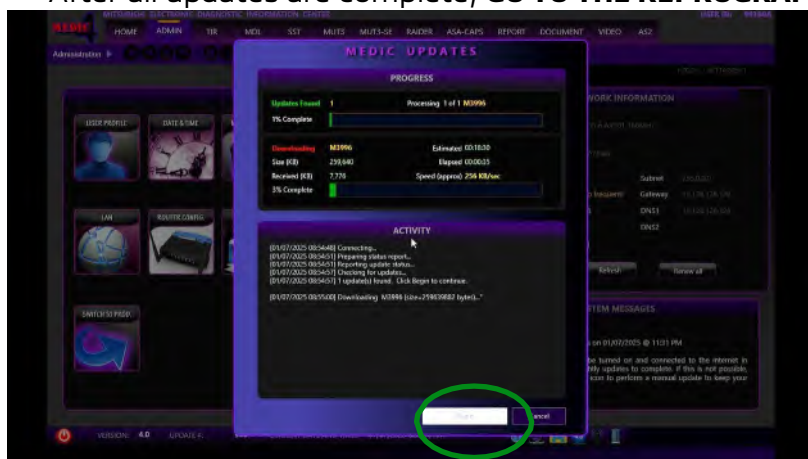
4. If the MEDIC update screen advises updates are available, click the "Begin" button. After all updates are complete, **GO TO THE REPROGRAMMING PROCEDURE.**

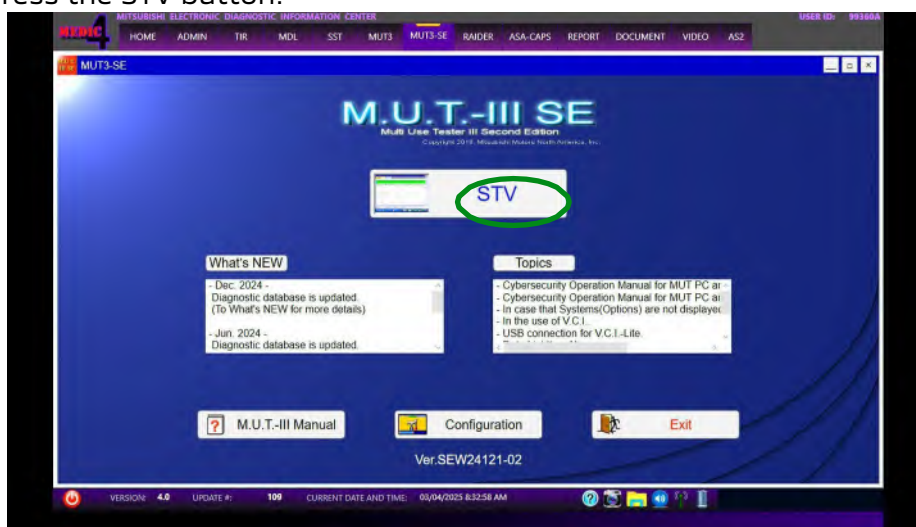
- a. Press the STV button.

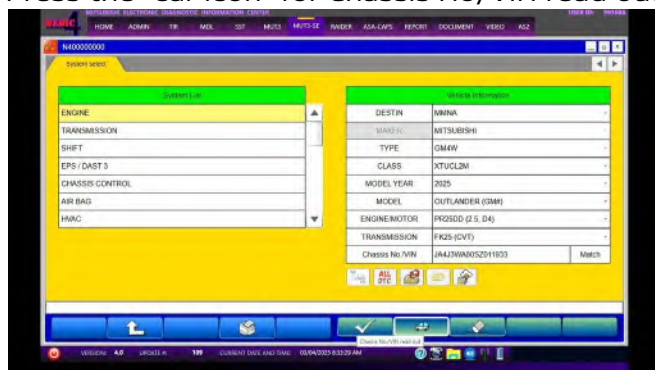
- b. Press the "car icon" for Chassis No/VIN read out.

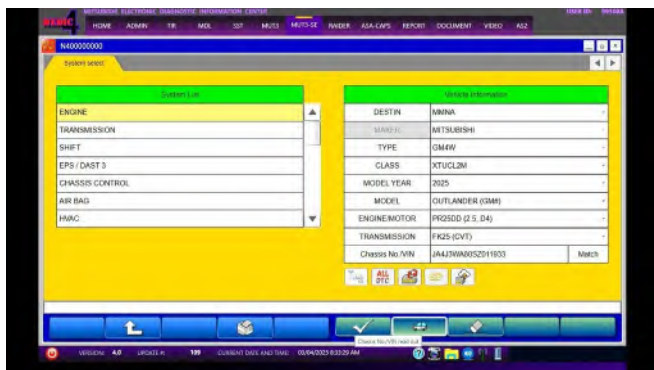
- c. Confirm the vehicle information displayed is complete/correct, after selecting the appropriate class and Meter/M&A. Note: Class can be found on the B pillar.

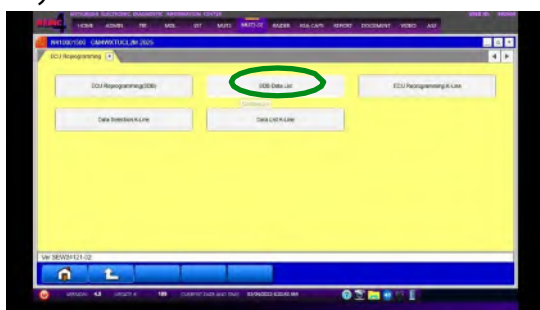
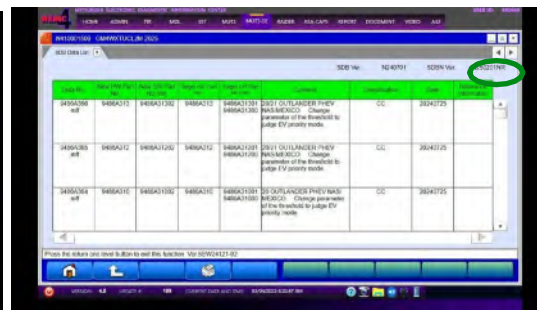
- d. Press the "SDB Data List button", verify software information according to the chart in this bulletin (page 2) and the SBDN Version number at the top right (see below).
  - i. If the database number displayed on your MUT-3 SE is **N260602NR** or greater, continue to the next section.
  - ii. If the reprogramming database number displayed on your MUT-3 SE is lower than **N260602NR**, then the MUT-3 SE database needs to be updated.
  - iii. Once the database number is confirmed, press the Home button to go back to the System Select screen.

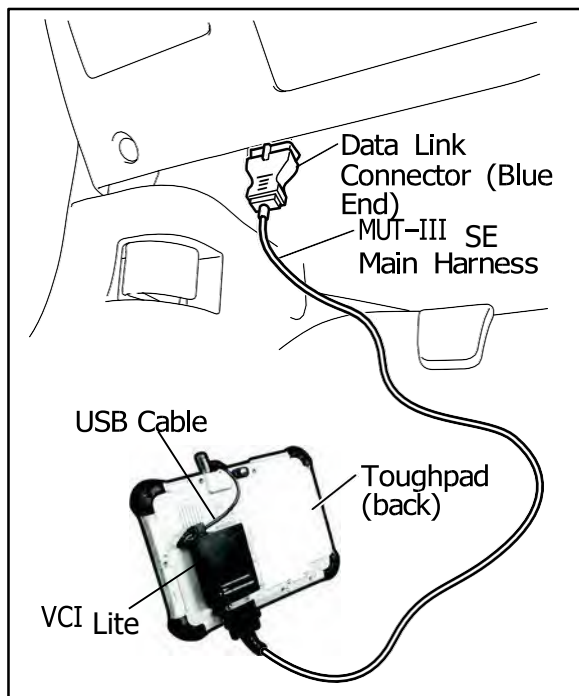
1. Connect the equipment as follows:

**NOTE:** VCI Lite and MEDIC 4.0 Toughpad shown for illustration purposes only.

- Turn the MEDIC PC/tablet on. If the battery indicator in the lower right hand corner of the screen does not show a full charge, it is recommended that either the battery be charged prior to beginning or the tablet should be used with the A/C power adapter connected.
- Connect the USB cable to the VCI/VCI Lite. When the laptop/tablet displays the MUT-III SE main screen, connect the USB cable to the device.
- Connect the MUT-3 SE main harness with the blue DLC connection to the VCI/VCI Lite. Connect the blue connection of the MUT-3 SE main harness to the vehicle's data link connector.
- For VCI only (p/n MB991824): Turn the VCI power switch ON. Verify that the indicator lamp in the upper right corner of the screen is green.

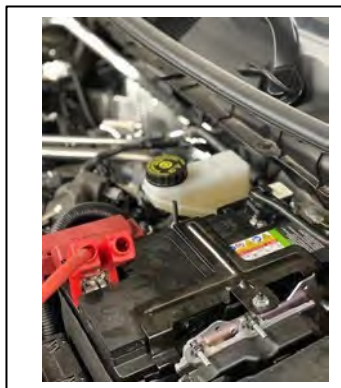
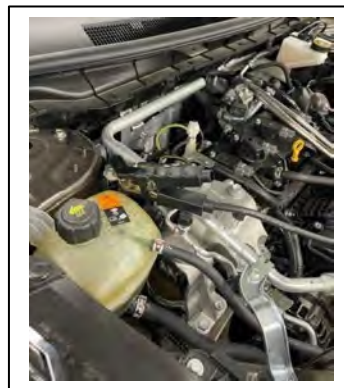
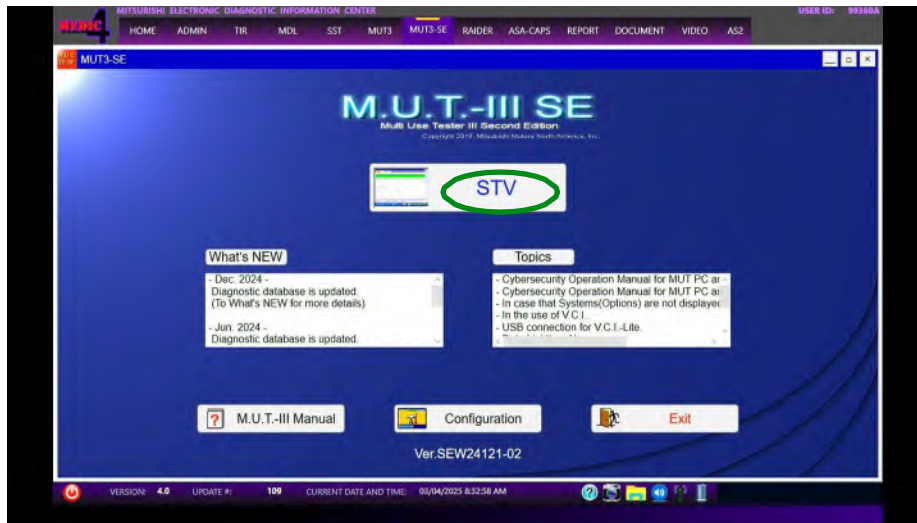
2. Place the push-button switch in the "ON" position.
3. Turn on flashers to prevent vehicle from shutting/powering down.
4. Press the "STV" button.

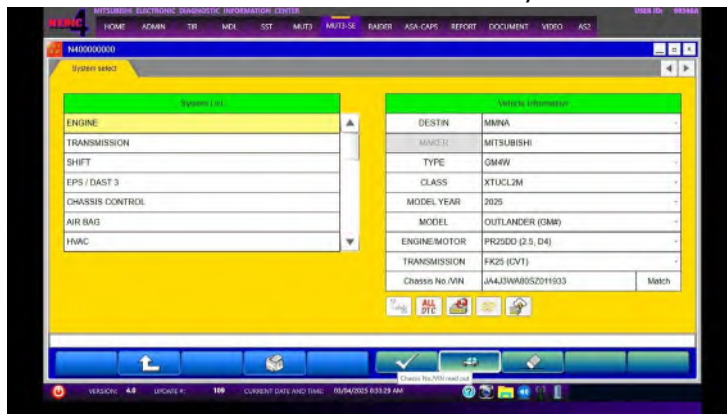
a. Press the "car icon" for Chassis No/VIN read out.

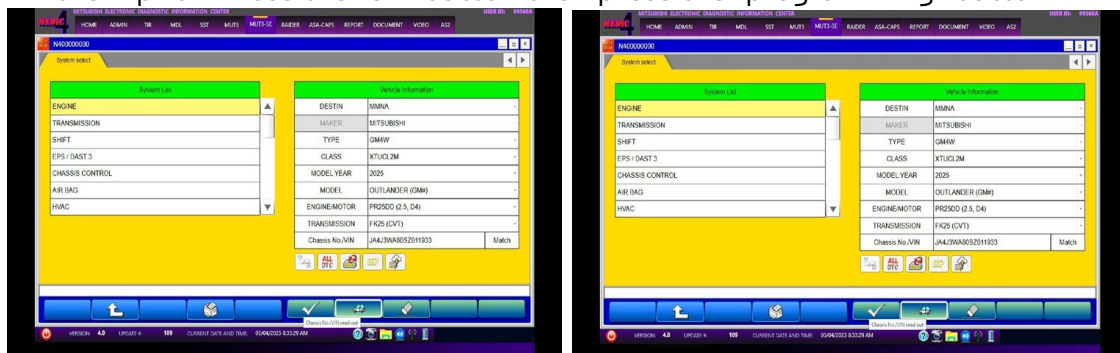
b. Confirm the vehicle information displayed is complete/correct. The class can be found on the B pillar. Press the "OK" button then press the "programming" button.

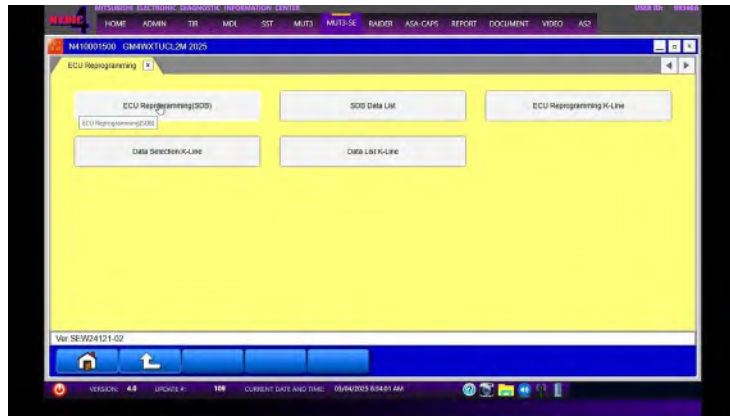
c. Press the "ECU Reprogramming (SDB) button.

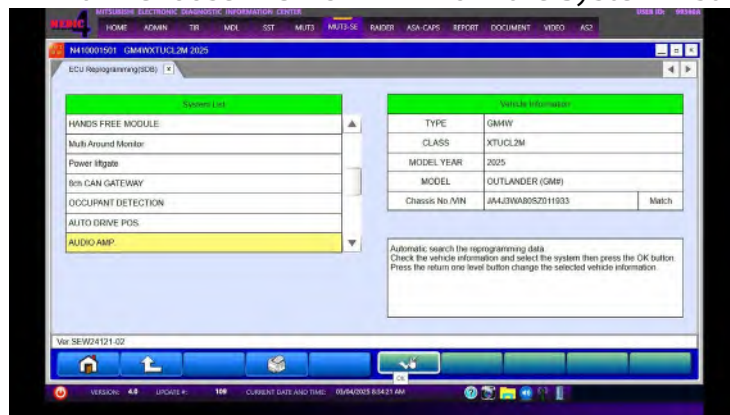
d. Choose "AUDIO AMP" from the System List and press the "OK" button.

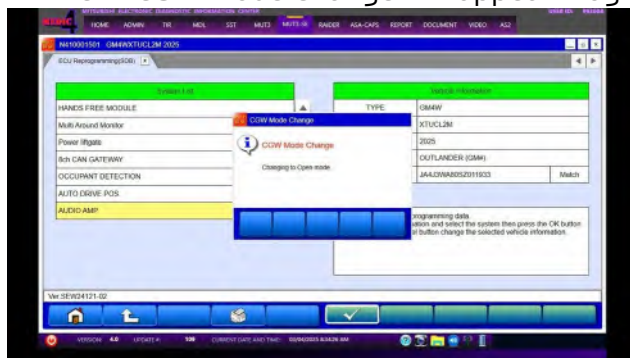
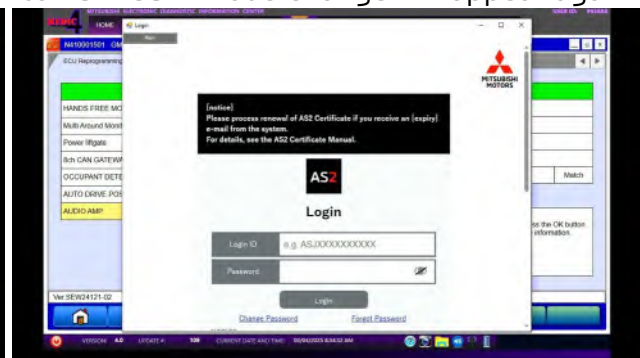
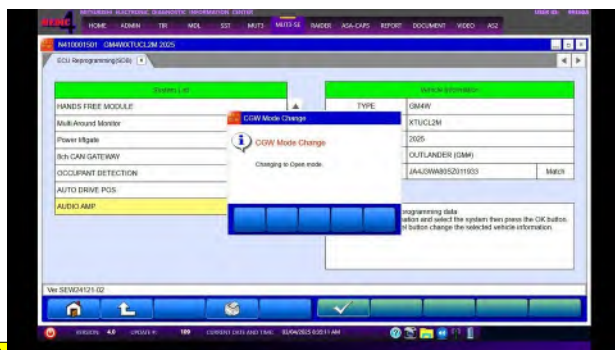
e. CGW Mode Change will appear. Login to AS2. CGW Mode Change will appear again.
