| GROUP | MODEL |
|---|---|
| Product Improvement | 2024-2026MY<br>EV9 (MV1, MV1a) |
| PI2601B | August 2026 |

### WIPER MESSAGE LOGIC IMPROVEMENT (PI2601B)

This bulletin provides information to install enhanced windshield wiper software on certain 2024-2026MY EV9 (MV1, MV1a) vehicles as listed in the table below.

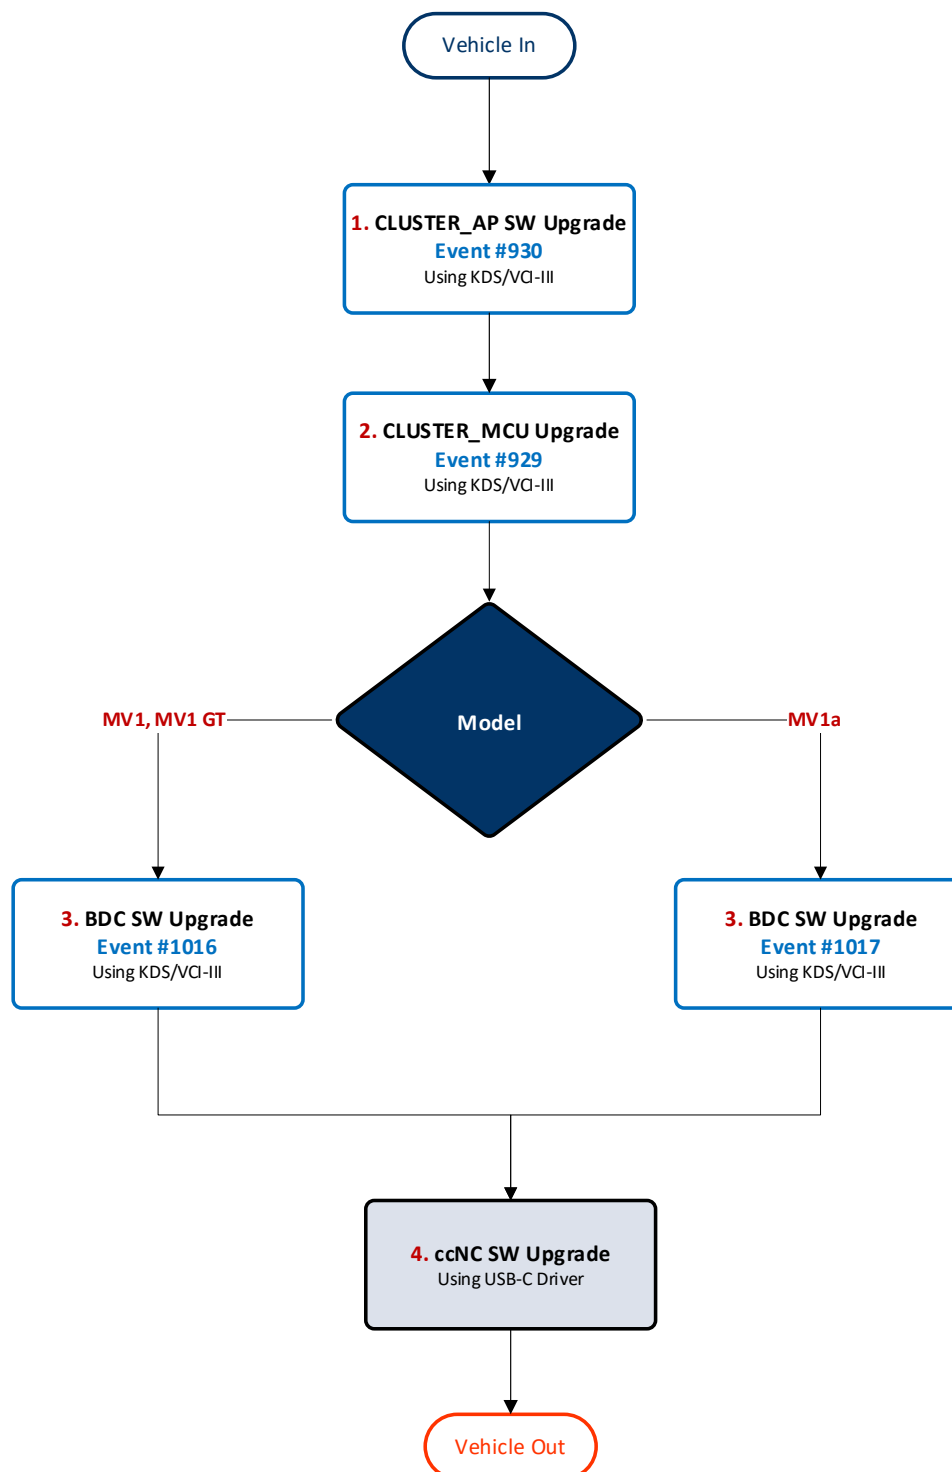
## Flowchart:

All three software upgrade events must be completed in the specified order. Updating the MCU before completing the AP update may result in an instrument cluster green screen condition requiring instrument cluster replacement.

Perform each software upgrade individually and in the correct sequence for the applicable vehicle:

- MV1 vehicles:
  - CLUSTER\_AP (#930), CLUSTER\_MCU (#929), BDC (#1016)
- MV1a vehicles:
  - CLUSTER\_AP (#930), CLUSTER\_MCU (#929), BDC (#1017)

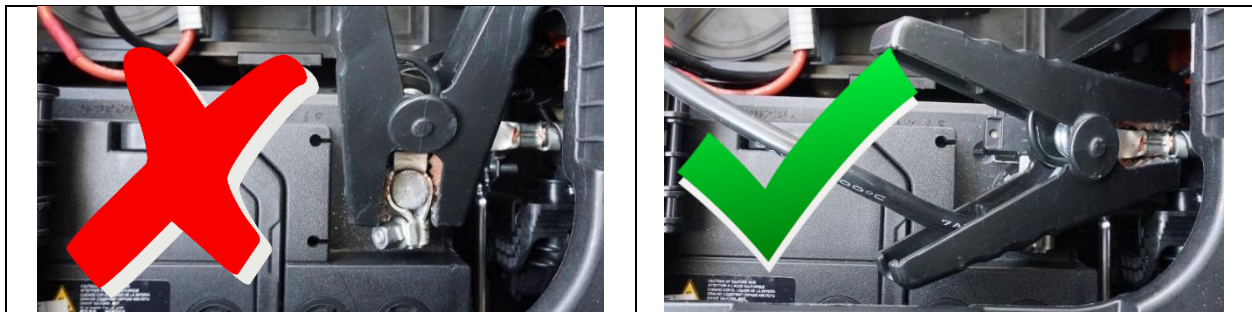
[Connect the negative \(-\) terminal to the battery as shown below.](#)

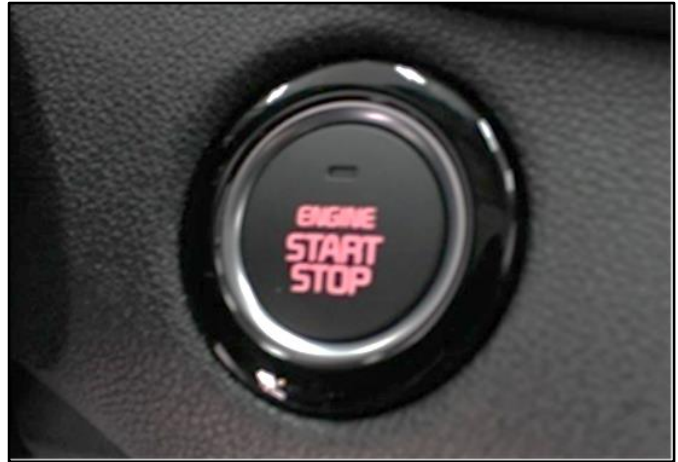
1. Turn on the vehicle.

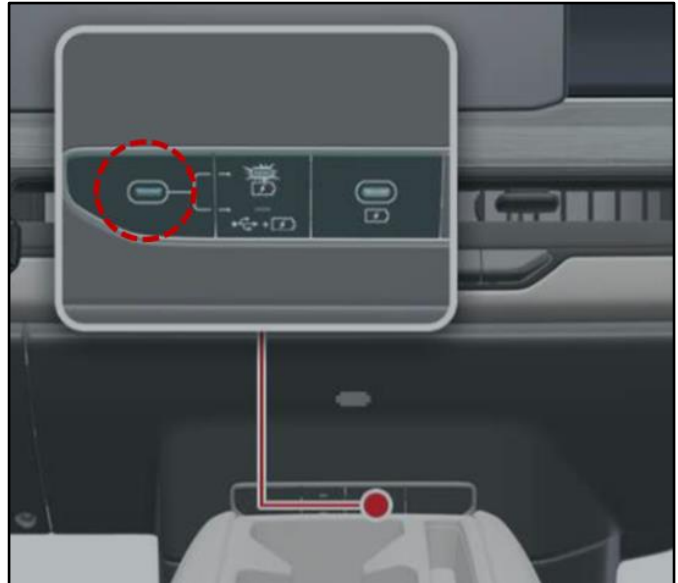
2. Insert the USB to the vehicle's USB data port.

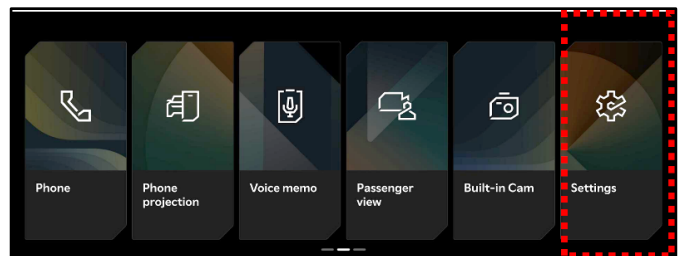
3. Select 'Setting' in Home screen.

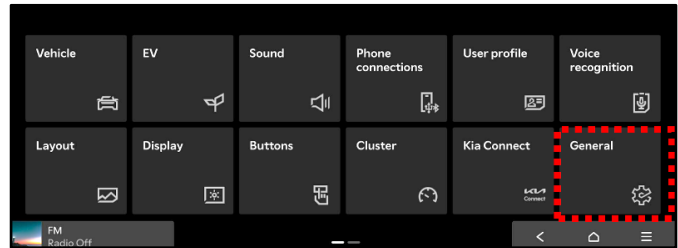
4. Select '**General**' on the Setup screen.

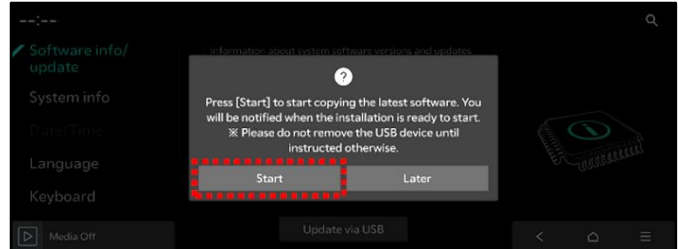
5. Select '**Start**' if a pop up is appears.

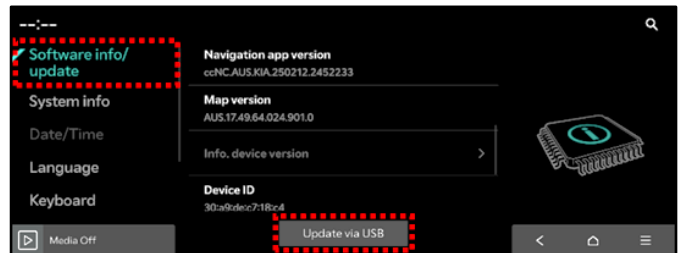
If a pop up does not appear, select '**Update via USB**' on 'Software info/Update'

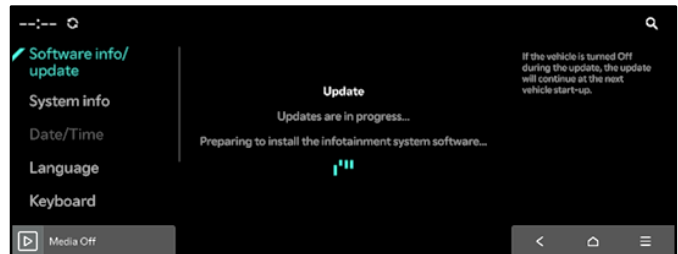
If the update icon appears in the upper-right corner of the screen, the background update is in progress.

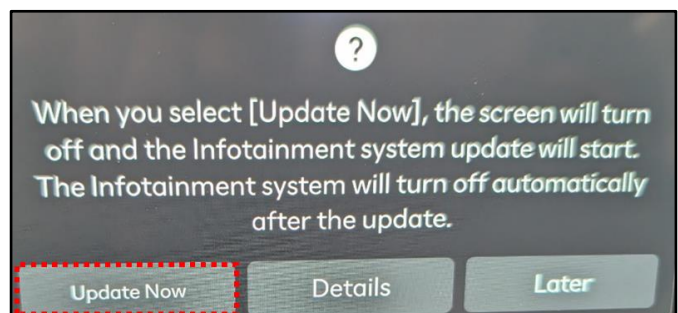
6. When the background update is complete, the message '**Ready to install the Navigation System software**' is displayed.
7. Once the update file download is complete select '**Update Now**' to install the software.

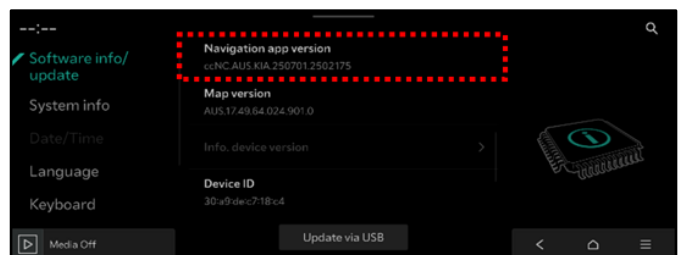
8. Confirm that the software update was completed successfully by checking the '**SW Info/Update**' screen.

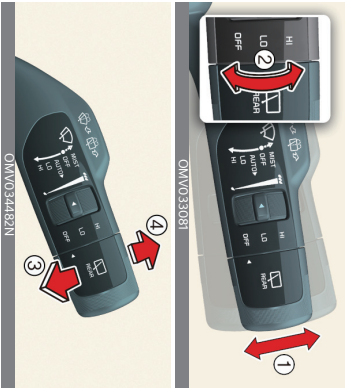
#### 3 Wash with brief wipes (Pull lever towards you)

#### 4 Wash with brief wipes (Rear/Push lever away from you)
