We sincerely regret that you experienced a concern with your 2005 Chevrolet Malibu, which resulted in an unexpected repair expense to you.

2 of 8				
PRODUCT ALLEGATION RESOLUTION				
PRELIMINARY INSPECTION STEERING SUSPENSION AXLE TIRE AND WHEEL SYSTEMS				
Customer's Name:Inspection Date:09/08/2006				
Vehicle Brand:         Chevrolet         Model:         Malibu				
<u>File # 1-428592121 VIN: 1G1ZT62825F</u>				
Shoulder Curb : Concrete Asphalt X Gravel Crushed rock Dirt Shoulder/Curb Condition: Dry X Wet Icy Other: <u>{</u> Posted Speed Limit <b>25 MPH</b> Any objects in the road? (rocks, scrap metal, pothole, speed bump, etc.) No objects. No road hazards.				
Length of Drive Prior to incident:				
Total Time (hrs. & mins.): <b>30 Minutes</b> Distance (miles): <b>17 Miles</b>				
Estimate of vehicle speed: 25 mph Source of est. Driver				
(Do Not report speed information from the Vetronix data here)				
If the driver/claimant description of the vehicle operation prior to and during the incident does not include the following information, please obtain it.

STE	PRELIMINARY INSPECTION ERING, SUSPENSION, AXLE, TIRE AND WHEEL SYSTEMS
Customer's Name	Inspection Date: 09/08/2006
Ve

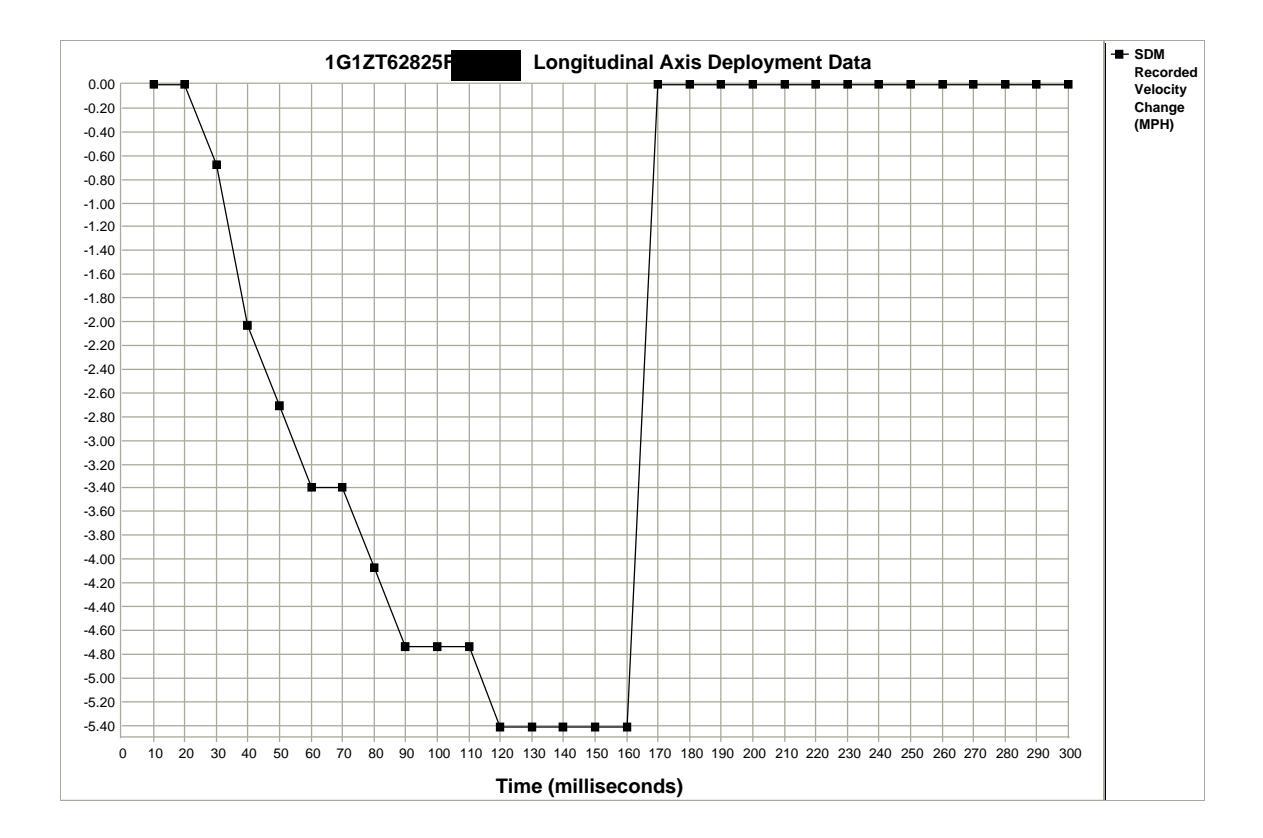
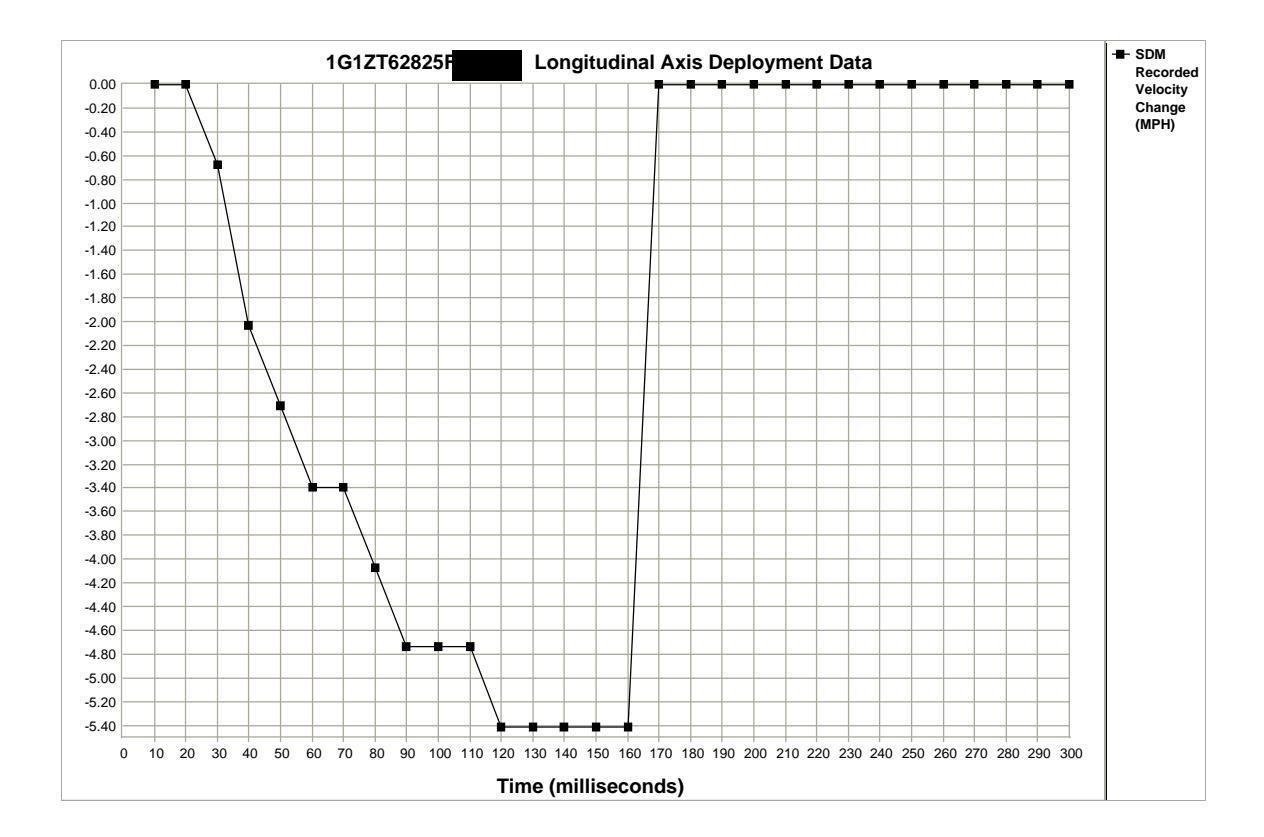
Time (milliseconds)	10	20	30	40	50	60	70	80	90	100	110	120	130	140	150
Longitudinal Axis Recorded Velocity	0.00	0.00	-0.68	-2.03	-2.71	-3.39	-3.39	-4.07	-4.74	-4.74	-4.74	-5.42	-5.42	-5.42	-5.42
Time (milliseconds)	160	170	180	190	200	210	220	230	240	250	260	270	280	290	300
Longitudinal Axis Recorded Velocity	-5.42	0.00	0.00	0.00	0.00	0.00	0.00	0.00	0.00	0.00	0.00	0.00	0.00	0.00	0.00

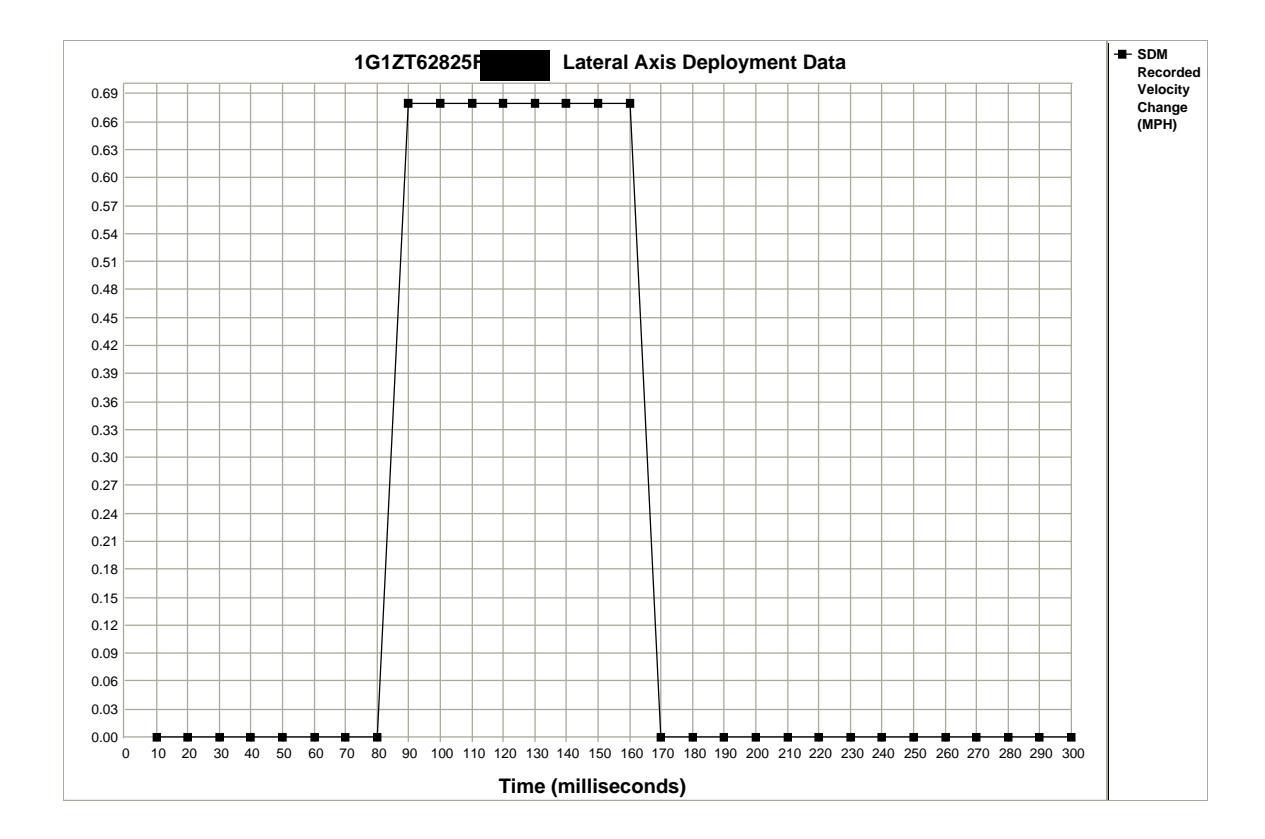
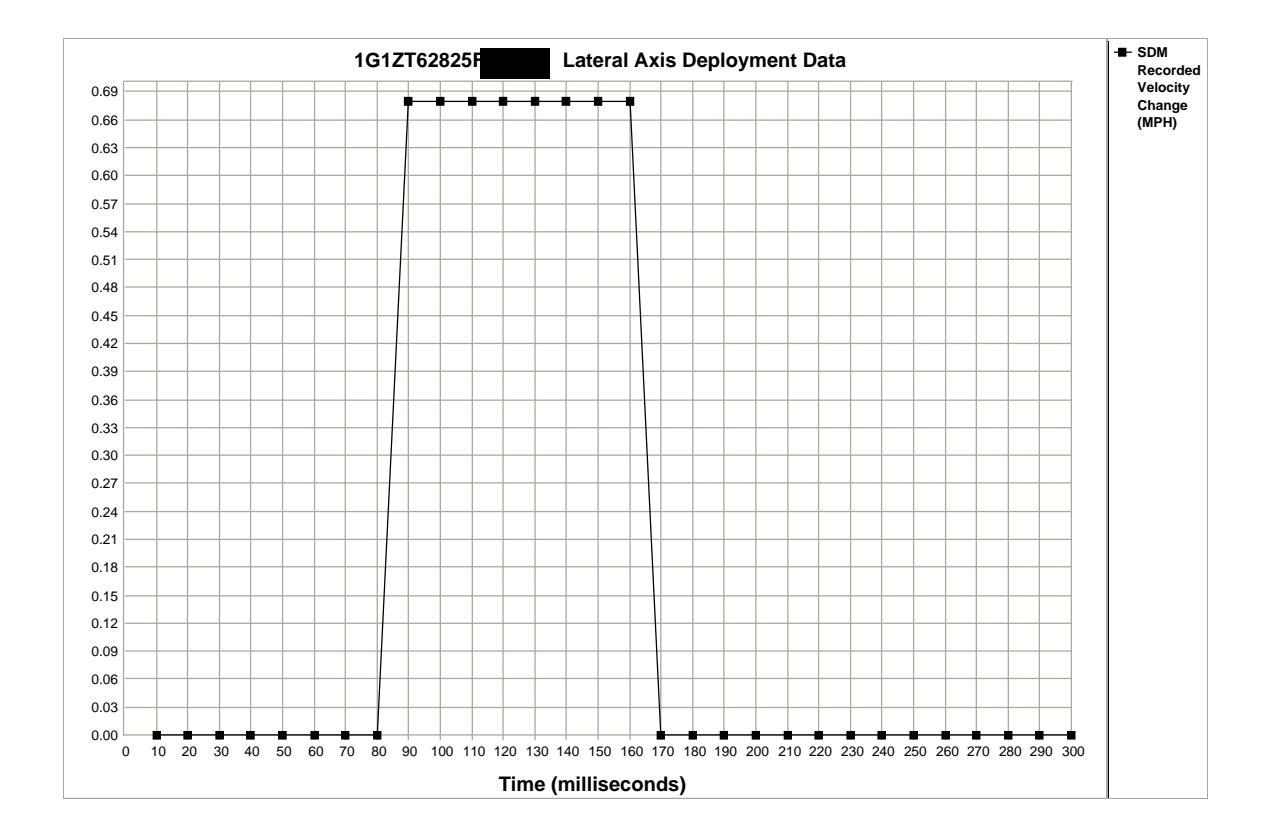
Time (milliseconds)	10	20	30	40	50	60	70	80	90	100	110	120	130	140	150
Lateral Axis Recorded Velocity Change (MPH)	0.00	0.00	0.00	0.00	0.00	0.00	0.00	0.00	0.68	0.68	0.68	0.68	0.68	0.68	0.68
Time (milliseconds)	160	170	180	190	200	210	220	230	240	250	260	270	280	290	300
Lateral Axis Recorded Velocity Change (MPH)	0.68	0.00	0.00	0.00	0.00	0.00	0.00	0.00	0.00	0.00	0.00	0.00	0.00	0.00	0.00
