We sincerely regret that you experienced a concern with your 2005 Chevrolet Malibu, which resulted in an unexpected repair expense to you.

2 of 8				
PRODUCT ALLEGATION RESOLUTION				
PRELIMINARY INSPECTION STEERING SUSPENSION AXLE TIRE AND WHEEL SYSTEMS				
Customer's Name:Inspection Date:09/08/2006				
Vehicle Brand:         Chevrolet         Model:         Malibu				
<u>File # 1-428592121 VIN: 1G1ZT62825F</u>				
Shoulder Curb : Concrete Asphalt X Gravel Crushed rock Dirt Shoulder/Curb Condition: Dry X Wet Icy Other: <u>{</u> Posted Speed Limit <b>25 MPH</b> Any objects in the road? (rocks, scrap metal, pothole, speed bump, etc.) No objects. No road hazards.				
Length of Drive Prior to incident:				
Total Time (hrs. & mins.): <b>30 Minutes</b> Distance (miles): <b>17 Miles</b>				
Estimate of vehicle speed: 25 mph Source of est. Driver				
(Do Not report speed information from the Vetronix data here)				
If the driver/claimant description of the vehicle operation prior to and during the incident does not include the following information, please obtain it.

STE	PRELIMINARY INSPECTION ERING, SUSPENSION, AXLE, TIRE AND WHEEL SYSTEMS
Customer's Name	Inspection Date: 09/08/2006
Ve

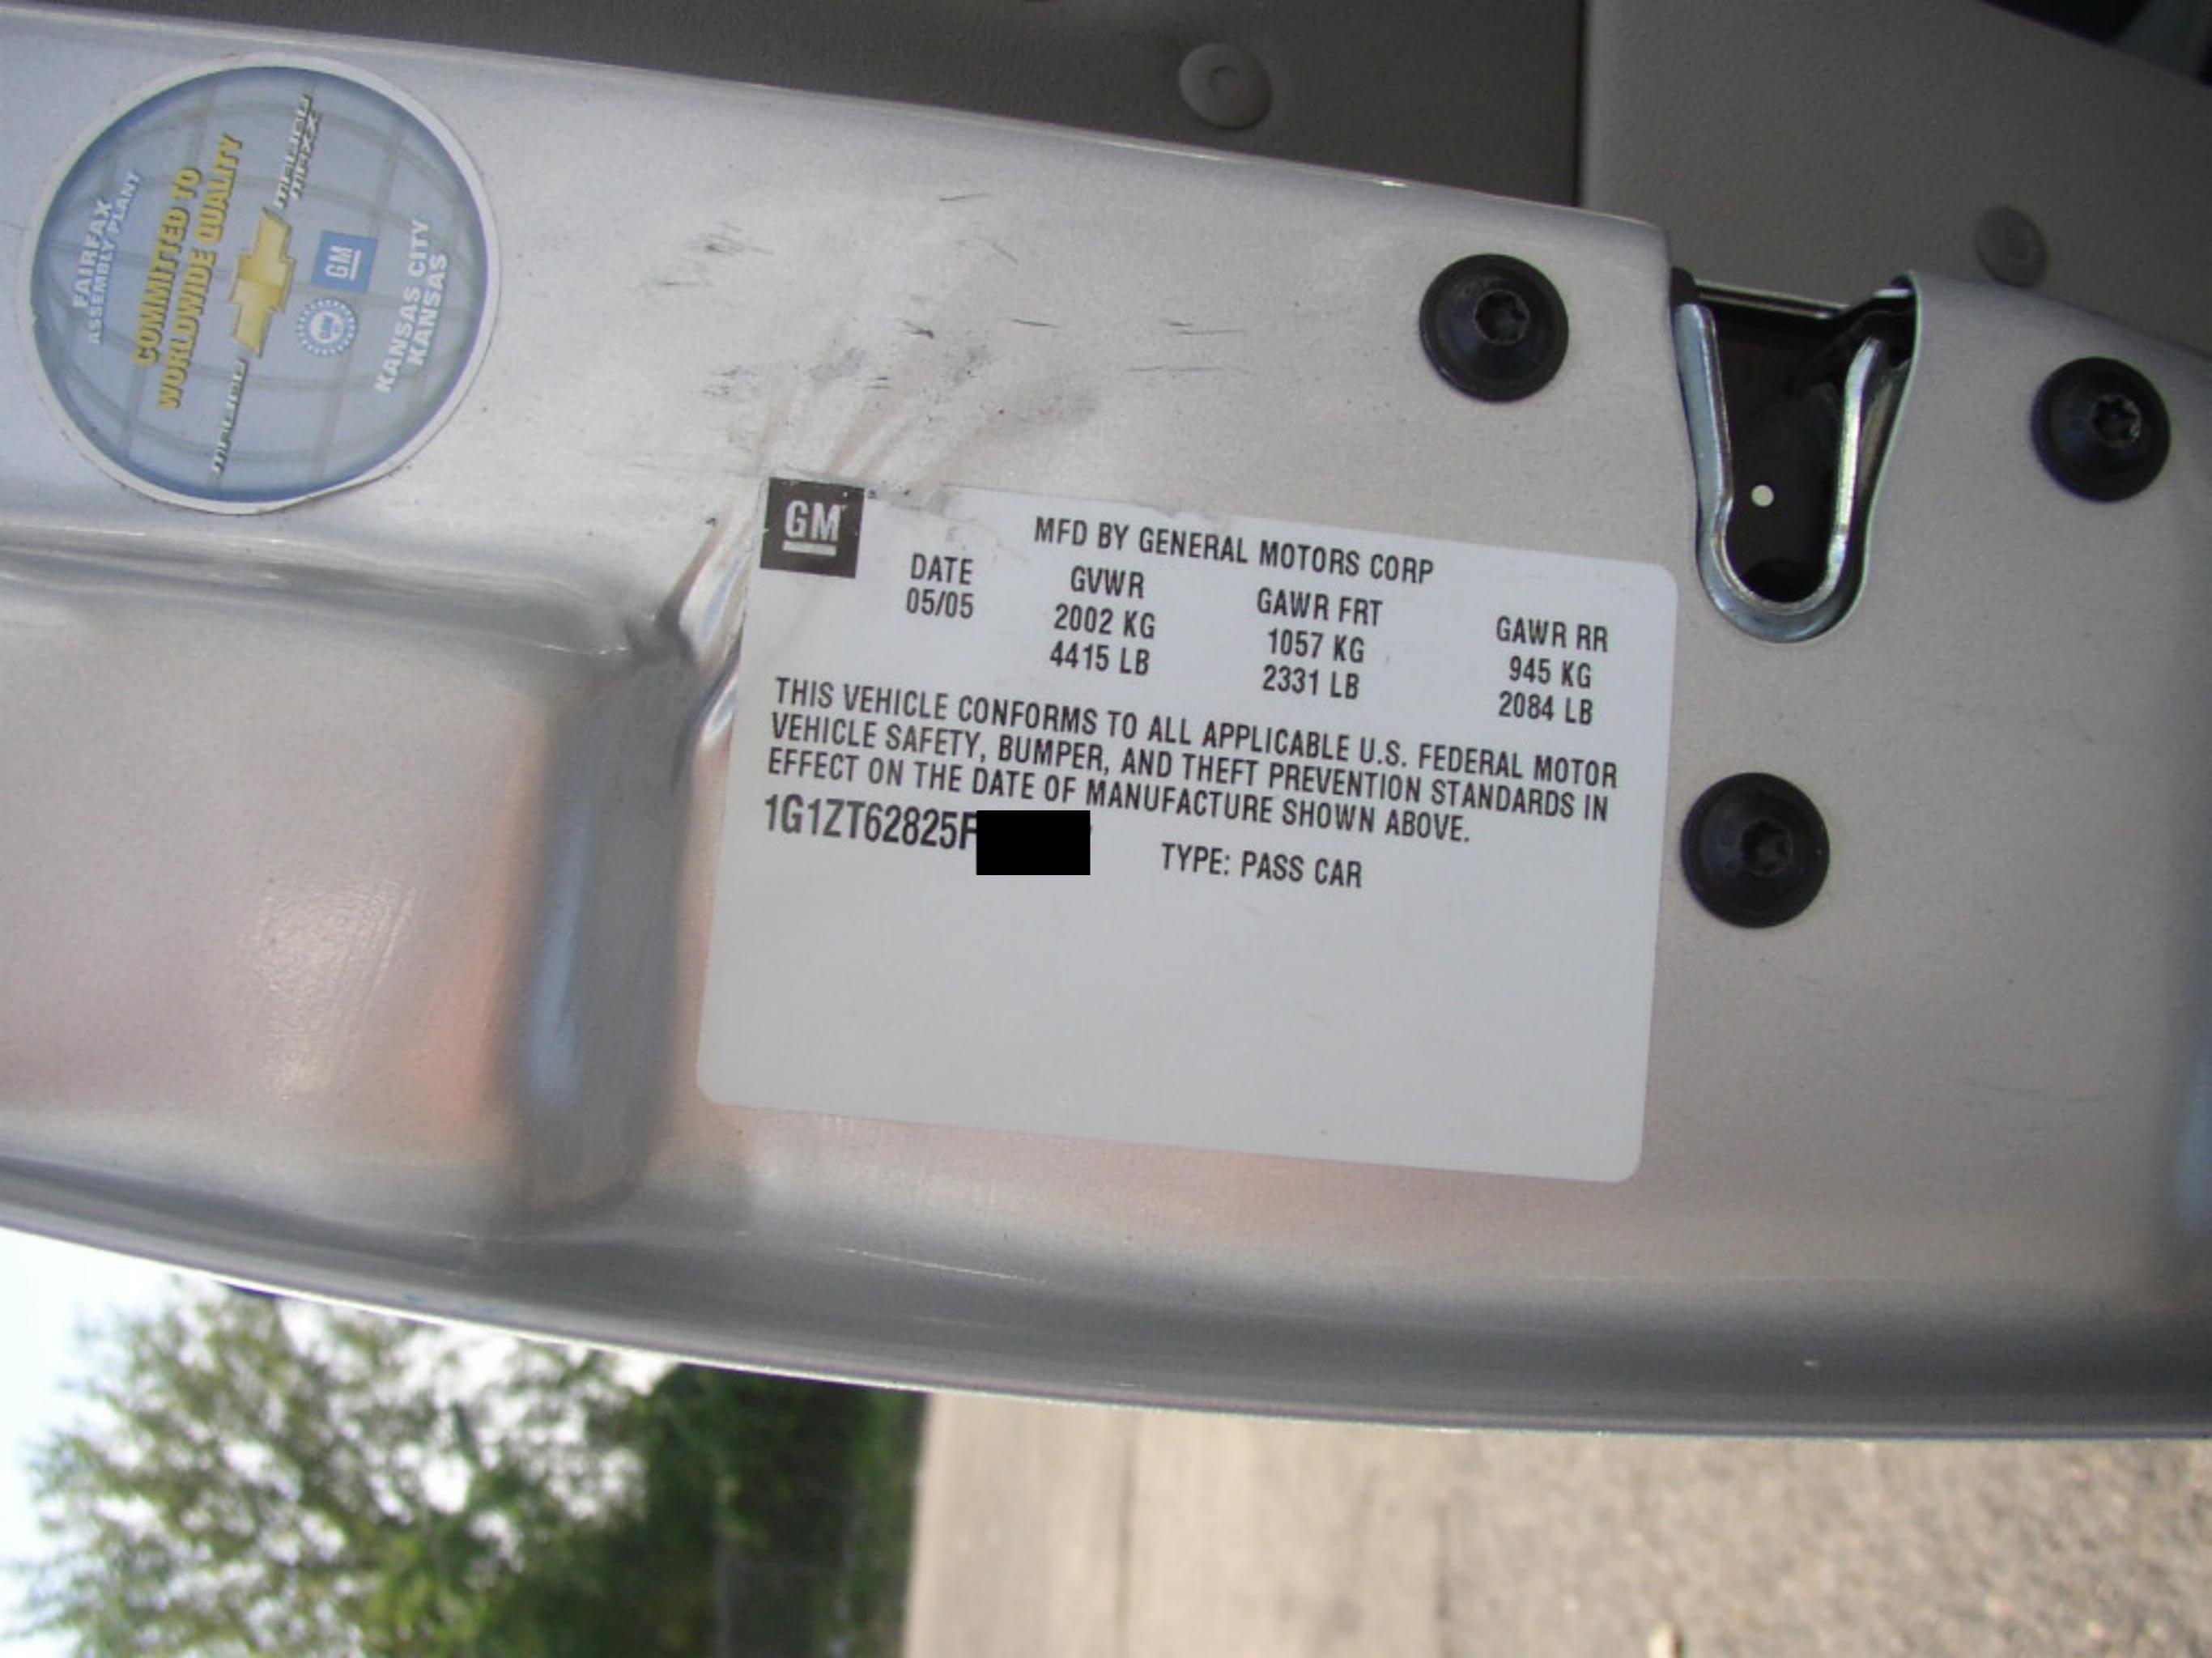
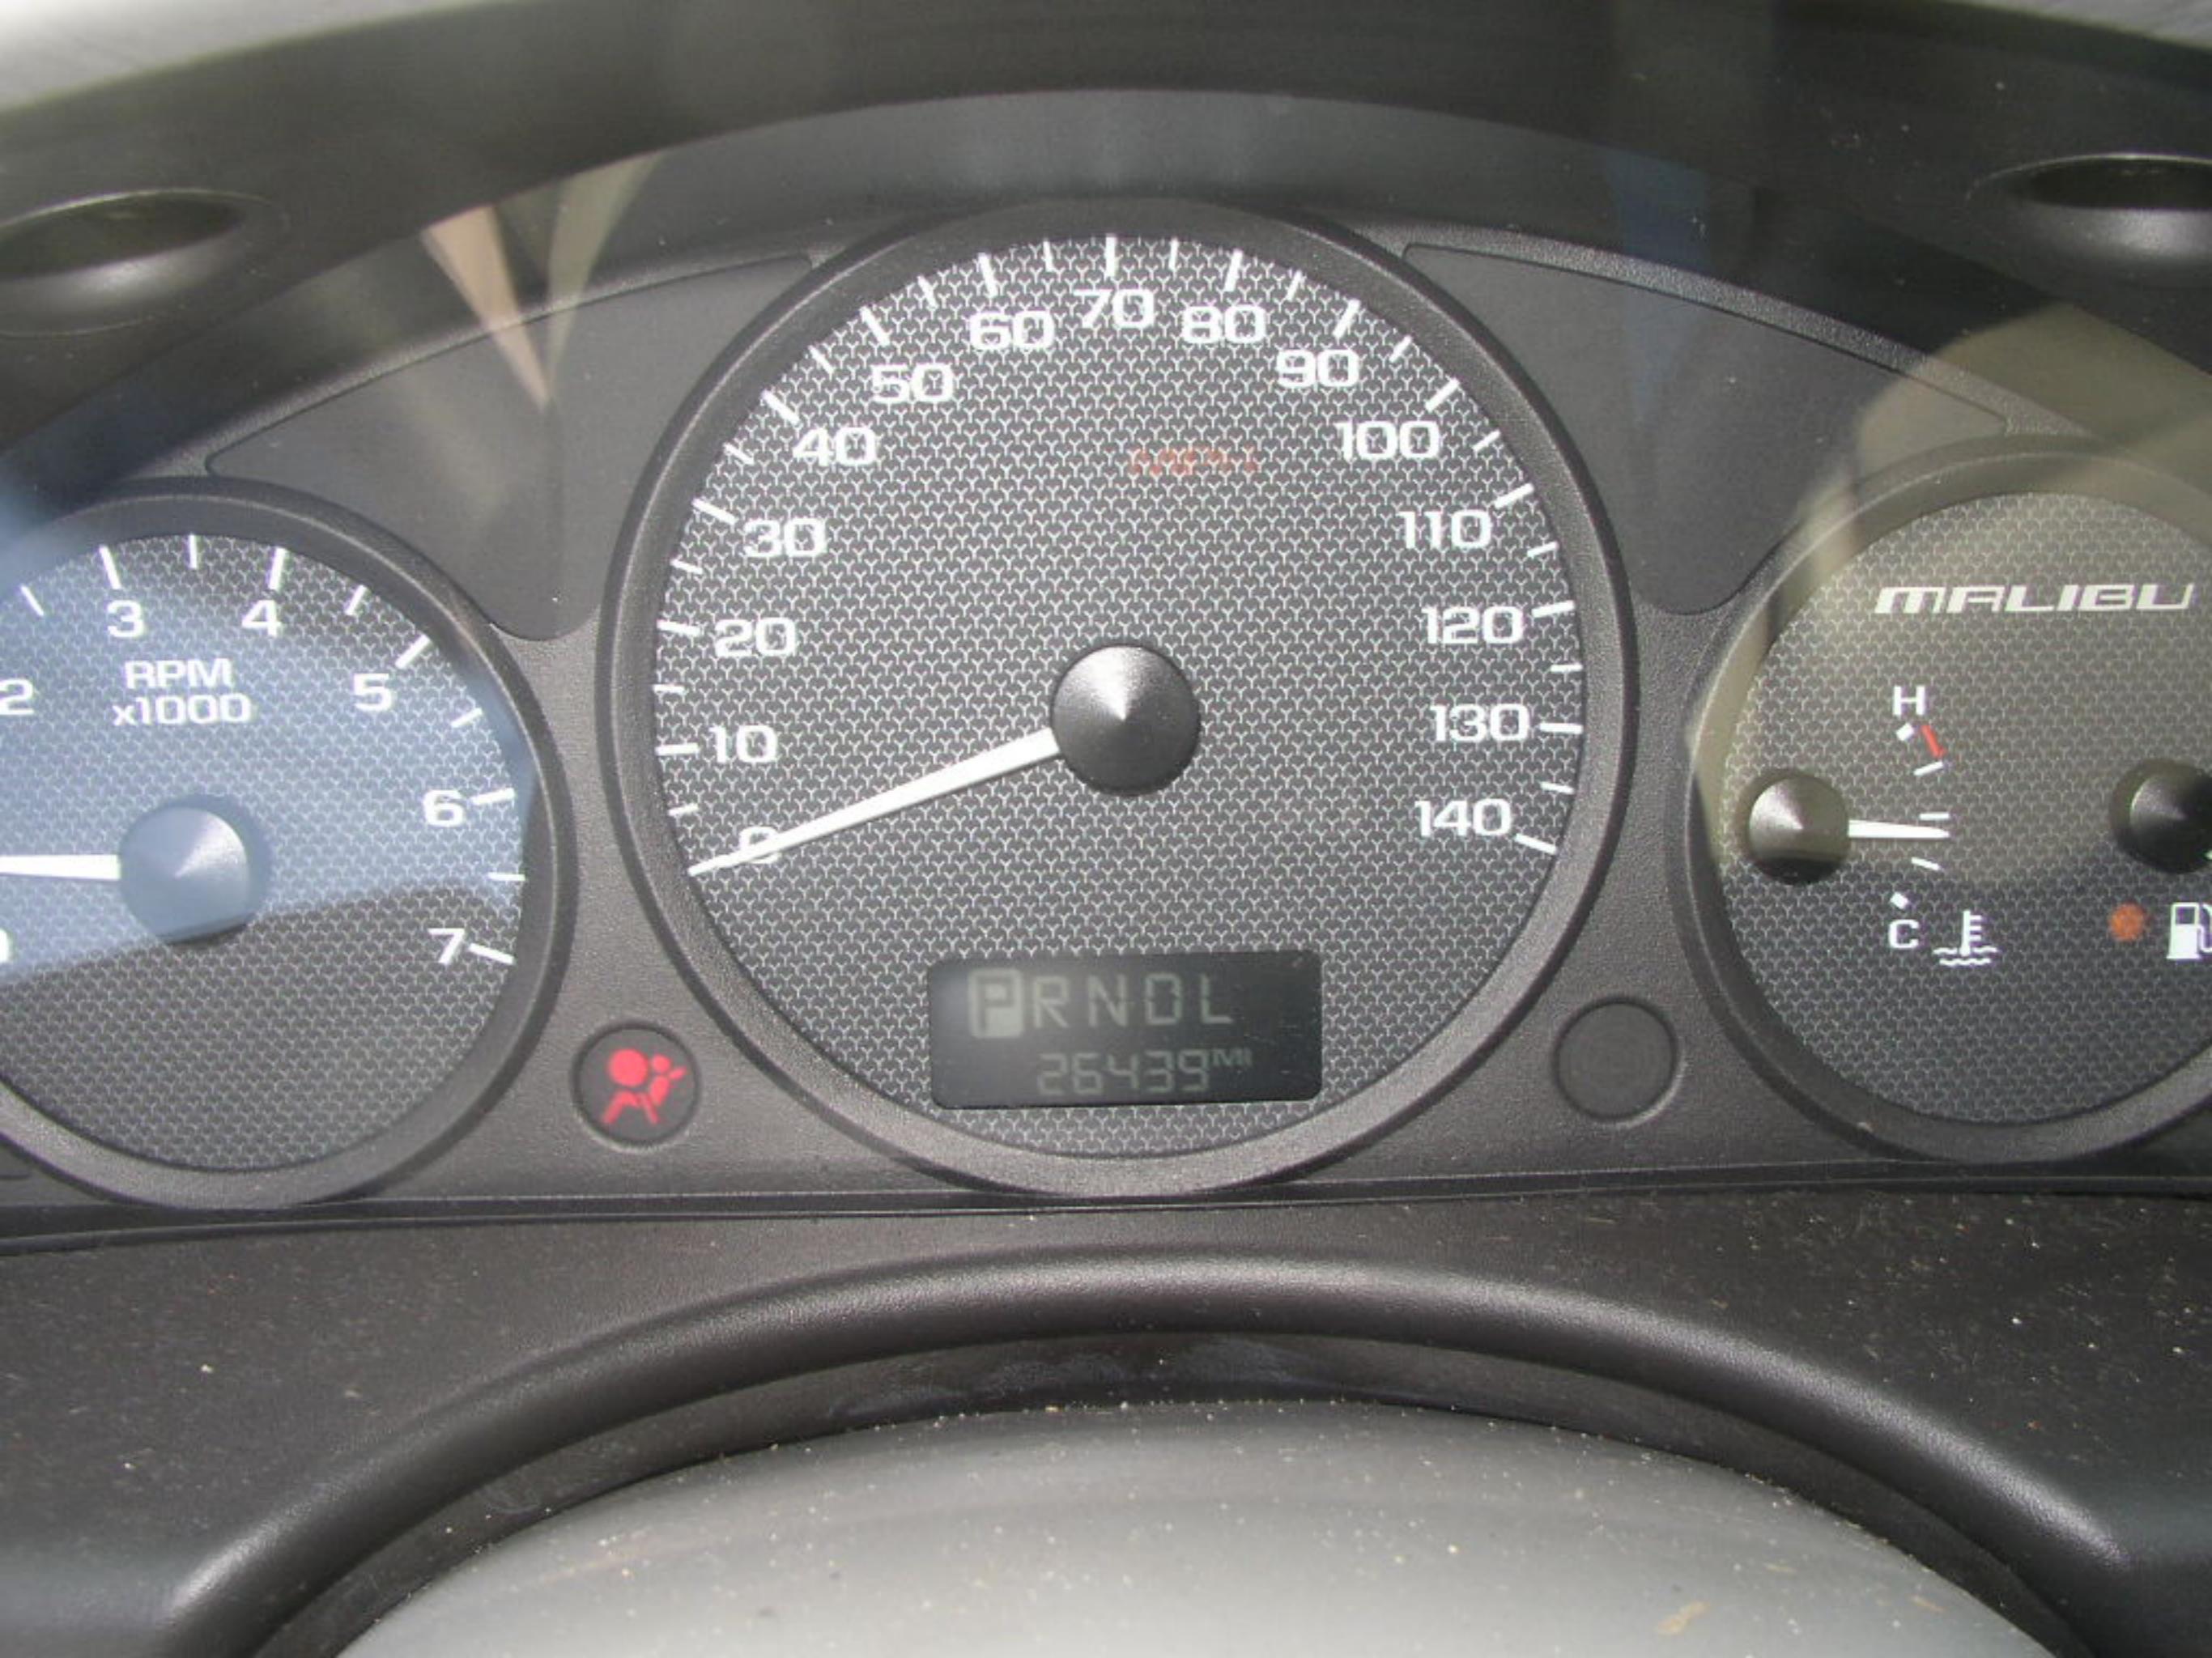
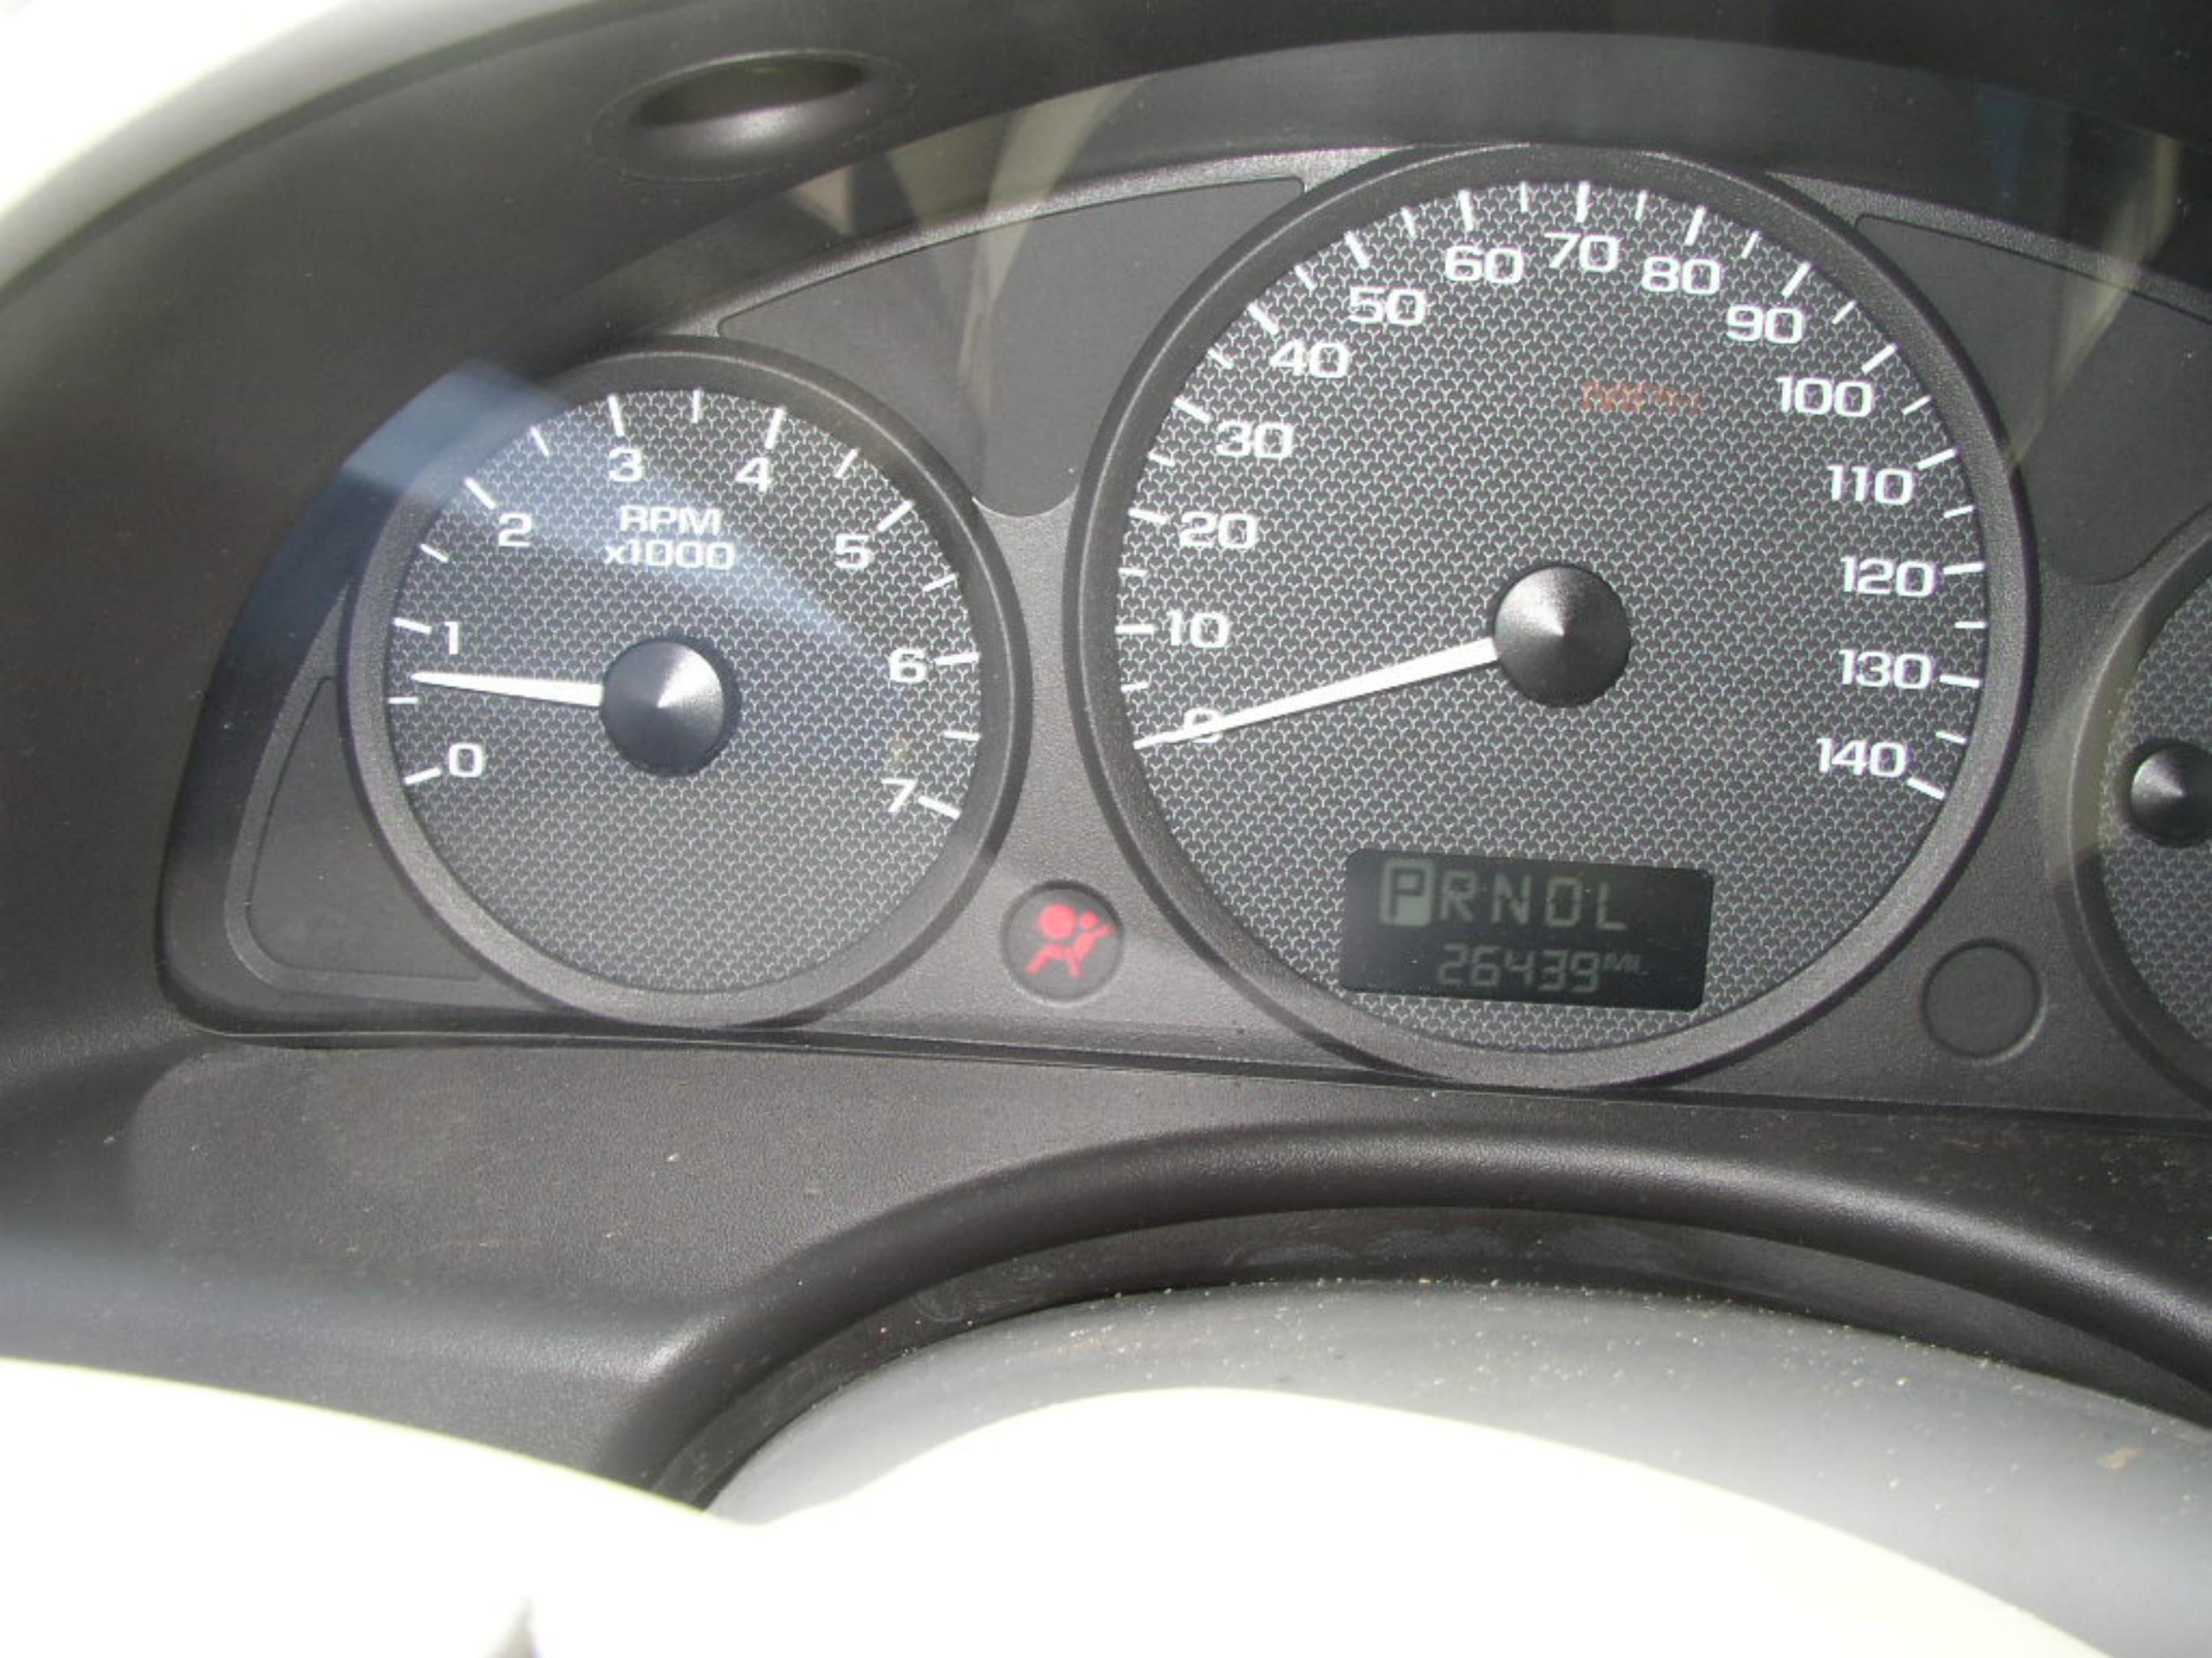
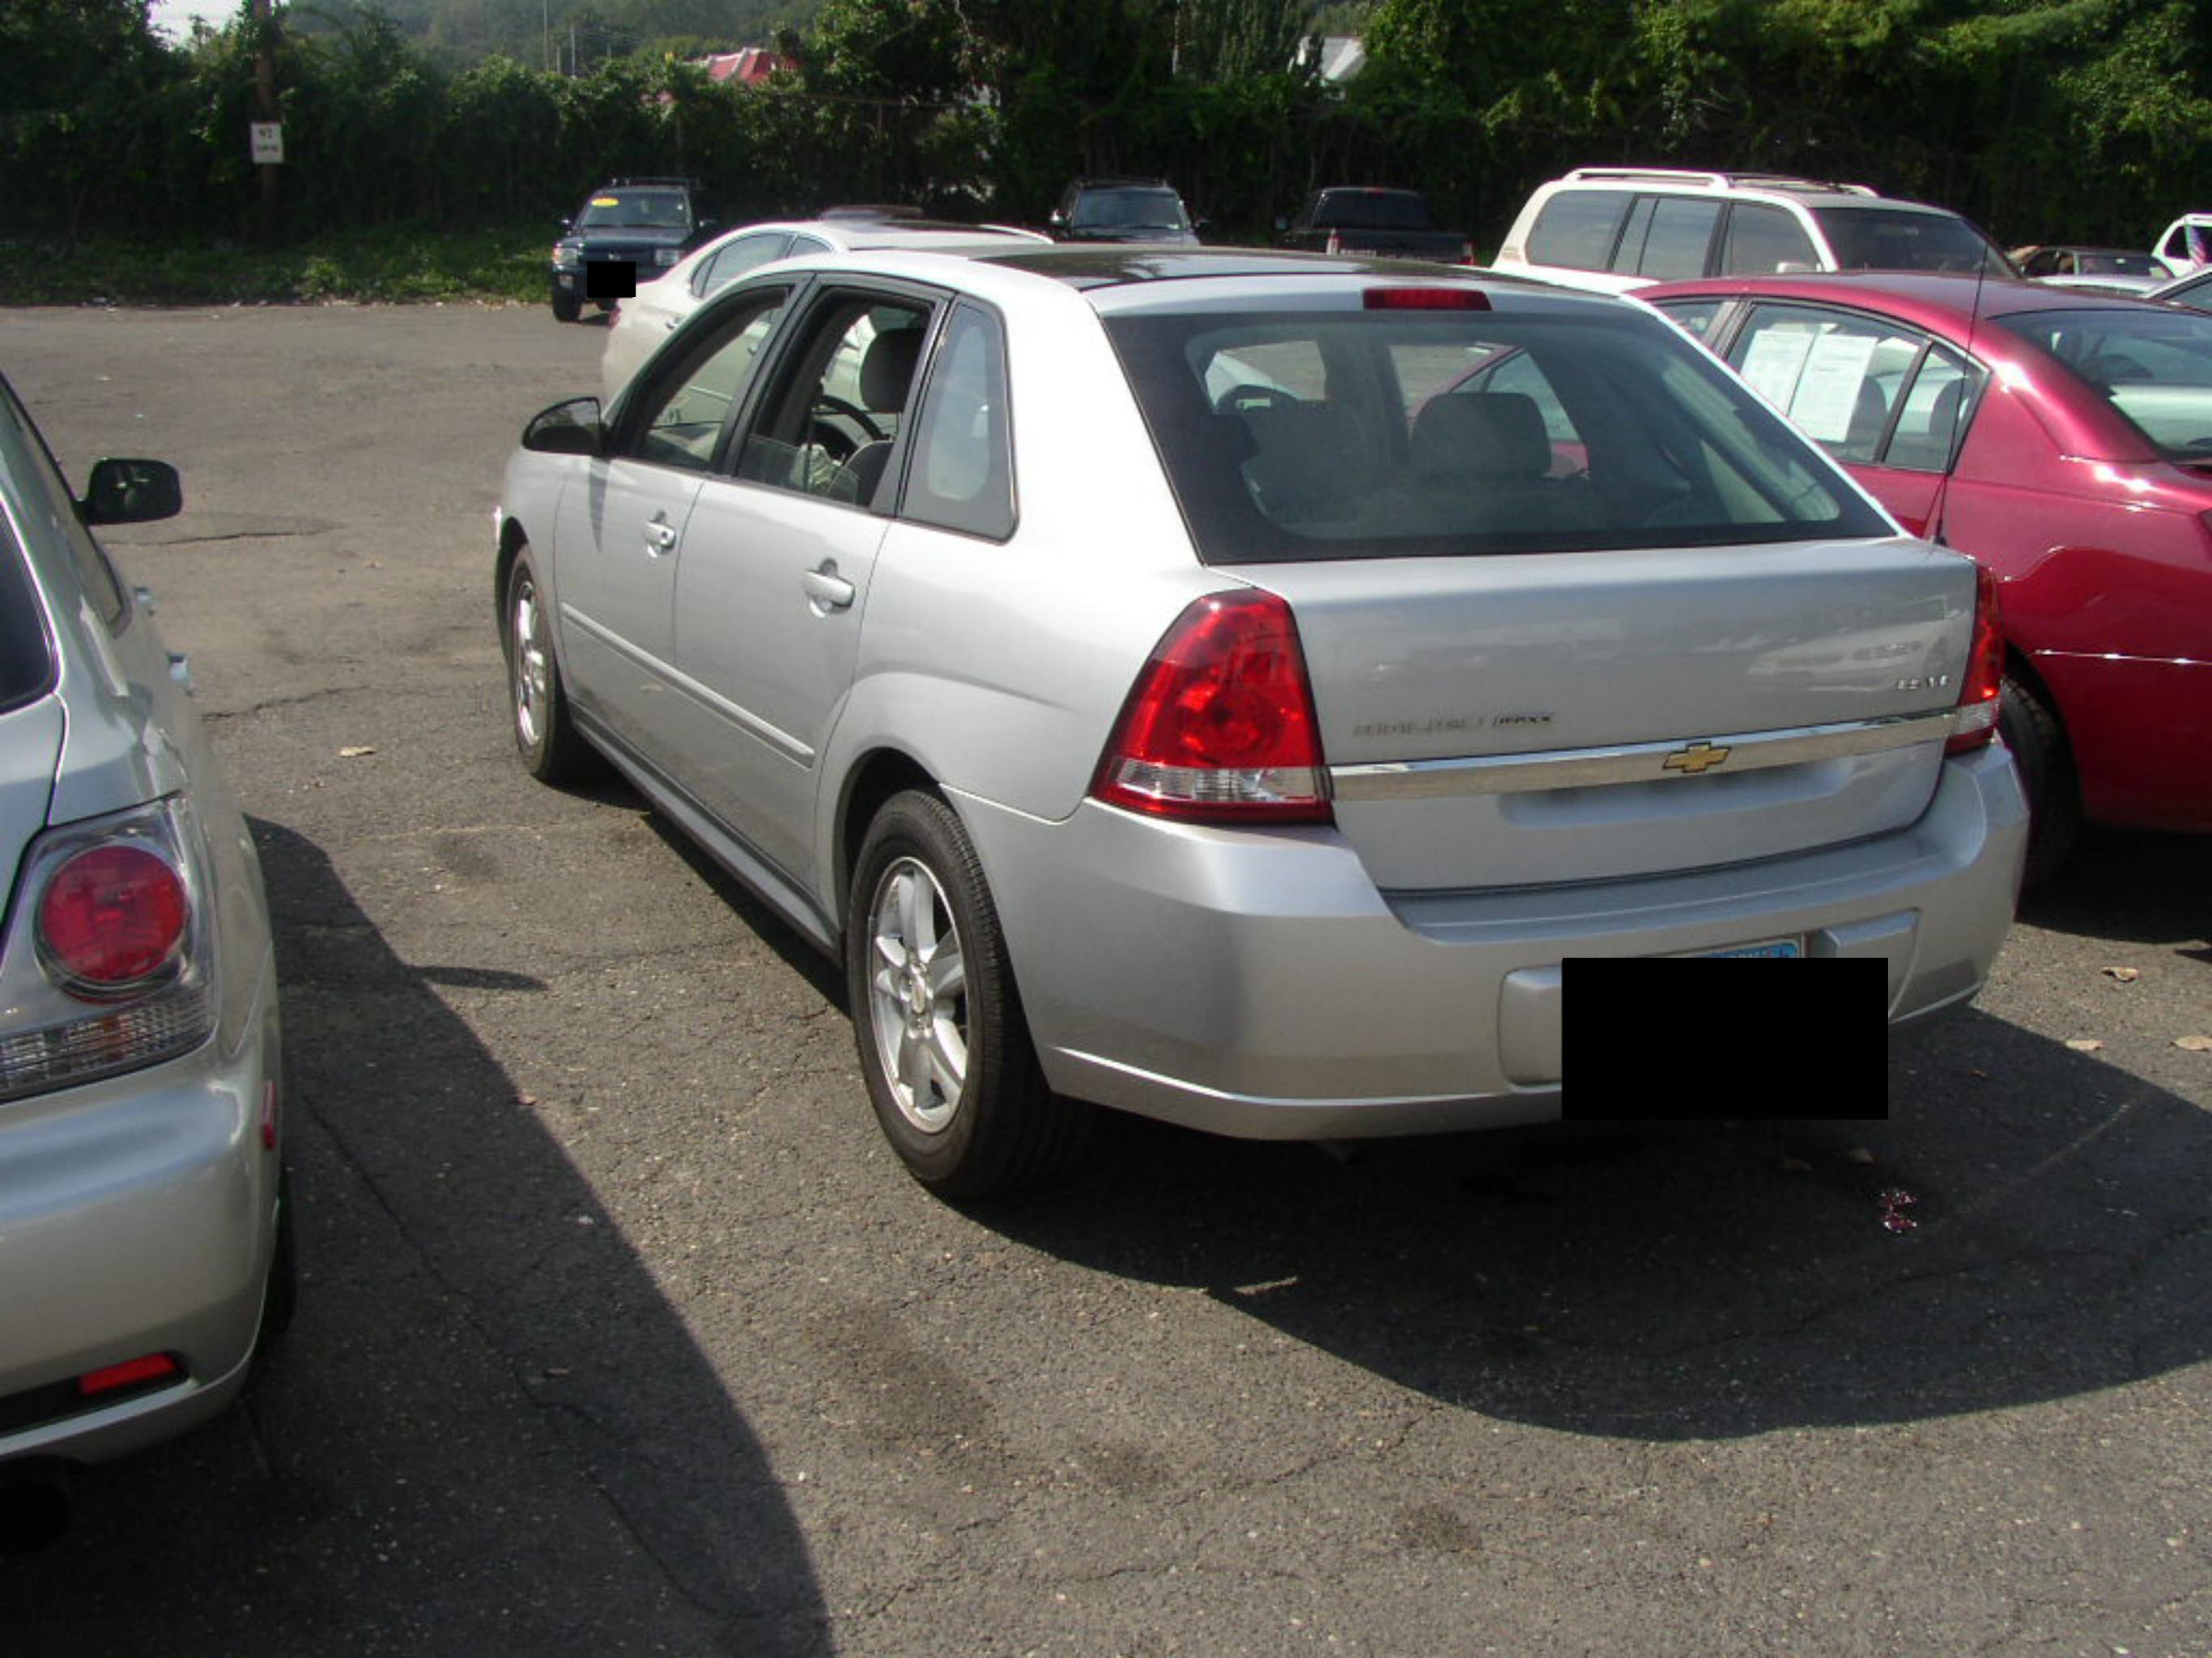
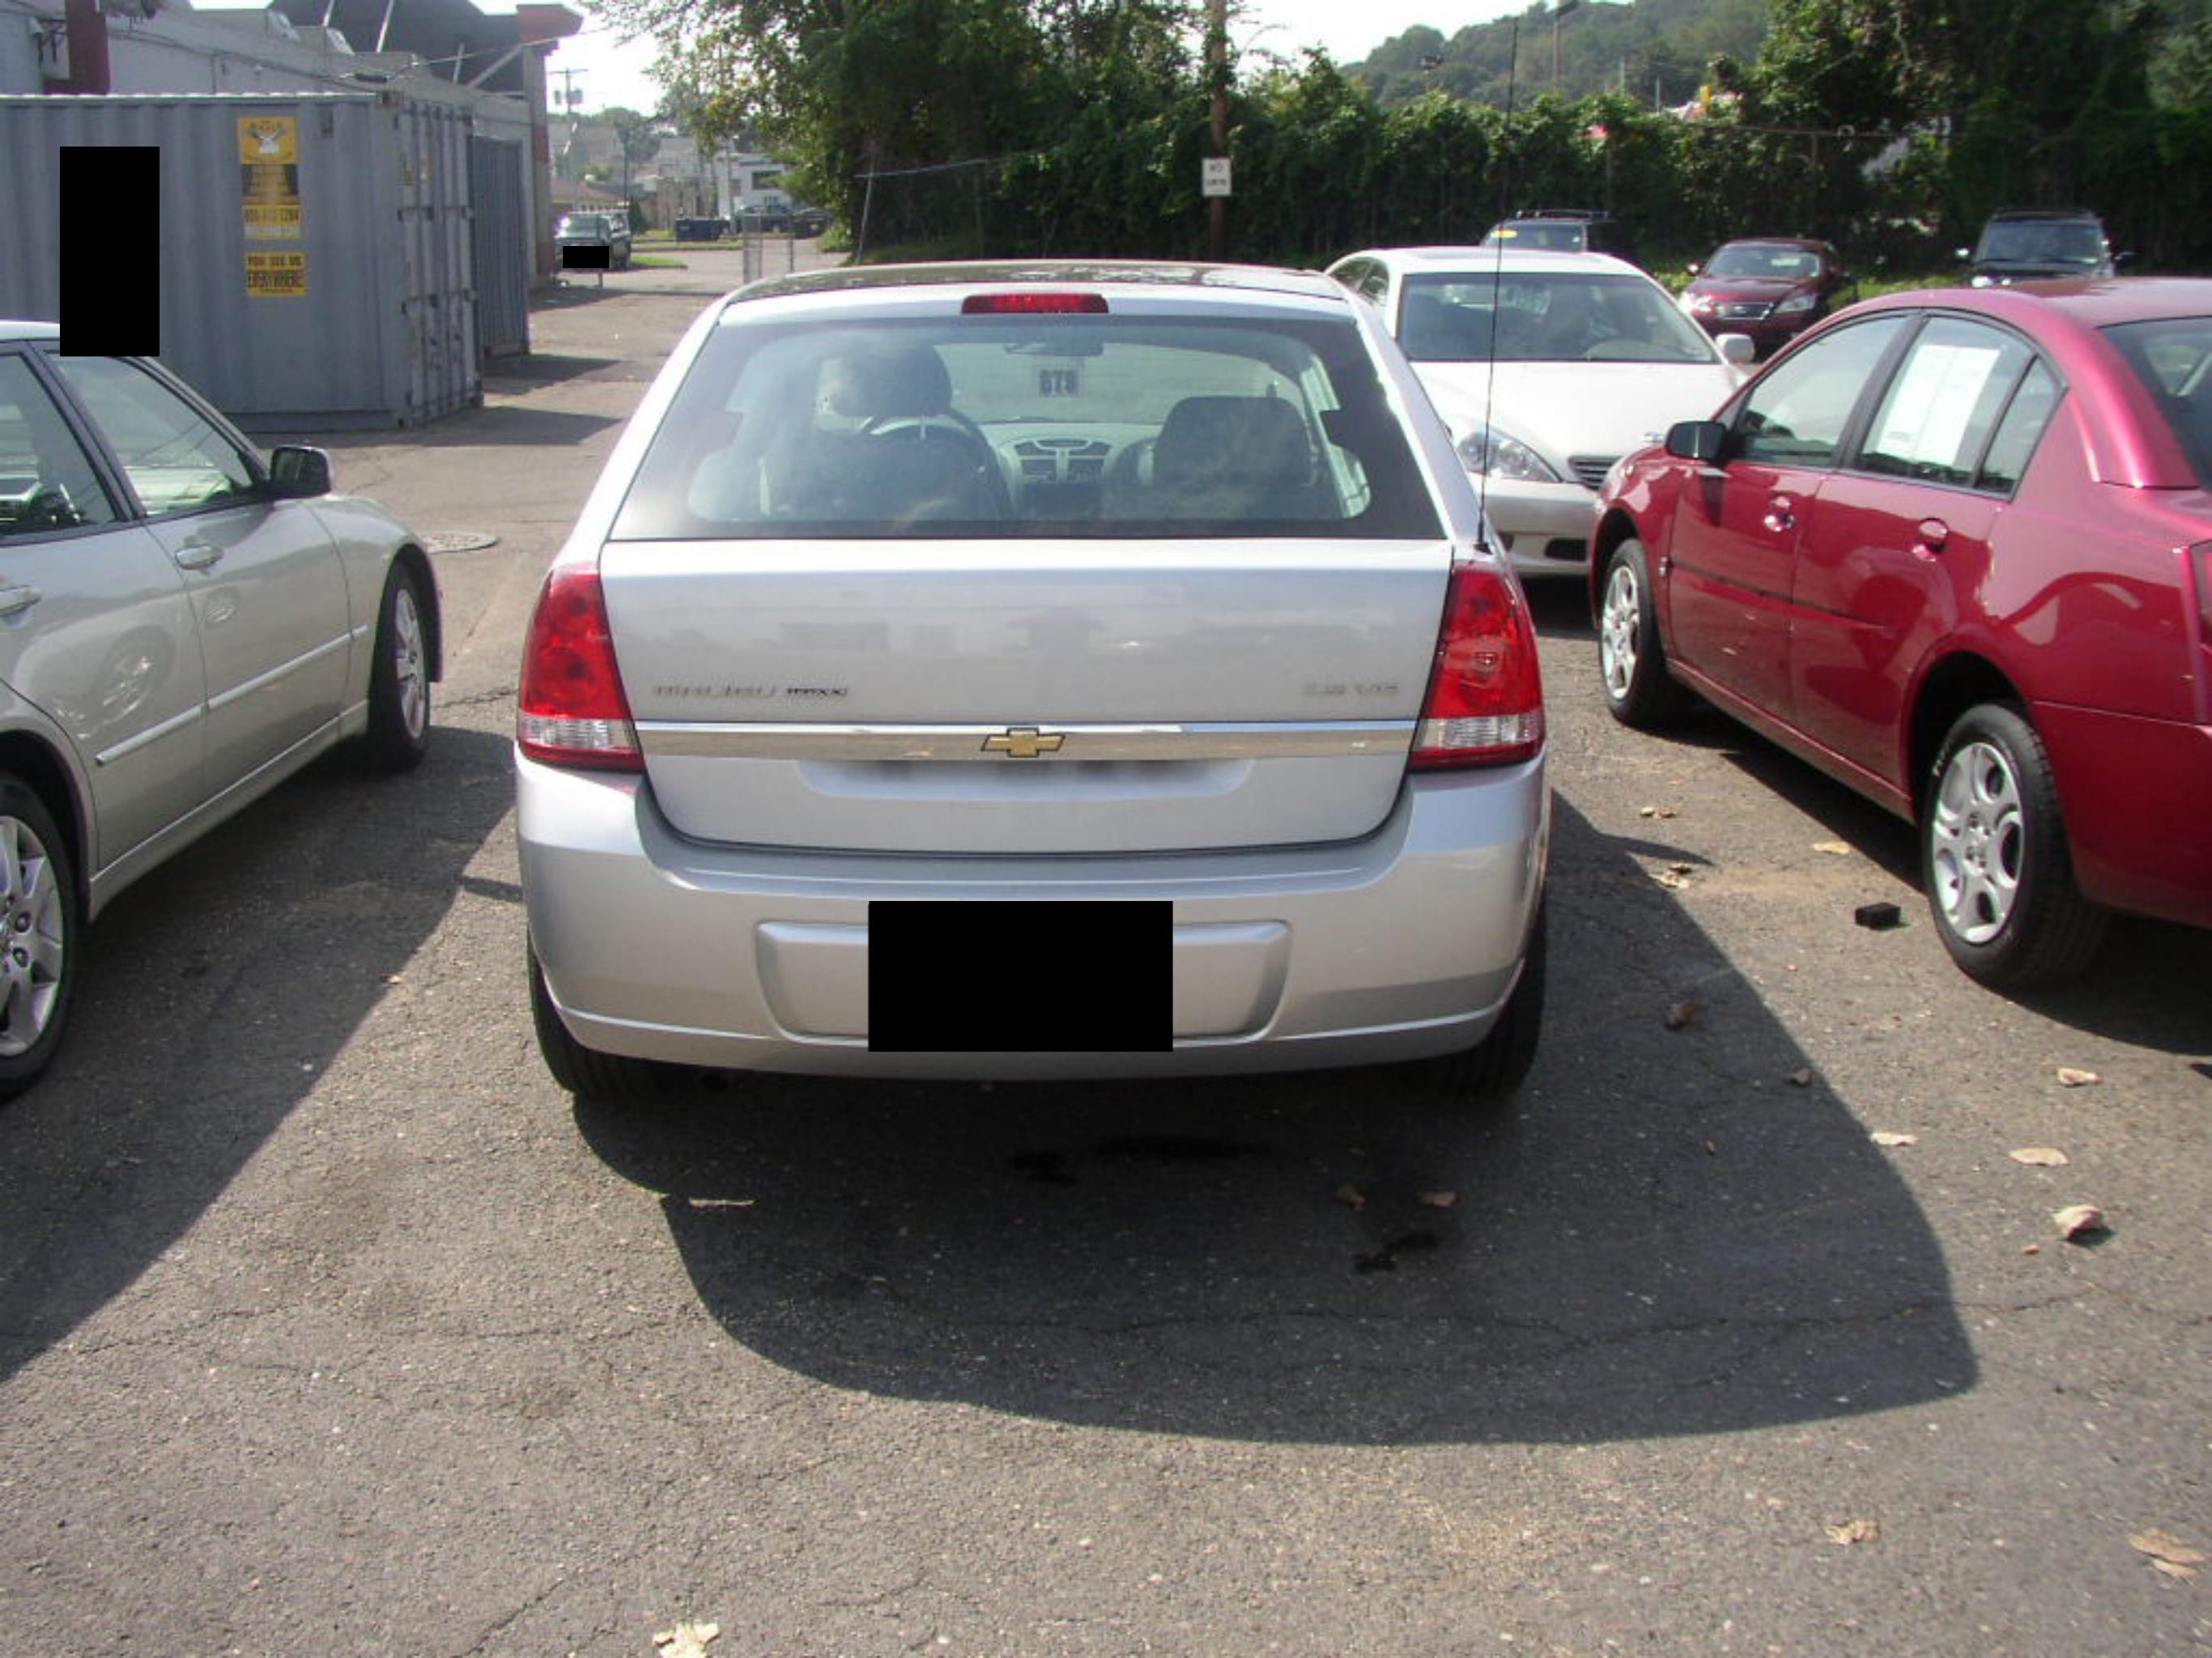
5. Speedometer 26/39 miles Airbag warning lamp on								
6 Speedometer and airbag light								
7 Left rear exterior. No damages								
8. Rear exterior. No damages.

9. Right rear exterior. No damages.								
10. Right front exterior. No damages.								
11. Front exterior. No damages.								
12. Left side, front exterior. No damages.

13. Left side exterior. No damages.								
14. Drivers side interior. Airbag deployed.								
15. Passengers side interior. Airbag deployed.								
16. Drivers side floor area. No floor mat.

17. Drivers side interior from right side. Airbag deployed.								
18. Passengers side interior. Airbag deployed.								
19. Radiator support area. No damages.

20. Engine compartment and engine area. No damages.								
21. Right side engine area. No damages.								
22. Front engine compartment area. No damages.

23. Front radiator support area. No damages.								
24. ABS. No leaks. No damages.								
25. Left side, bottom, front bumper and frame rail. Note damages to frame	me rail. Frontal impact.

26. Left side frame rail impact damages.								
27, Left side frame rail impact damages.								
28. Right side frame rail impact damages.								
29. Right side frame rail impact damages.

30. Left side frame rail impact damages.								
31. Right side frame rail impact damages.								
32. Right side frame rail impact damages.								
33. Right side frame rall impact damages.

34. Lett side floor pan impact damages.								
55. Let sue not par impact damages.

- 38 Right side, front of frame rail damage.
- 39 Left side, front of frame rail damage.
- 40 Tech 2 screen. Power steering data. No stored or active DTC'S
- 41 Tech 2 screen. Power steering data. No stored or active DTC'S
- 42 Tech 2 screen. Power steering data. No stored or active DTC'S

There was a severe impact to the left and front frame rails. Both left and right side frame rails are mangled and bent. There are scrape marks to the bottom of both frame rails. The floor pan at the left rear of this vehicle is scraped and dented. Both drivers and passengers airbags deployed. Both Drivers and passengers seat belt expanders deployed. No upper body damages. No sheet metal, glass or otherwise.
