Subject: Recall Campaign 07V-334 (55E5/JV)

Subject: Safety Recall JV 2006-2008 Model Year Audi A6 Avant and Model Year 2007-2008 Audi Q7 Automatic Rear Lid Software – Vehicles to be Reopened

Safety Recall Circular

Subject: 2006-2008 MY Audi A6 Avant 2007-2008 MY Audi Q7 Automatic Rear Lid Software Code: 55E5/JV REVISION #3

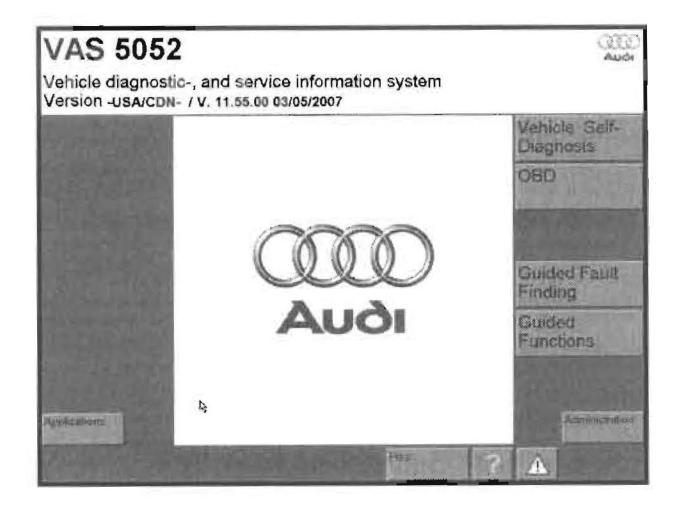
- Connect vehicle diagnostic, testing and information system -VAS 5051B- or -VAS 5052- (with online capability) to the vehicle
- Insert the Update CD (Part No. 4L0 906 961 G for VAS 5052) or Update CD (Part No. 4E0 906 961 AD for VAS 5051B) in the CD drive of the appropriate tester
- Connect tester to your workshop network (CPN) using network connection cable
- Insert memory stick so *Diagnosis Log* can be recorded following SVM update
- Enter the SVM update into the User Test Plan by selecting the following inside Guided Fault Finding:

Go to >> Function/Component Selection >> Problem Related Hardware and Software Update >> Direct Input: SVM code for problem related update

- Follow the SVM update procedure and enter the SVM Action Code 55E5A001 when prompted
- Enter your GeKo ID when requested and data will be transmitted to the SVM server, which will respond with instructions to continue

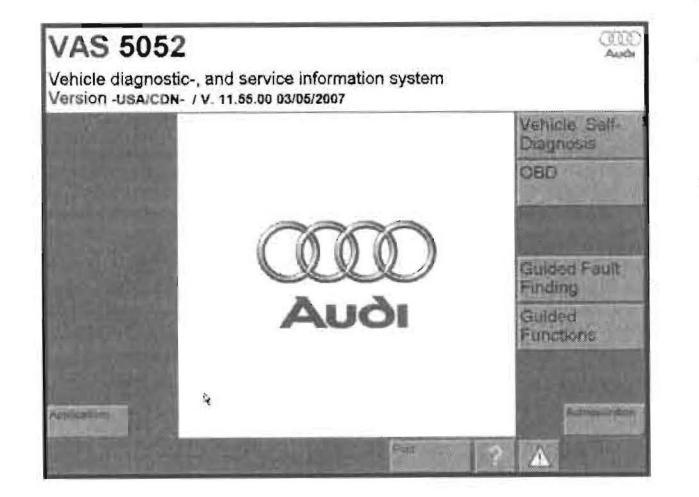
- With vehicle diagnostic, testing and information system -VAS 5051B- or -VAS 5052- (with online capability) connected to the vehicle
- Select:

Applications>>Start application from CD ROM

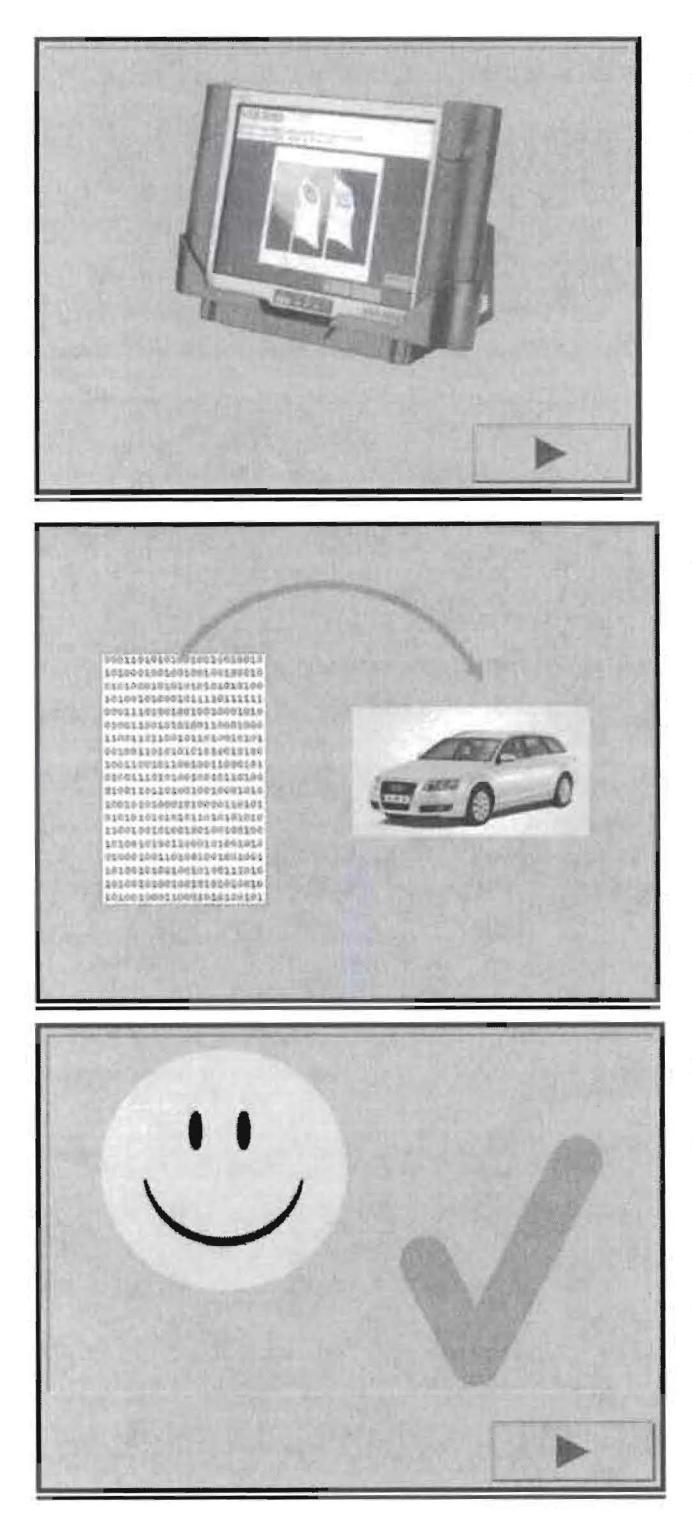
- ⇐ The start screen shows the tester
- Press the 'Next' button (►)

When this screen is displayed, both tailgate drives will then be flashed. Wait until the software update is completed

- If this screen display appears, the software update was successful
- Press the 'Next' button (▶)

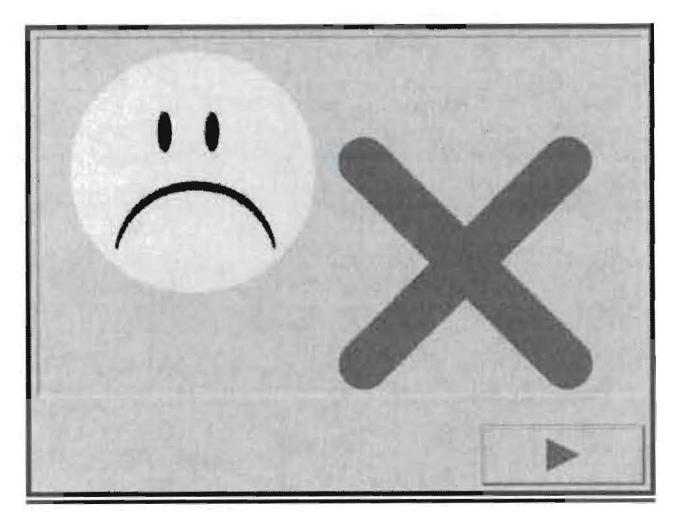
- If this screen display appears, the software update was not successful
- Make a note of the error number displayed on the screen
- Press the 'Next' button (►)
- If the update was unsuccessful do not continue to Section C

If the software update of the rear lid is unsuccessful:

- Open a TAC ticket and contact the Audi Technical Assistance Center (TAC)
- Check CD installed in tester for proper installation and correct CD
- Lay tester flat and try update again

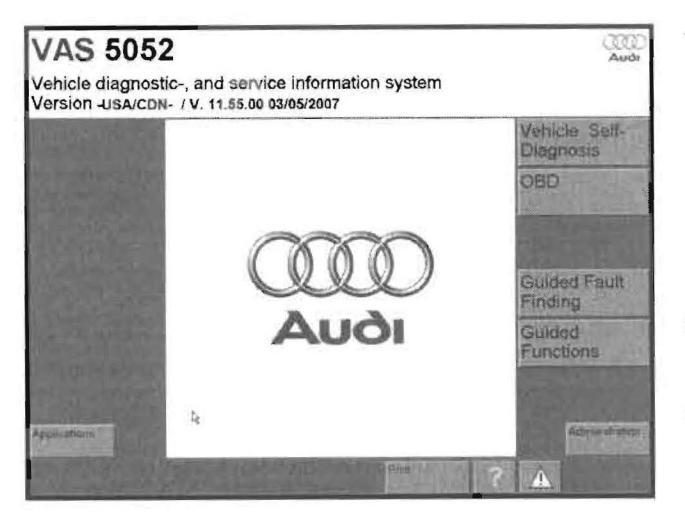
Section C – Activating data bus diagnosis interface (J533)

With tester still connected to the vehicle, enter the SVM update into the User Test Plan by selecting the following inside *Guided Fault Finding*:

> Go to >> Function/Component Selection >> Problem Related Hardware and Software Update >> Direct Input: SVM code for problem related update

- Follow the SVM update procedure and enter the SVM Action Code 55E5B001 when prompted
- Enter your GeKo ID when requested and data will be transmitted to the SVM server, which will respond with instructions to continue
