NUMBER:	08-100-14
GROUP:	Electrical
DATE:	December 02, 2014

Loss Of Power Heated Mirror Function - Recall P61 Interim Repair

2011 - 2013 (JK)

Jeep Wrangler

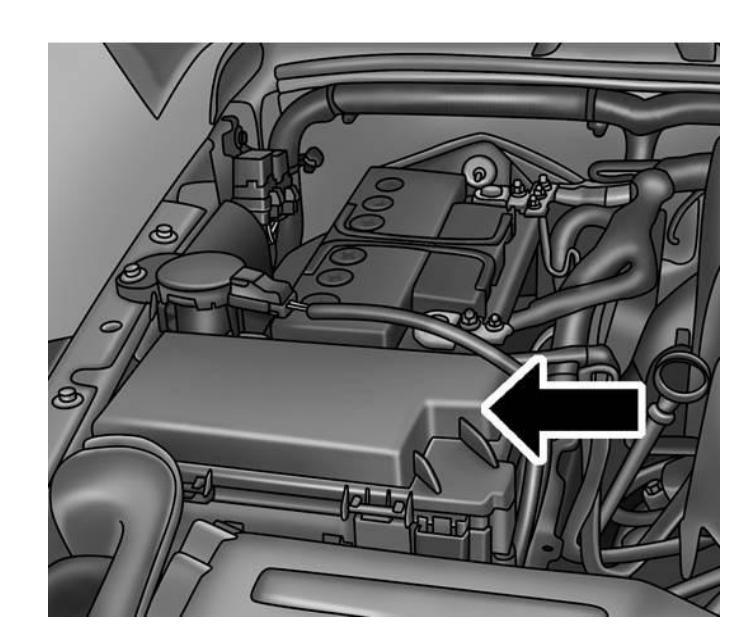
Fig. 1 Totally Integrated Power Module

The power side view mirrors may experience a loss of right and/or left heated power mirror function. Water may travel along the heated power mirror wiring harness and into the heated power mirror electrical connector(s). This can cause corrosion inside the heated mirror connector(s) and the formation of a resistive bridge between the power and ground electrical terminals. A resistive bridge between the power and ground electrical terminals in the heated power mirror connector(s) could cause an electrical fire without warning.

In the meantime, if the customer is uncomfortable with the current situation, remove the 10 amp red M35 heated mirrors fuse from the totally integrated power module (Fig. 1).
