# **Safety Recall R59 / NHTSA 15V-661** Left Rear Axle Shaft

# 2015 – 2016 (DS) RAM Truck

The left axle shaft on about 61,000 of the above vehicles may not have been heat treated properly at the axle shaft bearing journal. An improperly heat treated axle shaft may cause the bearing to create a grinding noise during operation, illuminate the Anti-Lock Brake System (ABS) warning lamp and eventually an axle shaft fracture. If the axle shaft fractures, wheel separation from the vehicle may occur. This could cause a crash without warning, injure pedestrians and/or damage property.

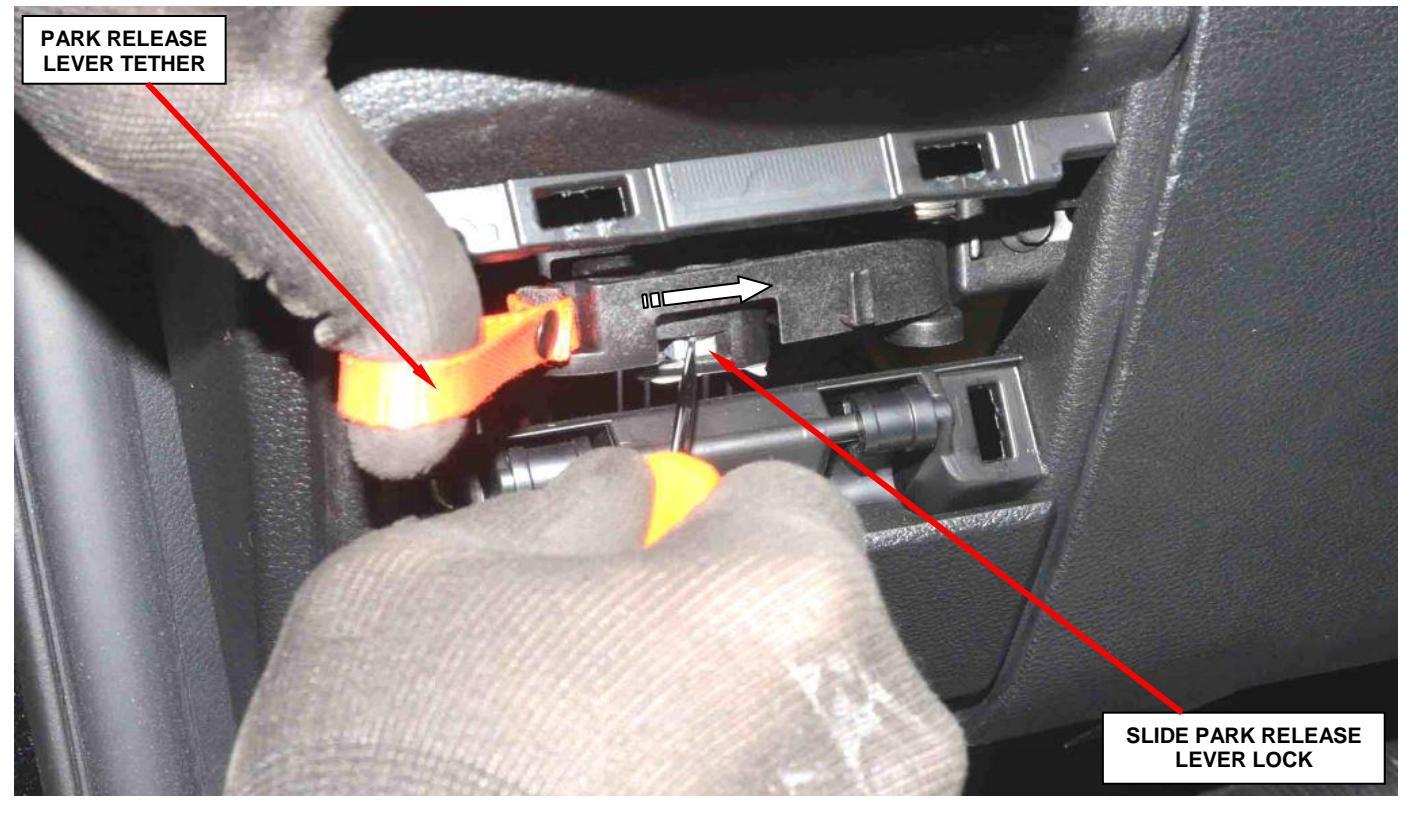
Figure 2 – Transmission Manual Park Release

- 1. Use the following procedure to release the transmission manual park release lever:
  - a. Remove and save the transmission manual park release access cover (Figure 1).
  - b. Using a small screwdriver, slide the release lever lock to the right and hold in that position (Figure 2).
  - c. Pull the orange release lever tether until it locks in place (Figure 2).

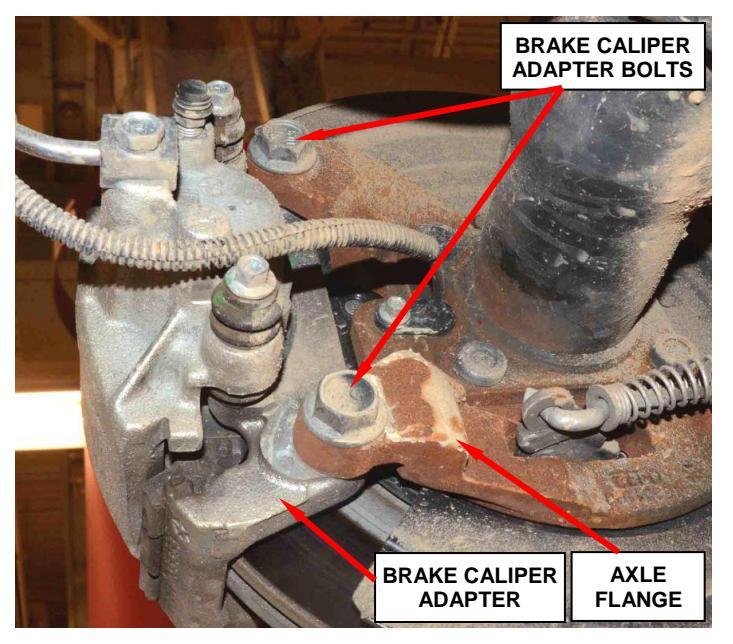
Figure 3 – Brake Caliper and Adapter

- 2. Raise the vehicle on an appropriate hoist.
- 3. Remove and save the left rear wheel/tire assembly.
- 4. Remove and discard the left side rear caliper adapter bolts and position the left side brake caliper and adapter assembly aside (Figure 3).

weight of the brake caliper and adapter to hang from the brake hose.

Do not allow the

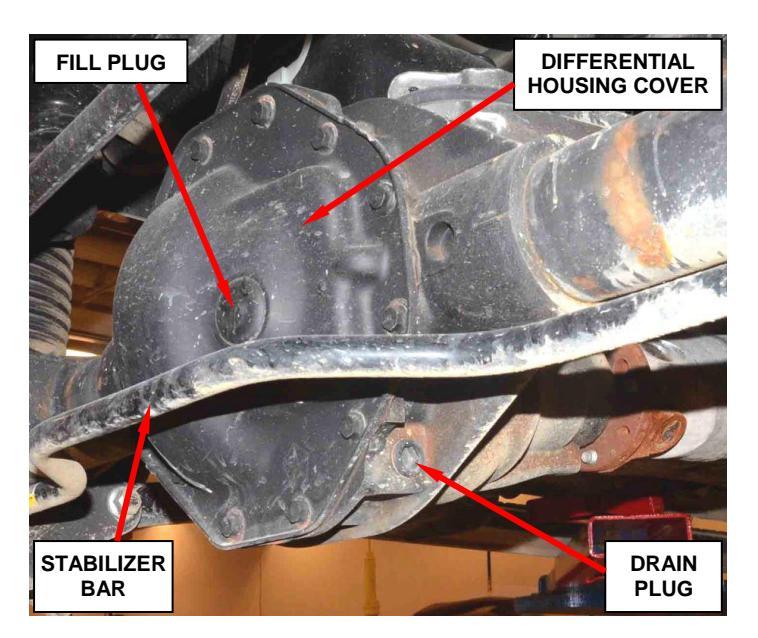
Figure 4 – Drain Rear Axle Fluid

- 5. Remove and save the left brake rotor.
- 6. Clean the differential and drain plug area to prevent debris from entering the rear axle during differential cover removal.
- 7. Remove and save the rear axle oil drain plug to drain the rear axle fluid (Figure 4).

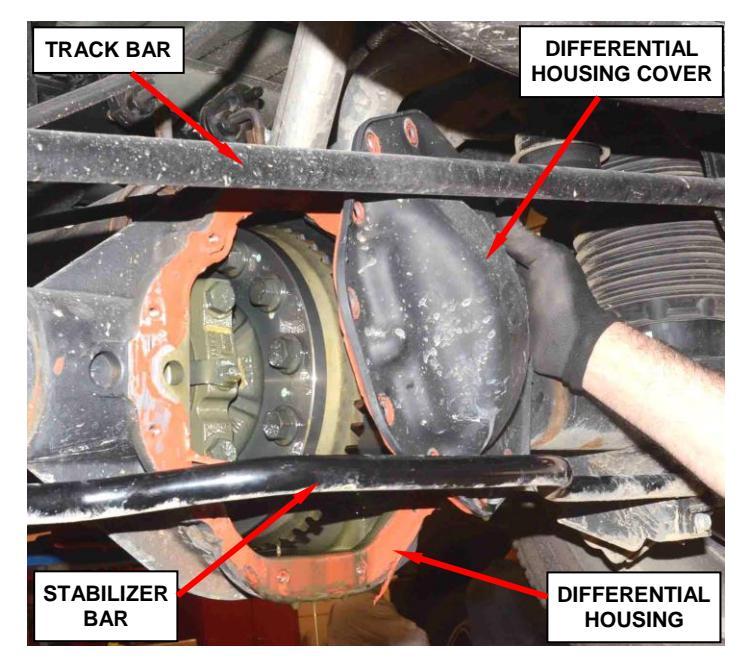
Figure 5 – Differential Case Cover

- 8. Remove and save the rear axle differential housing cover (Figure 5).
- 9. Rotate the differential case so pinion shaft lock screw is aligned with the differential bearing cap detent (Figure 6).

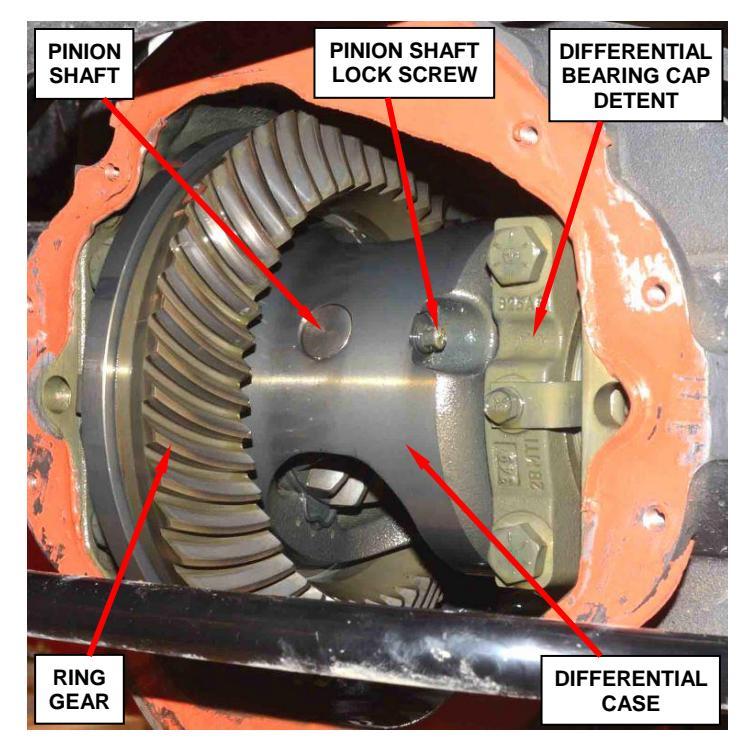
Figure 6 – Pinion Shaft

10. Remove and discard the original pinion shaft lock screw (Figure 6).

11. Remove and save the pinion shaft from the differential case (Figure 6).

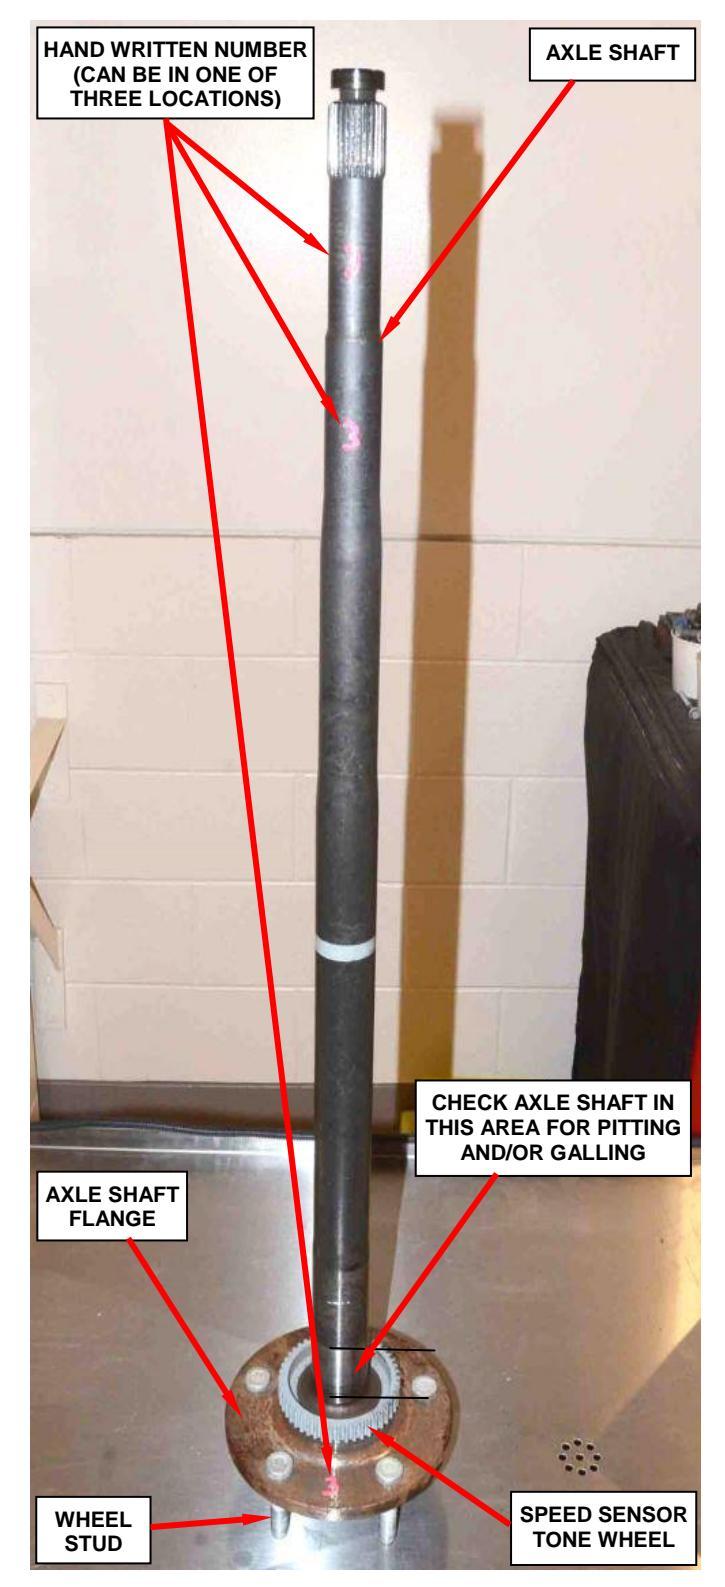
Figure 7 – Inspect Hand Written Number on Axle Shaft

14. Inspect the left axle shaft (Figure 7):

**NOTE:** The hand written number can be in three different locations on the axle shaft (Figure 7).

- If the left axle shaft has a hand written number "1" - "2" - "5" - "6" -"7" - "8" or "9" on the axle shaft, continue with Step 15 of this procedure.
- If the left axle shaft has a hand written number "3" or "4" on the axle shaft and has not failed, continue with Step 16 of this procedure.
- If the left axle shaft has no hand written number (or the number is not legible) and the axle shaft has not failed, continue with Step 16 of this procedure.
- If the left axle shaft failed, for trucks with air suspension, continue with Section B. Depressurize Air Suspension and for trucks without air suspension, continue with Section C. Replace Rear Axle.

NOTE: A failed axle shaft will have metal pitting and/or galling on the axle shaft where the axle shaft bearing rides (Figure 7).

- 15. For vehicles with a hand written number "1" "2" "5" "6" "7" "8" or <u>a "9" on the axle shaft</u>, install the <u>original left axle shaft</u> and engage into side gear splines.

- 16. For vehicles with a hand written number "3" or "4" on the axle shaft or the hand written number is missing or illegible, install a new left axle shaft and engage into side gear splines.

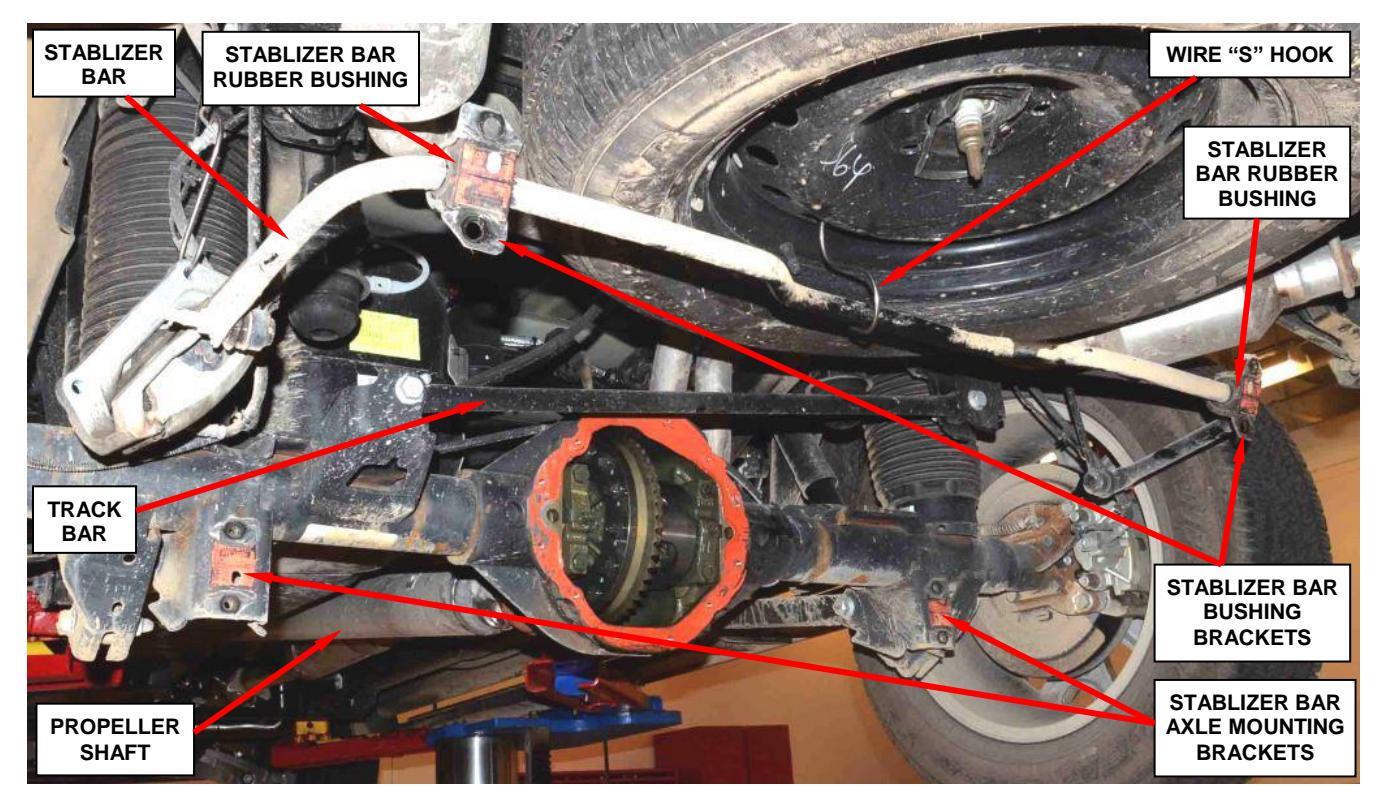
Figure 8 – Relocate Stabilizer Bar to Gain Clearance to Install Rear Axle Cover

- 20. Remove and save the four stabilizer bar mounting bolts at the axle mounting brackets (Figure 8).
- 21. Swing the stabilizer bar back towards the spare tire and secure the stabilizer bar with a hook (Figure 8).

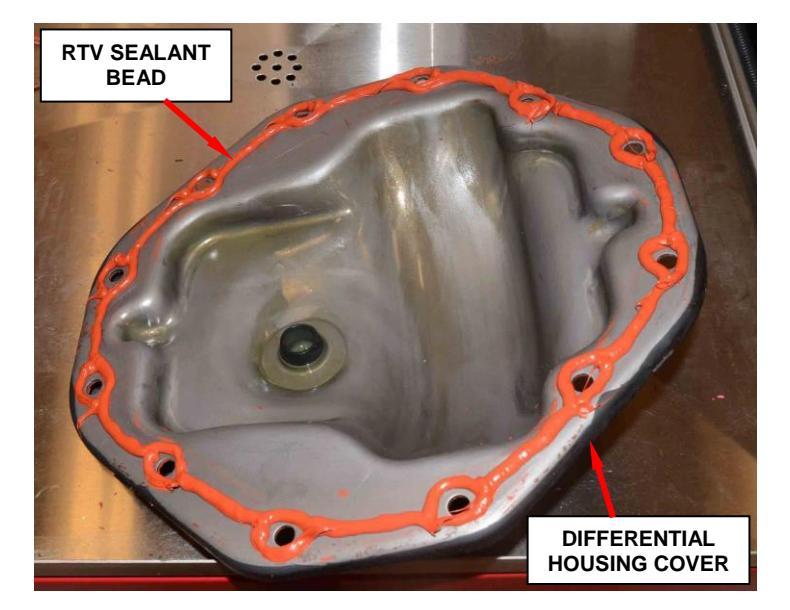
Figure 10 – Apply Mopar Axle RTV Sealant

25. Apply a ¼ inch (6.35mm) bead of Mopar Axle RTV Sealant to the cover with the RTV sealant bead to the inner side of the bolt holes (Figure 10).

> CAUTION: Do not use any other type of RTV silicone sealant to seal the rear differential housing cover.

> CAUTION: The differential housing cover must be installed within five minutes of applying RTV sealant.

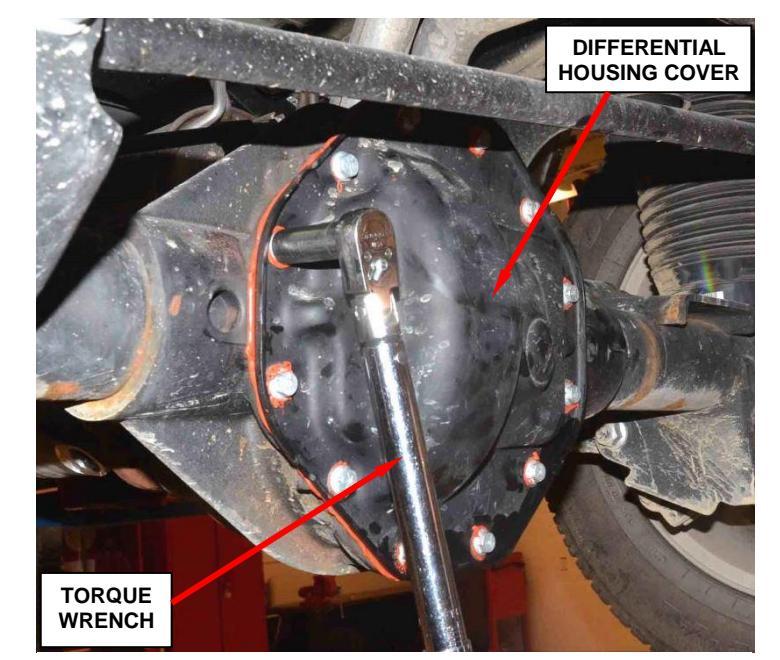
Figure 11 – Install Differential Cover

- 26. Using new differential cover bolts, install the differential cover and the differential cover bolts. Tighten the differential cover bolts in a crisscross pattern to 32 ft. lbs. (44 N·m) (Figure 11).
- 27. Apply sealant to the drain plug threads and install the rear axle drain plug. Tighten the rear axle drain plug to 52 ft. lbs. (70 N⋅m).
- 28. For vehicles equipped with a <u>limited slip differential</u>, install five ounces of Mopar Limited Slip Additive (friction modifier).

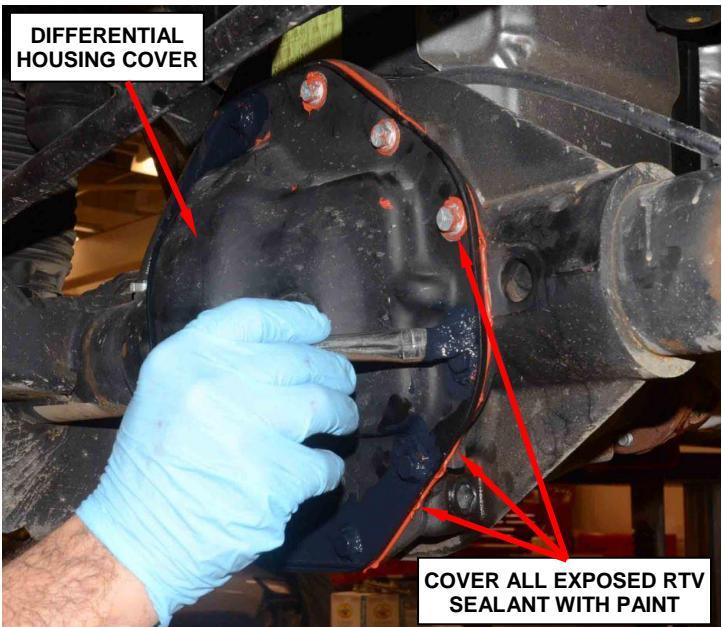
Figure 12 – Apply Black Paint to Exposed RTV Sealant

- 30. <u>Using the supplied paint</u>, paint all areas of the rear axle where orange silicone sealant can be seen (Figure 12).
- Place the stabilizer bar into position and install the four retaining bolts. Tighten the bolts to 37 ft. lbs. (50 N⋅m) (Figure 8).
- 32. Install brake rotor onto the axle shaft hub.
- 33. Install the brake caliper adapter and brake caliper as an assembly. Tighten the NEW brake caliper adapter bolts to 132 ft. lbs. (179 N⋅m).

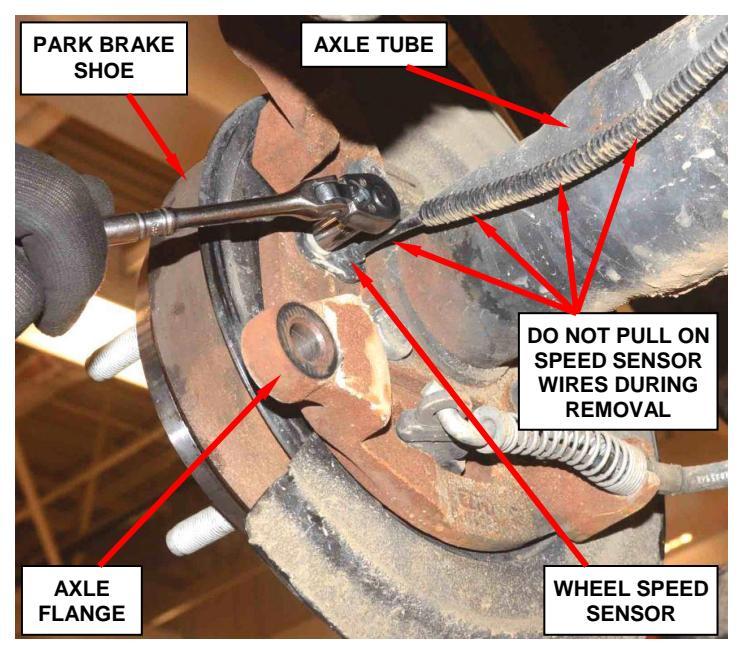
Figure 13 – Speed Sensor

- 3. Remove the right side rear brake rotor.
- 4. Remove and save the mounting bolt from the rear wheel speed sensors (Figure 13).
- 5. Remove the right and left side wheel speed sensors from the axle flanges (Figure 13).

CAUTION: When removing the speed sensor from the axle flange, do not pull on the speed sensor wires. Speed sensor damage may occur.

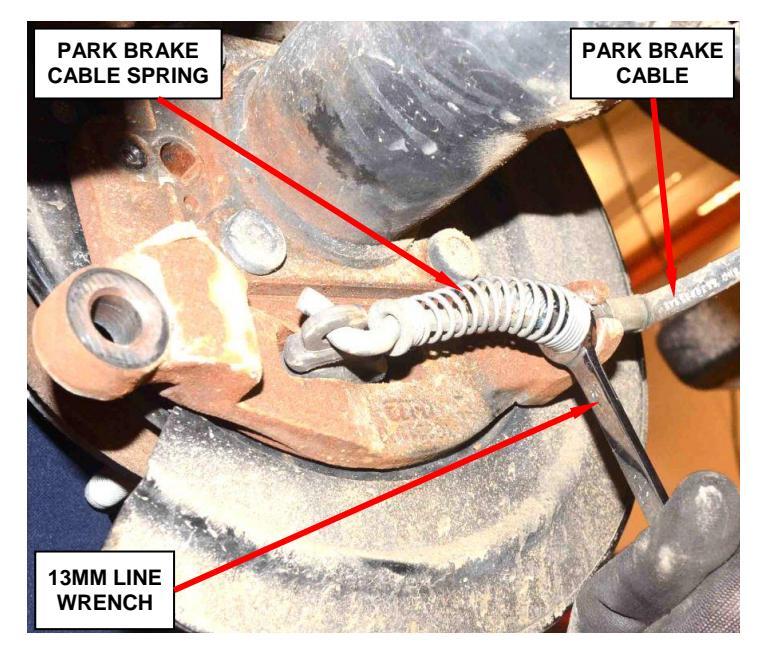
Figure 14 – Park Brake Cable

- 6. Disconnect the park brake cables using the following procedure:
  - a. Pull the park brake cable spring back.
  - b. Compress the cable tabs on each cable end fitting at the brake cable support plate using a 13 mm line wrench (Figure 14).

NOTE: A 13mm line wrench can be used to compress the cable tabs. Insert while spring is pulled back and rotate the wrench to compress the cable tabs.

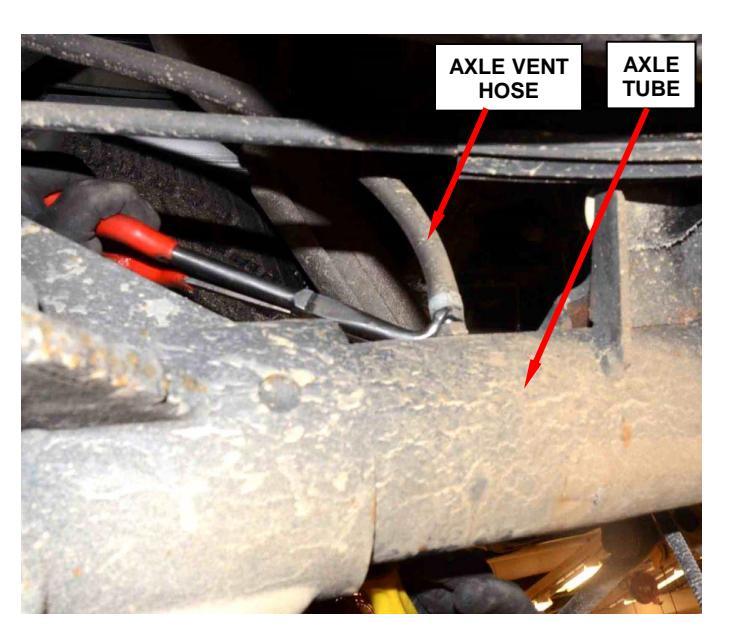
Figure 15 – Axle Vent Hose

- c. Remove the park brake cable from the brake cable support plate.
- d. Remove the upper park brake cable bolt from the rear axle.
- e. Remove the park brake bolt on the upper control arm bracket.
- f. Position the park brake cable away from the rear axle.
- 7. Loosen the clamp and disconnect the axle vent hose from the rear axle (Figure 15).

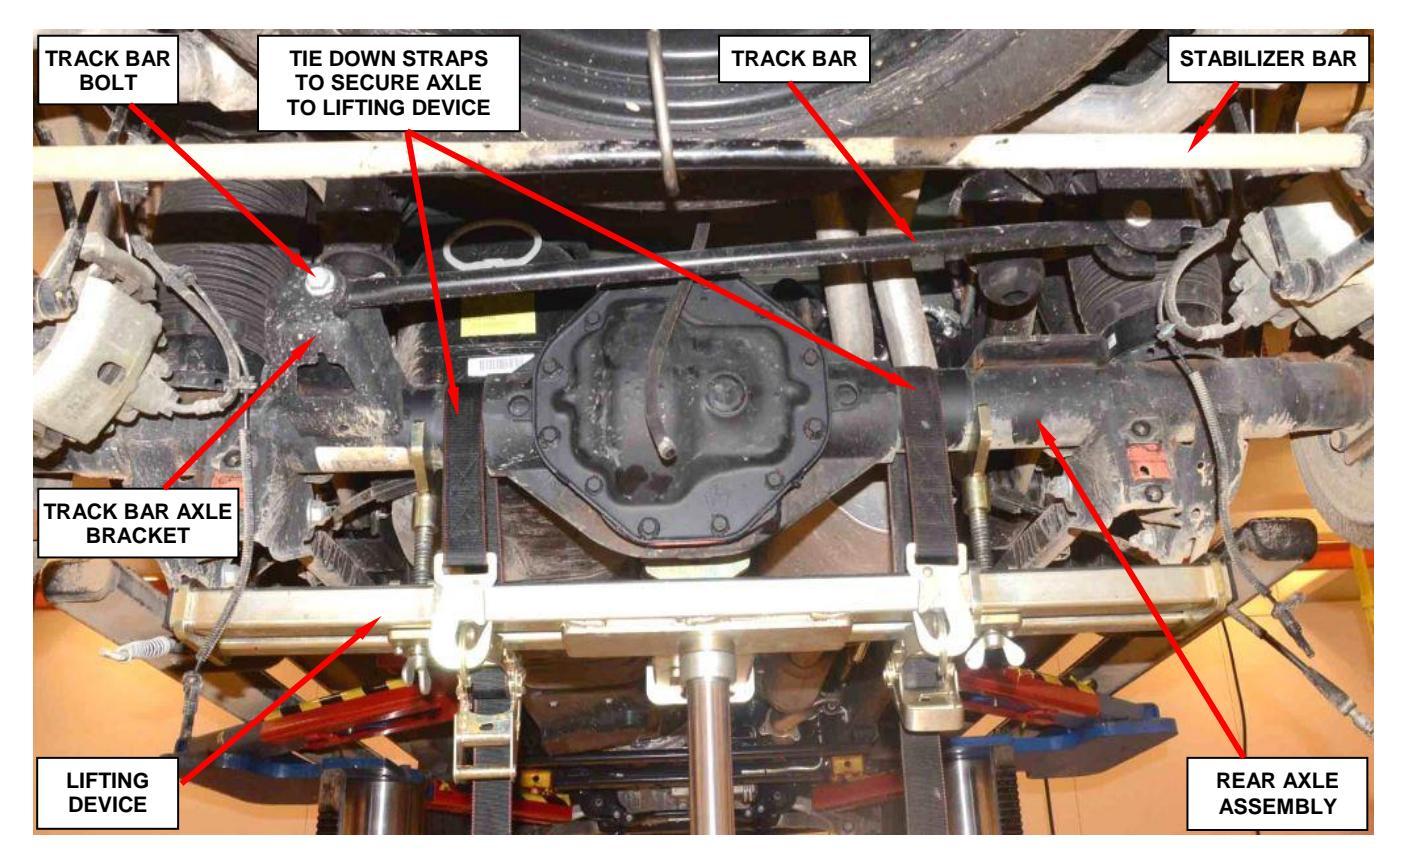
Figure 16 – Secure Axle Assembly to a Lifting Device

- 8. Remove and discard the rear propeller shaft companion flange bolts.
- 9. Suspend the rear propeller shaft using a bungee cord or equivalent.
- 10. Position a lifting device under the rear axle and secure the rear axle to the lifting device (Figure 16).
- 11. Remove and discard the track bar bolt and position the track bar away from the rear axle (Figure 16 and 17).

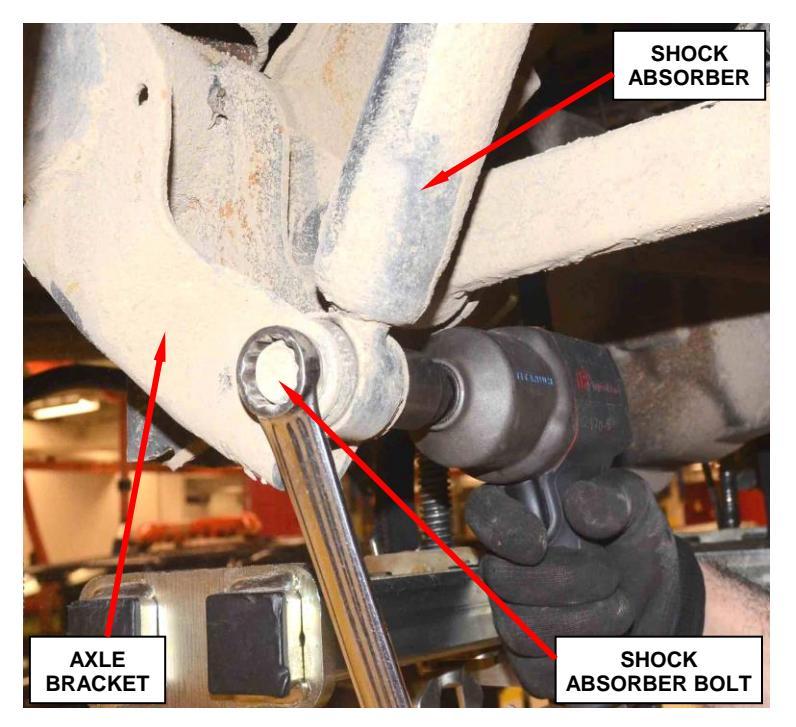
Figure 18 – Shock Absorber Lower Bolt

- 12. Remove and save both lower shock absorber bolts and position the shock absorbers away from the rear axle (Figure 18).
- 13. Remove and discard both the upper control arm-to-rear axle bolts and position the upper control arms away from the rear axle (Figure 19).
- 14. Remove and discard both the lower control arm-to-rear axle bolts and position the lower control arms away from the rear axle (Figure 19).

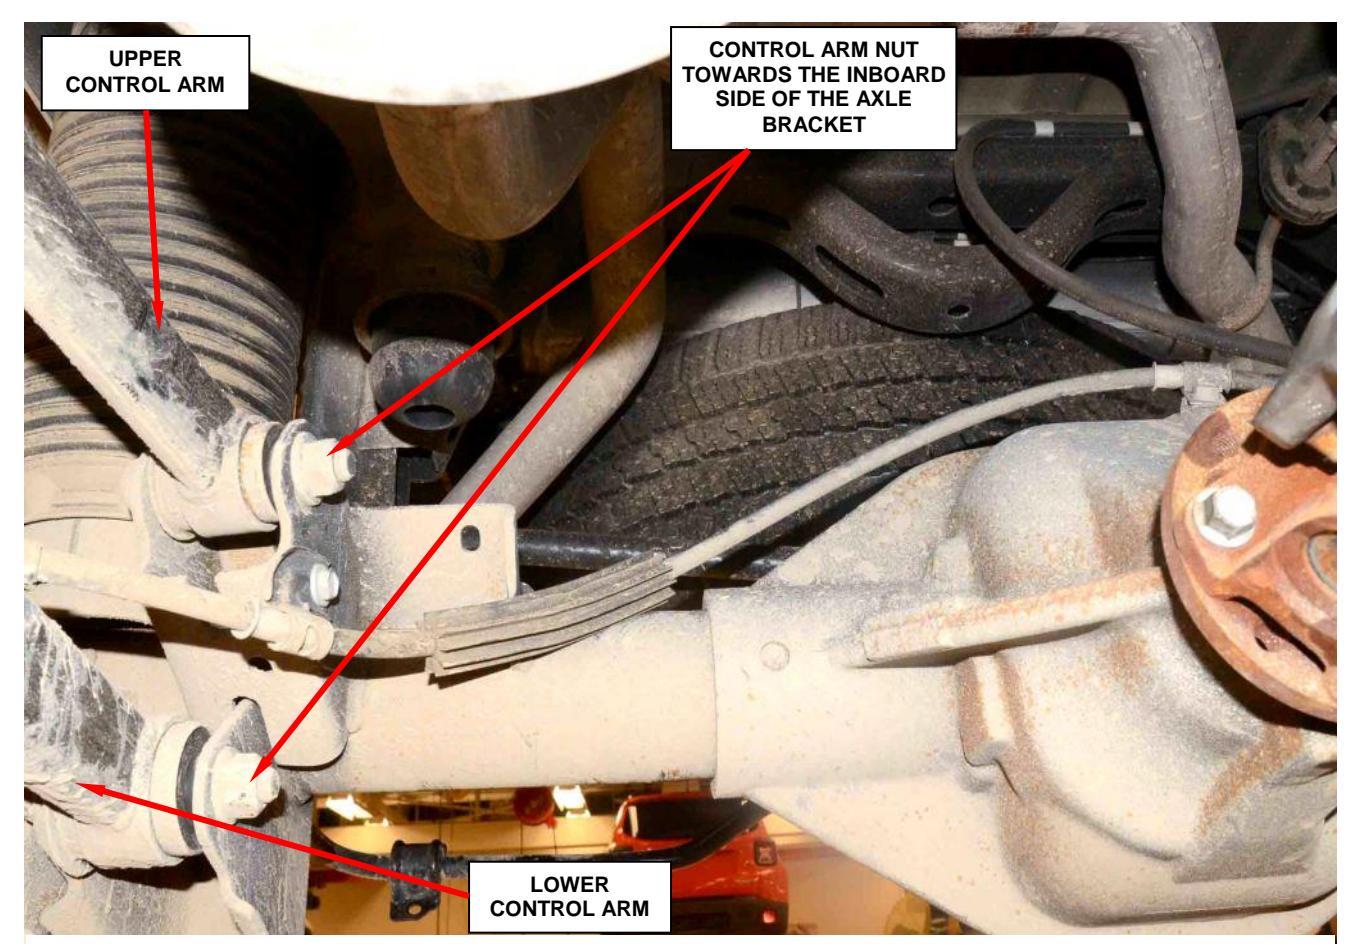
Figure 20 – Upper and Lower Control Arm Bolt Orientation (right side shown)

**CAUTION:** The lower control arm bolt must be installed pointing inward (nut on the inside of the mounting bracket) (Figure 20).

**CAUTION:** The upper control arm bolt must be installed pointing inward (nut on the inside of the mounting bracket) (Figure 20).

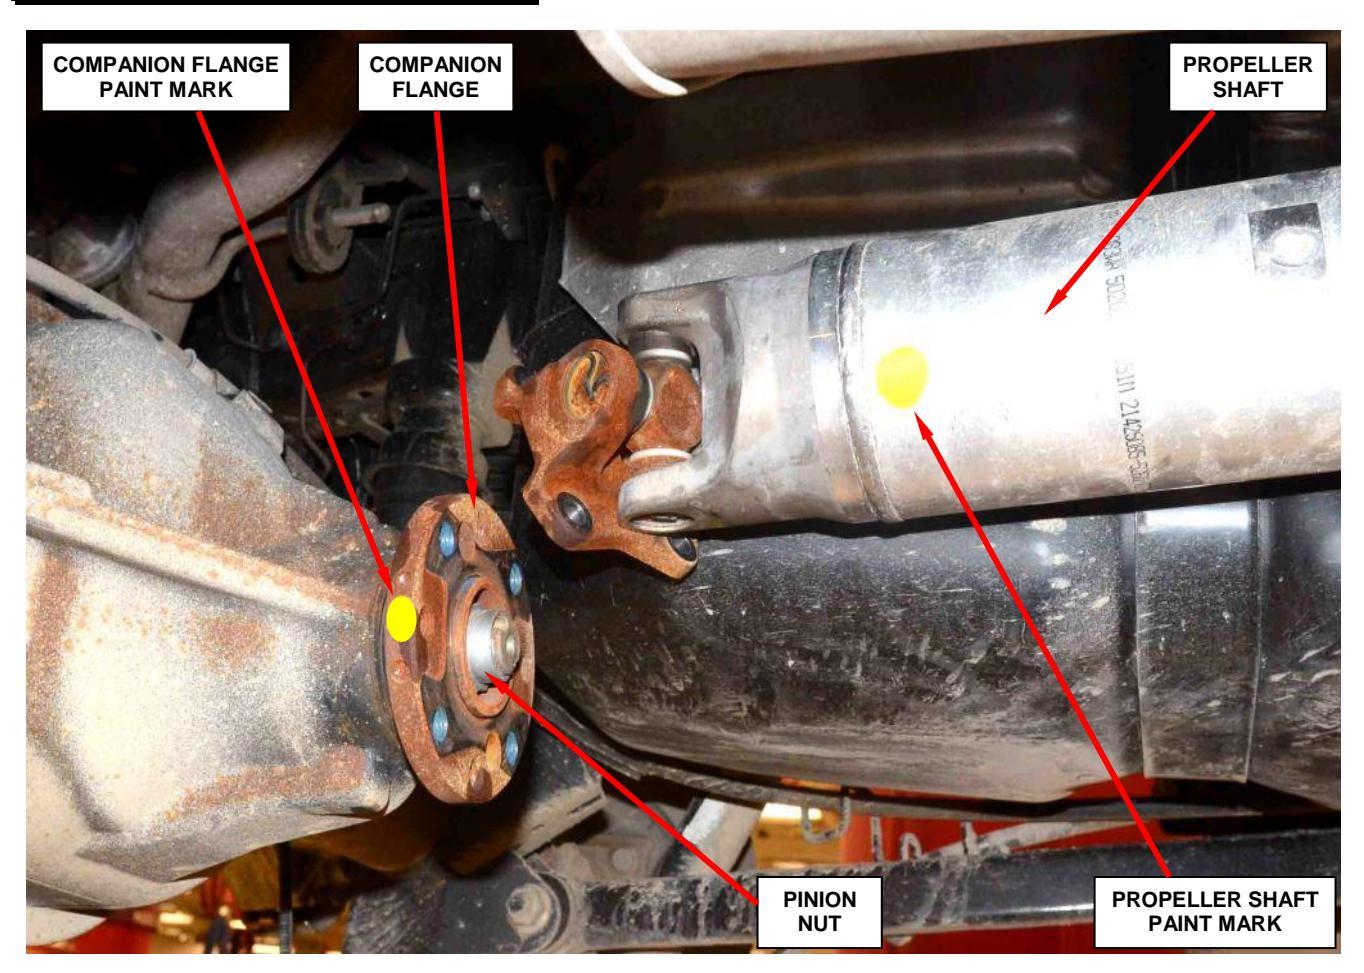
Figure 21 – Align Marks on Propeller Shaft and Companion Flange

32. Place the rear propeller shaft into position. Install new rear propeller shaft companion flange bolts and tighten to 85 ft. lbs. (115 N·m).

**CAUTION:** Be sure to align the factory alignment paint mark on the propeller shaft as closely to the factory alignment paint mark on the new axle companion flange (Figure 21).
