TECHNICAL INSTRUCTIONS

SAFETY RECALL GLH

FRONT PASSENGER AIRBAG MODULE

CERTAIN 2007 – 20010 MY ES 350 UPDATED 1-9-2018

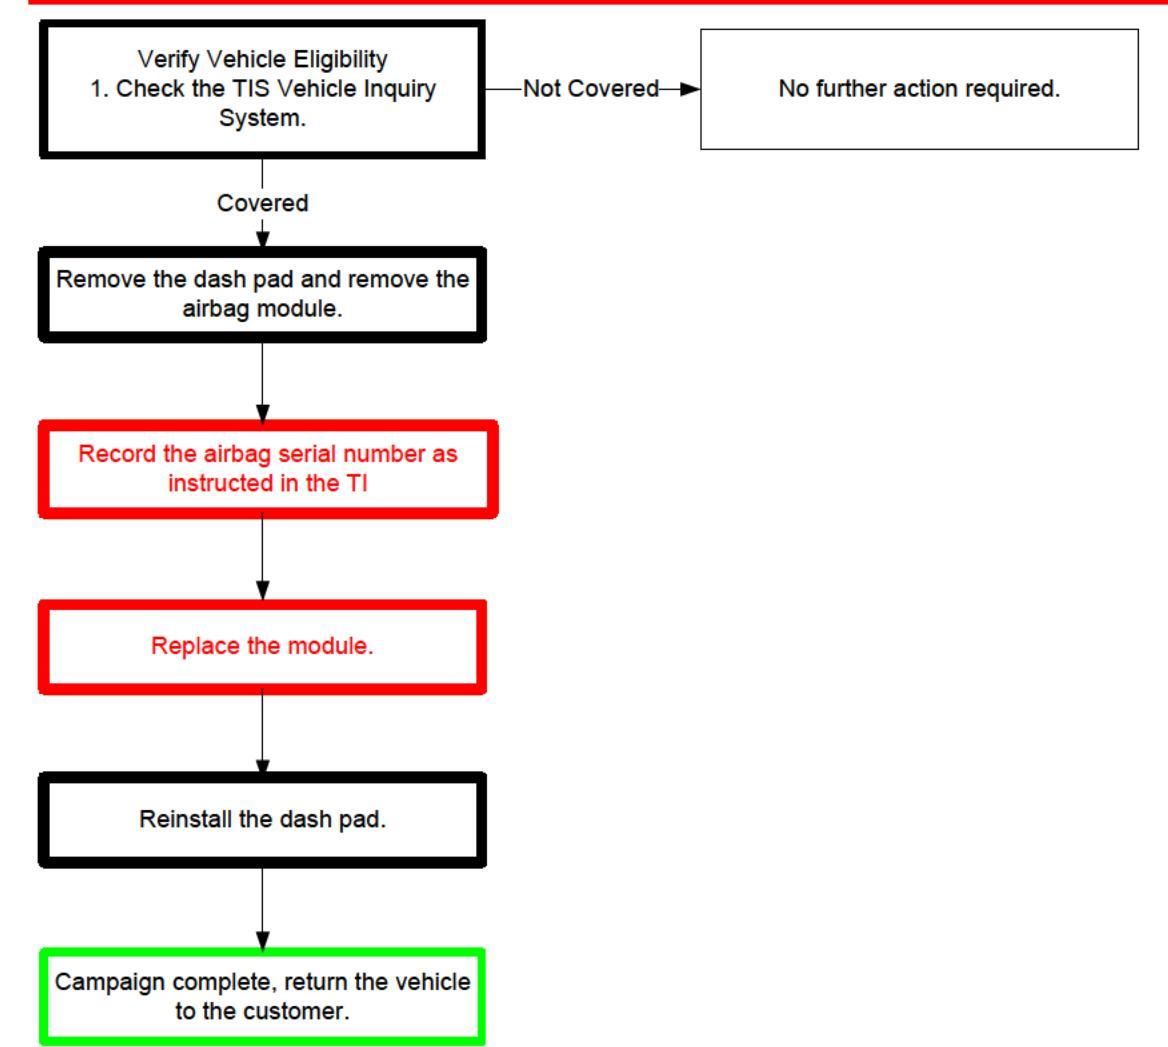
I. OPERATION FLOW CHART

The flow chart is for reference only. *DO NOT* use it in place of the full technical instructions. Follow *ALL* steps as outlined in the full technical instructions to confirm the campaign is completed correctly.

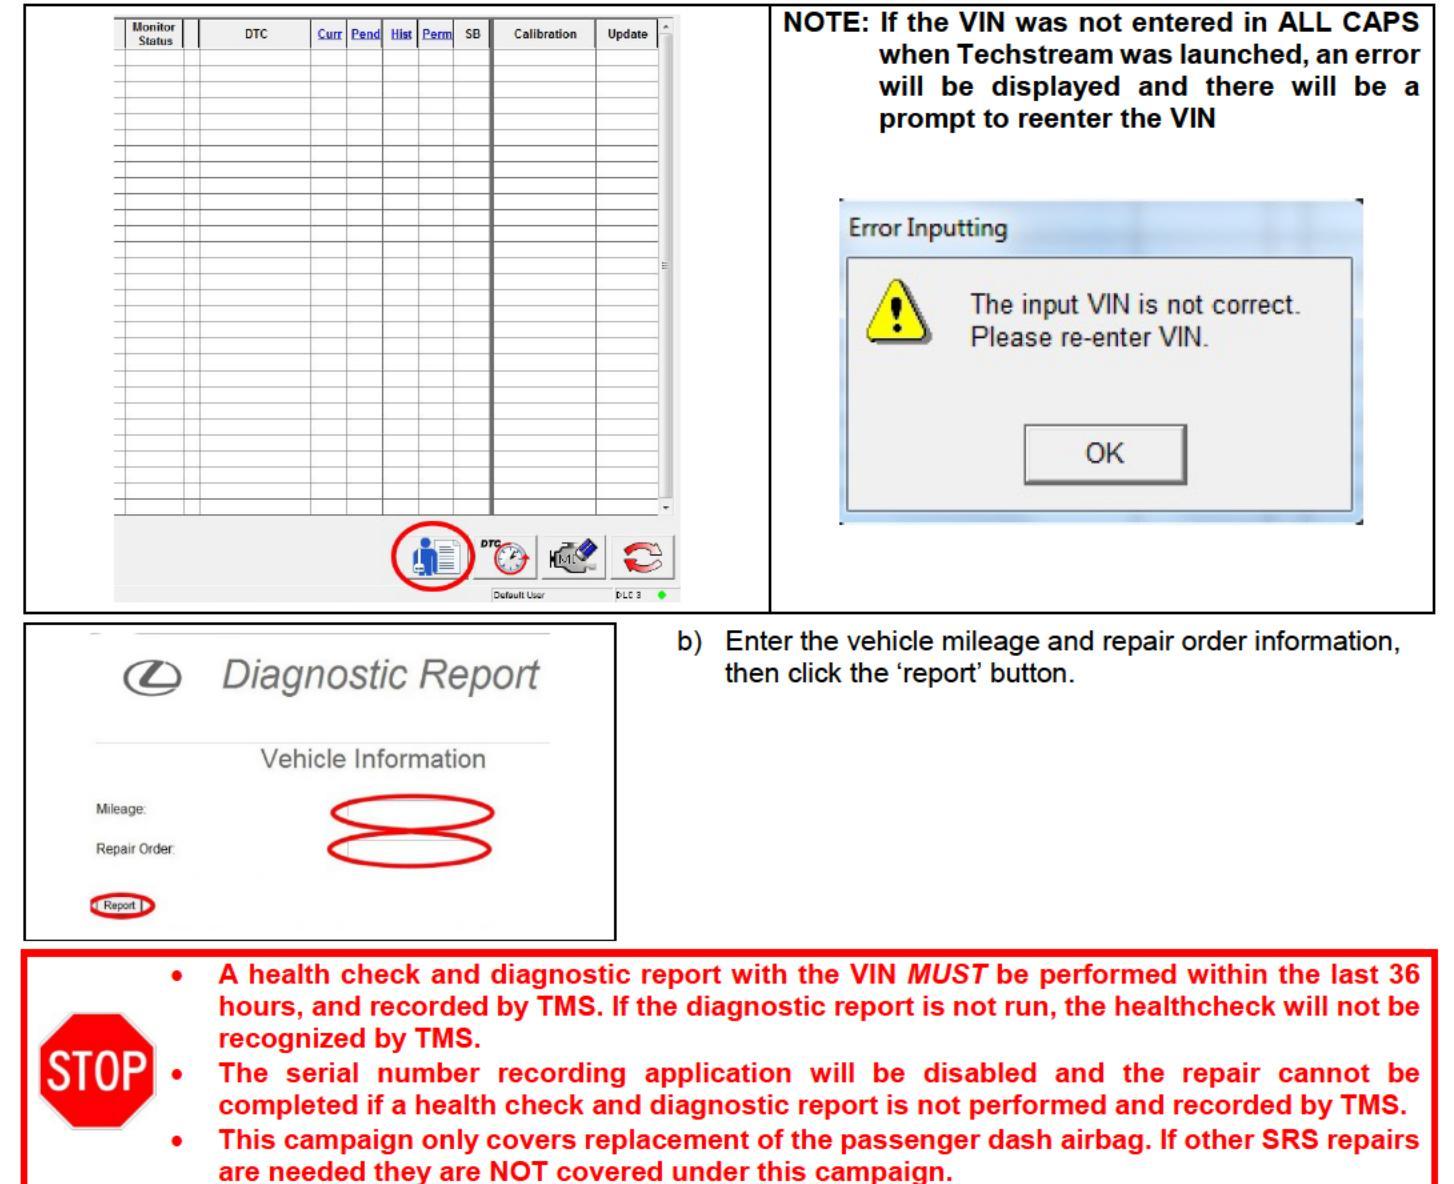
a) After the health check has completed, run a diagnostic report by clicking on the link on the health check screen.

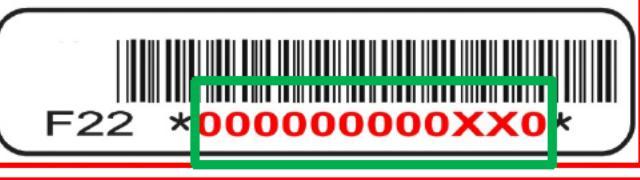
Airbag Serial Number Label Example

- The airbag serial number is *ALWAYS* the 12 *DIGITS* located between the asterisks.
- The 3 digits before the asterisk *ARE NOT* part of the serial number, and *SHOULD NOT* be entered or an inaccurate response may be returned.

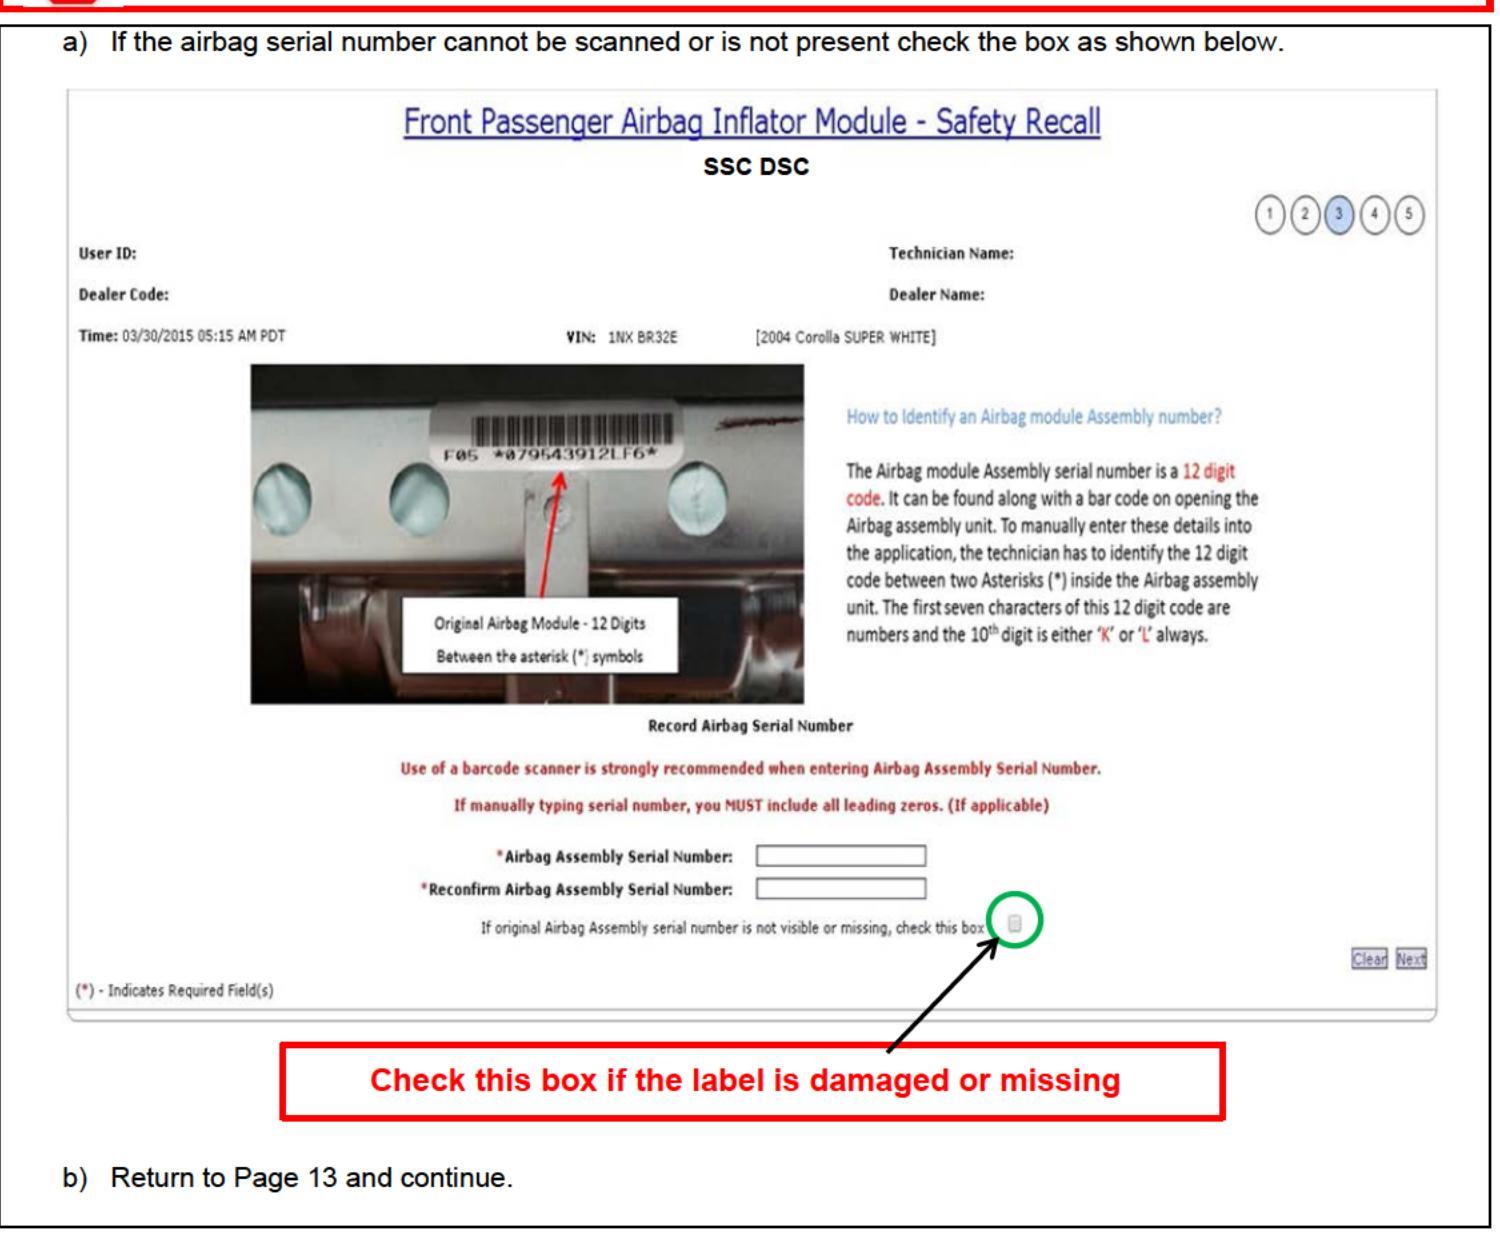
If the airbag serial number and barcode are not legible or are not present, check the box in the application indicating the serial number is not legible.
