Safety Recall Code: 45F5

Subject	ABS Control Module Software
Release Date	March 17, 2017
Revision Summary	Work procedure and claiming instructions updated.
Affected Vehicles	U.S.A. & CANADA: 2009 MY Audi A3
	Check Campaigns/Actions screen in Elsa on the day of repair to verify that a VIN qualifies for repair under this action. Elsa is the <u>only</u> valid campaign inquiry & verification source.
	 ✓ Campaign status must show "open."
	 If Elsa shows other open action(s), inform your customer so that the work can also be completed at the same time the vehicle is in the workshop for this campaign.
Problem Description	On certain vehicles, a fault within the antilock brake system (ABS) may cause the module to fail during ABS and/or electronic stability control (ESC) activation. This will cause warning lights for ABS, brake and the ESC systems to illuminate. If this happens, the brake system related vehicle stabilizing functions (ABS/ESC) may not be available, increasing the risk of a loss of vehicle control and could lead to a crash causing injury and/or property damage.

Subject: Safety Recall 45F5 - ABS Control Module Software Certain 2009 Model Year Audi A3

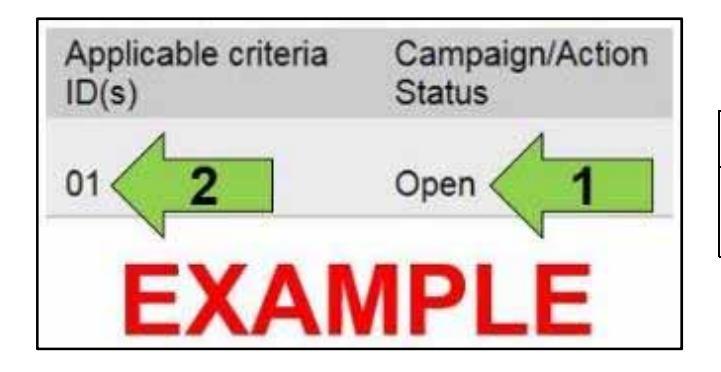
Section A - Check for Previous Repair

Enter the VIN in Elsa and proceed to the "Campaign/Action" screen.

- Confirm the Campaign/Action is open <arrow 1>. • If the status is closed, no further work is required.
- Note the Applicable Criteria ID <arrow 2> for use • in determining the correct work to be done and corresponding parts associated.

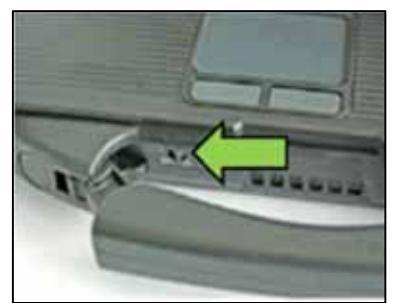
VAS 6150 & VAS 6150A (Front panel behind handle)

The Bluetooth function of the scan tool is physically switched off <see pictures below>.

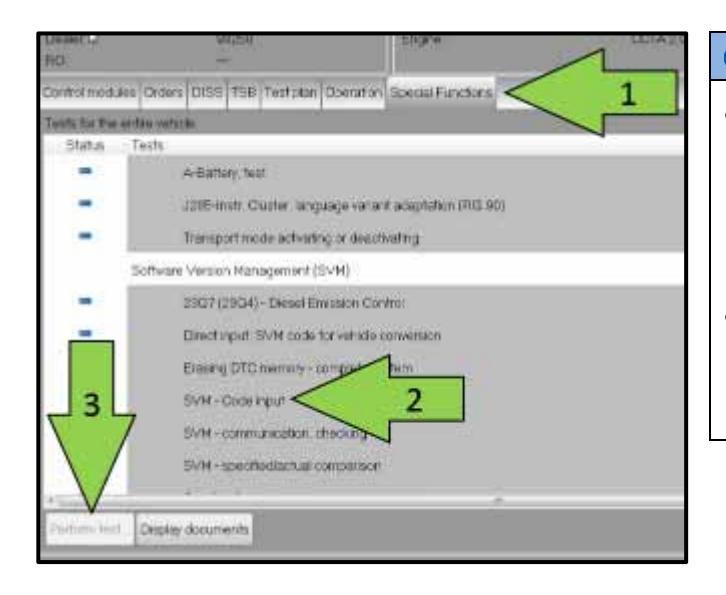
- Fault 01130 MUST have 125 shown in the 4th line of the Expanded ambient conditions to qualify for ABS module replacement and/or fault 16352 MUST have 96 shown in the 4th line of the Expanded ambient conditions to qualify for ABS module replacement under this Campaign.
- Diagnosis and repair of faults other than the faults listed above will not be covered under this Campaign and should be addressed prior to updating the ABS Control Module.
 - Once the GFF scan is complete:
 - Record any faults that may be stored.
 - Select "Special functions" < arrow 1>, then 0 "SVM - Code input" <arrow 2>, then select "Perform test" <arrow 3>.
 - Select the appropriate option to update "through measures code" <arrow>.

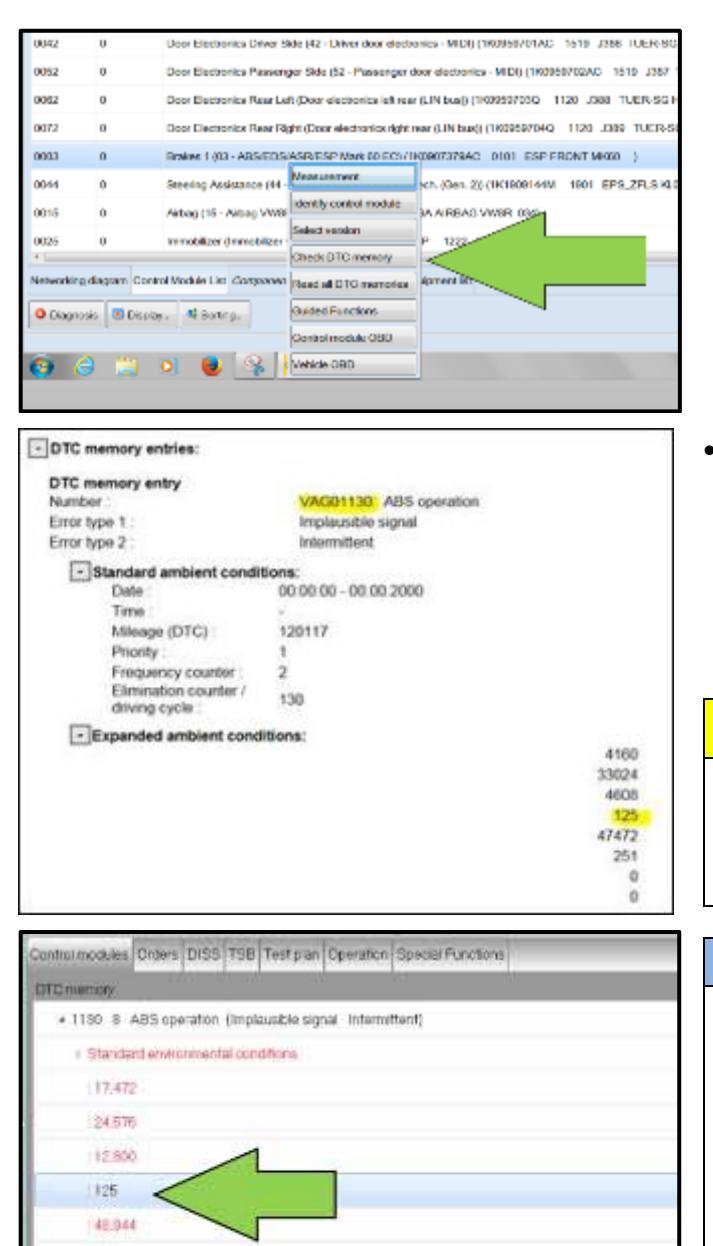
- After the short road test, turn off the ignition and cycle ignition back on.
- Select the "Control Module" tab.
- Scroll down and right click on Address Word 0003/ABS Control Module.
- Select Check DTC Memory.
- If faults 01130: ABS Operation Implausible Signal with 125 shown in the 4th line of the Expanded ambient conditions and/or 16352: Control Module Faulty with 96 shown in the 4th line of the Expanded ambient conditions are stored in the ABS Control Module (address word 0003), the ABS module will require replacement. Continue to Section D.

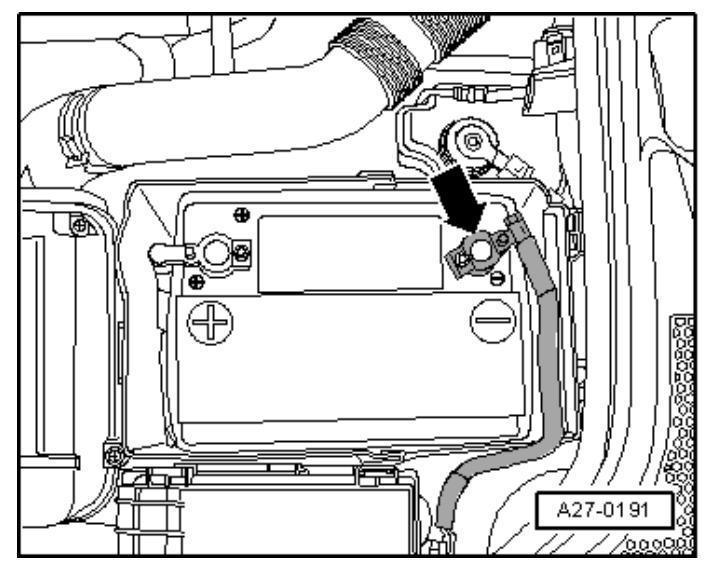
- Switch off ignition and remove ignition key.
- Remove battery cover <1> by pressing release button in direction of <arrow>.

- Loosen the nut <arrow>.
- Remove and isolate the battery ground cable terminal from the battery terminal.

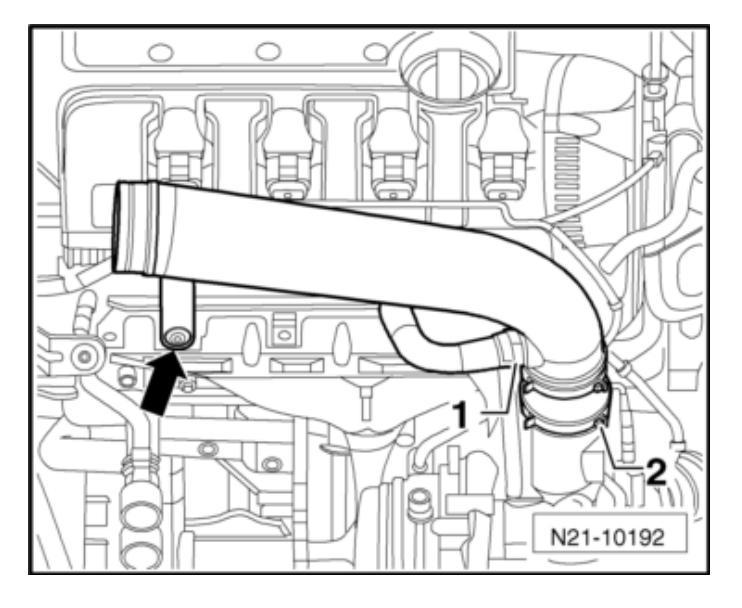
- Press the release button to disconnect the air duct hose <1>.
- Remove the air duct pipe bolt <arrow>.
- Loosen hose clamp <2> and remove air duct.
- Remove the intake hose between the intermediate pipe and the turbocharger.
- Seal the turbocharger with the Engine Bung Set -VAS6122-.

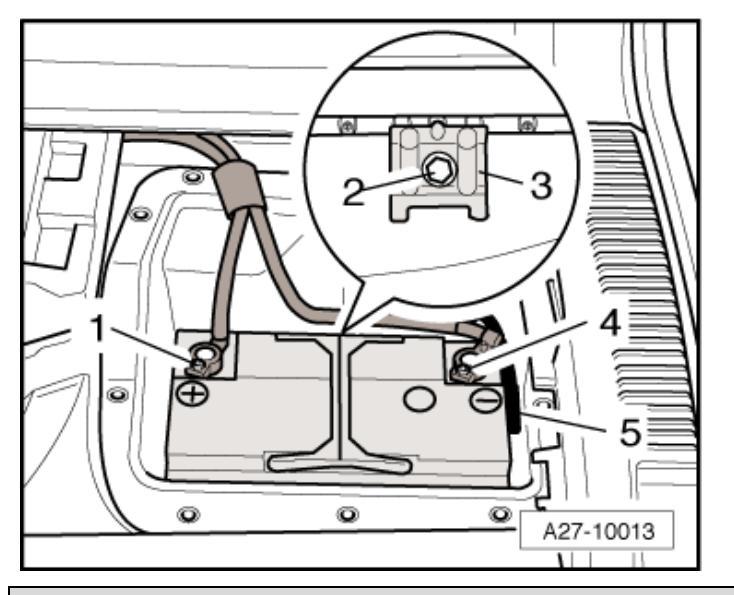
Loosen nut <4> a few turns, remove and isolate the battery ground cable terminal from the battery terminal.

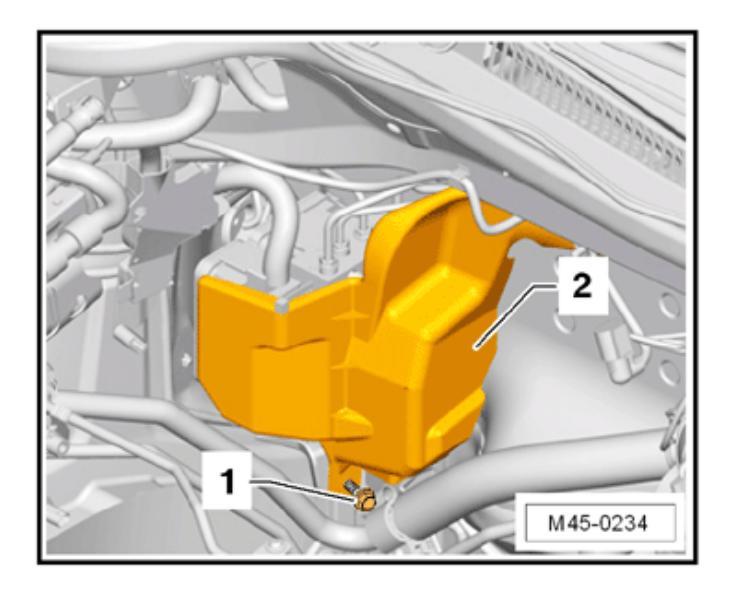
Remove the nut <1> and remove the heat shield <2> (if equipped).

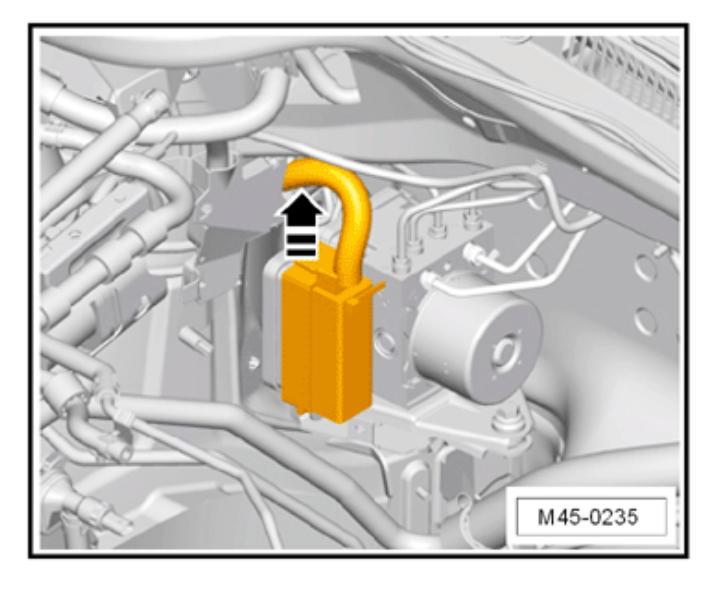
Release and remove connector from control • module in <direction of arrow>.

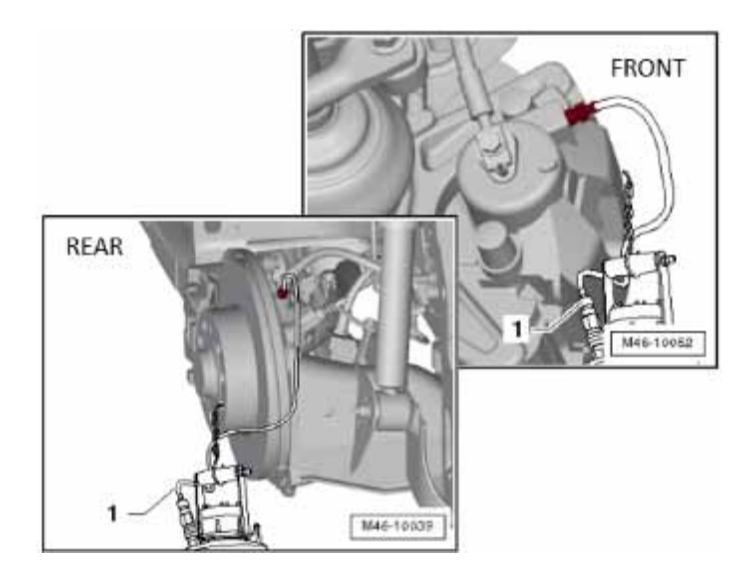
Attach a bleed hose to the left front and left rear brake caliper breather valves.

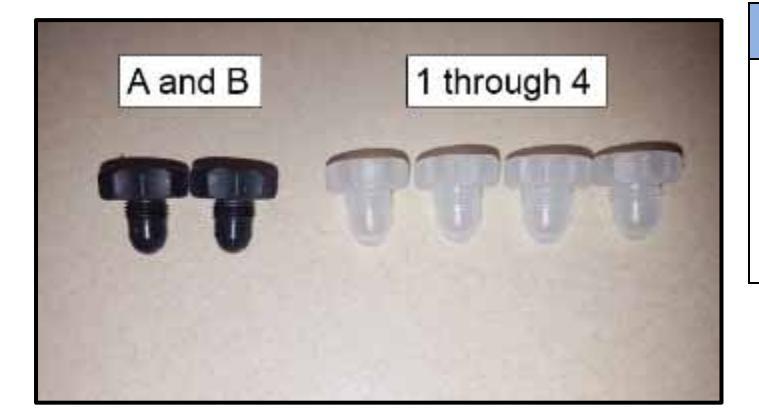
When removing the brake lines from the ABS module, the threaded holes in the hydraulic unit must be sealed. The new ABS module includes sealing plugs. The black plugs are for threaded holes <A and B> in the work procedure and the clear plugs are for threaded holes <1 through 4> in the work procedure.

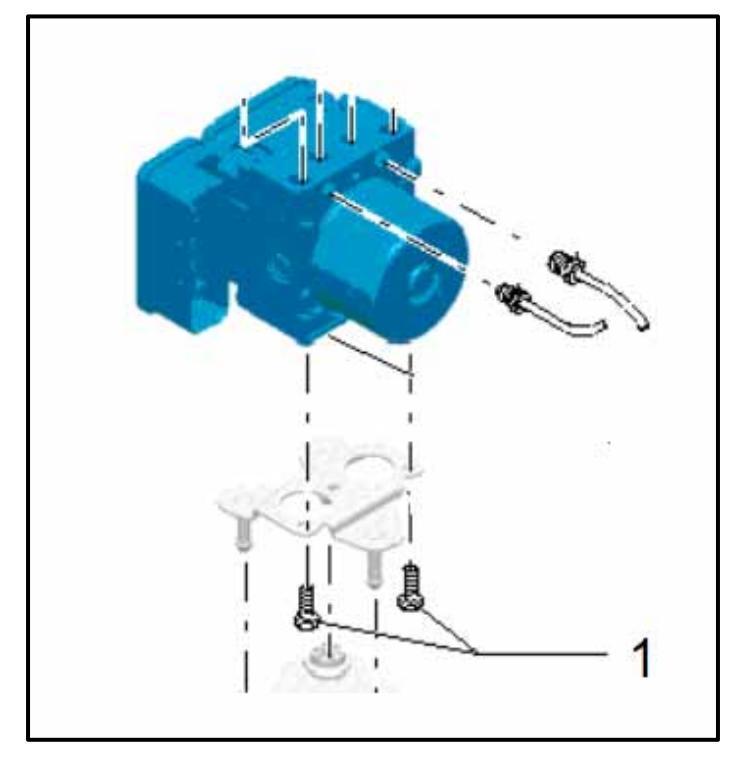
- First, mark the installed position of both brake lines from master cylinder <A and B> and remove from the hydraulic unit.
- Seal threaded holes with black sealing plugs • (provided with new ABS module) and cover exposed brake lines using a clean plastic bag.
- Mark the installed position of brake lines (brake • caliper) <1 through 4> and remove.
- Seal threaded holes with clear sealing plugs (provided with new ABS module) and cover exposed brake lines using a clean plastic bag.
- Remove bolt <arrow> from the bracket.
- Remove the hydraulic unit, the control module and • the side retainer in <direction of arrow> from the bracket rubber insulation.
- Remove bolts <1> and separate the hyrdraulic unit • from the bracket.

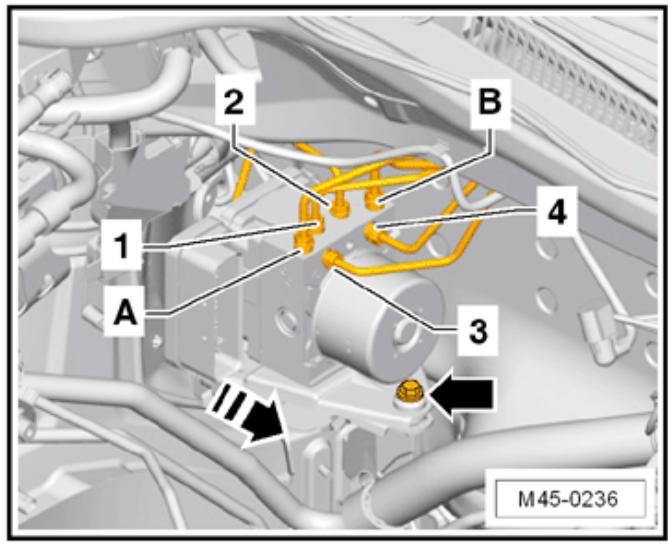
Woking inside the engine compartment, install the bracket to the ABS Hydraulic Unit -N55and torque the bolts <1> to 8 Nm.

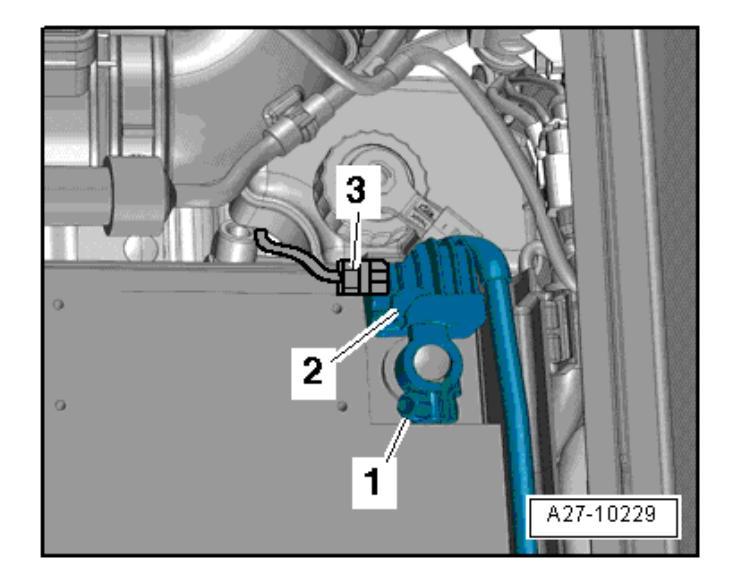
Install heat shield <2> (if equipped) and torque bolt <1> to 8 Nm.

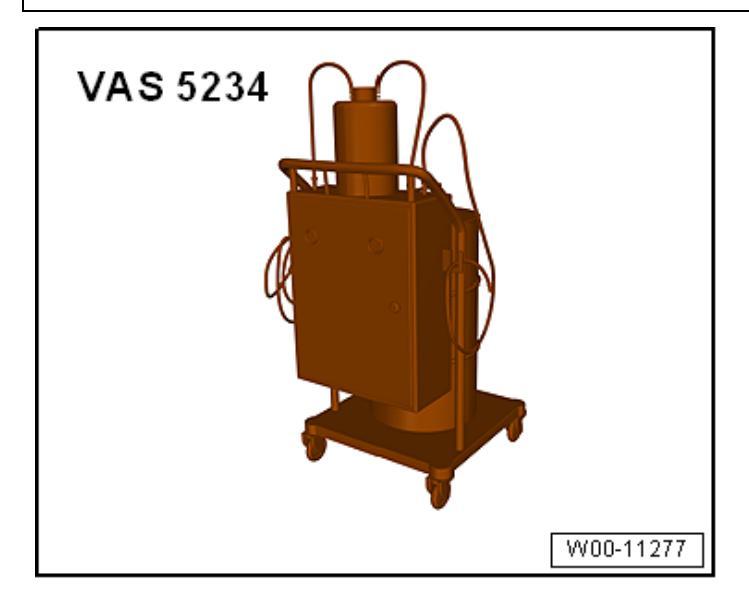
- Remove all four wheels. •
- Connect Brake Charger/Bleeder Unit -VAS 5234and perform **Pre-Bleeding** of the brake system.

There must be a positive pressure of 2 bar when bleeding the hydraulic unit.

- With bleeder bottle hoses attached, leave bleeder valves open long enough that brake fluid exits without bubbles using the following bleeding sequence:
 - Bleed left front and right front brake caliper 0 together simultaneously.
 - Bleed left rear and right rear brake caliper 0 together simultaneously.

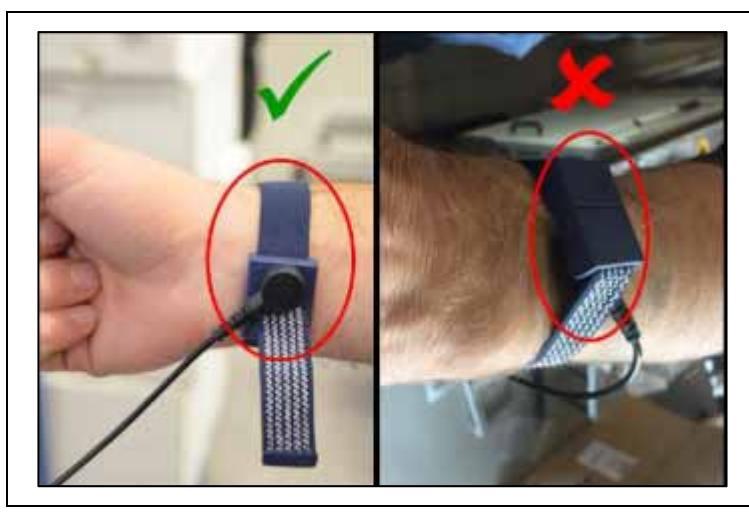
- Prior to beginning work, all parts and tools are to be placed on the ESD table mat.
- Assemble ESD workplace according to the instructions included with the ESD Workplace.
- The wall socket or extension cord used must have a sufficient ground.

The white dots on the wrist strap must be against the skin.
