GROUP	MODEL	
	Safety Recall Campaign	2014-2016MY Soul (PS) Soul (PS EV)	
	NUMBER	DATE	
	SC155 (Rev 1, 12/22/2017)	November 2017	
A	LL CAMPAIGN

## STEERING GEAR ASSEMBLY PINION PLUG INSPECTION/REPAIR/REPLACEMENT (SC155)

This bulletin provides information related to inspection, repair, and, if necessary, the replacement of the steering gear assembly of some 2014-2016MY Kia Soul (PS) and Soul EV (PS EV) vehicles, produced from July 21, 2013 through September 30, 2015. The vehicles included in this recall were previously recalled under Recall SC108 (14v332) and SC125 (15v736). This recall is being conducted to confirm that the subject vehicles received a proper repair. In some cases, the pinion plug may not have been secured properly. As a result, the pinion gear may separate from the steering gear assembly, causing loss of steering and could increase the risk of a crash.

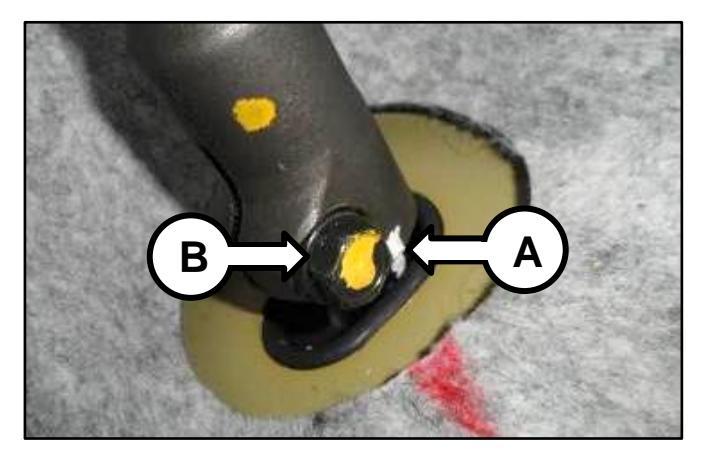
- 1. With the steering wheel centered and the ignition off, place the vehicle on a lift.
- Using a white marker, place a mark (A), as shown, on the universal joint and joint spline for ease of reinstallation and to prevent steering wheel dislocation (offcenter).
- 3. Remove the universal joint and steering gear connecting bolt (B). <u>Be sure to</u> replace the connecting bolt.

### Tightening torque: 27.5 lb.ft (37.3 N.m, 3.8 kgf.m)

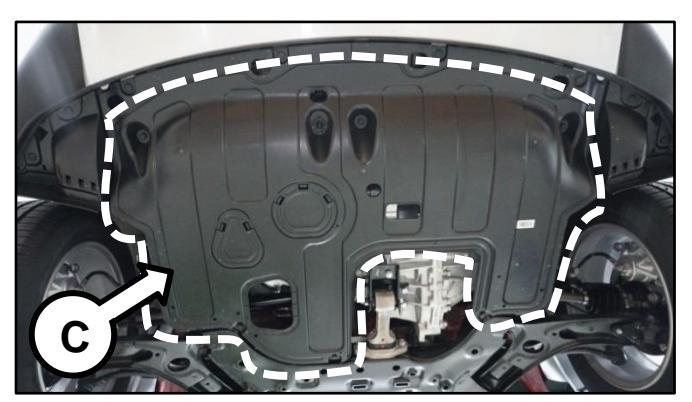
4. Raise the vehicle and remove the engine under-cover (C) (PS) or front battery cover splash shield (PS EV).

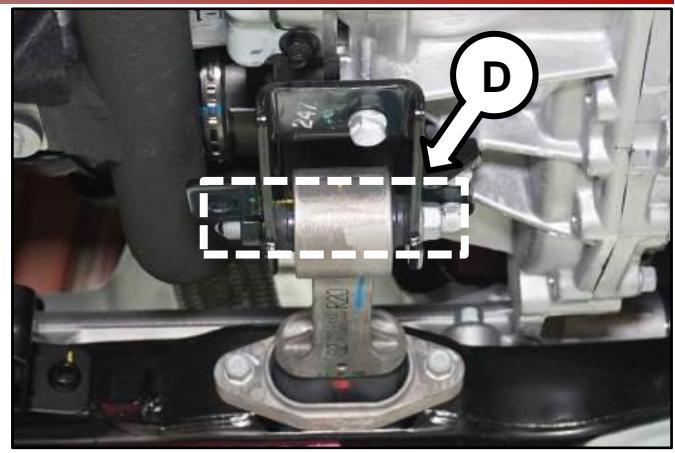
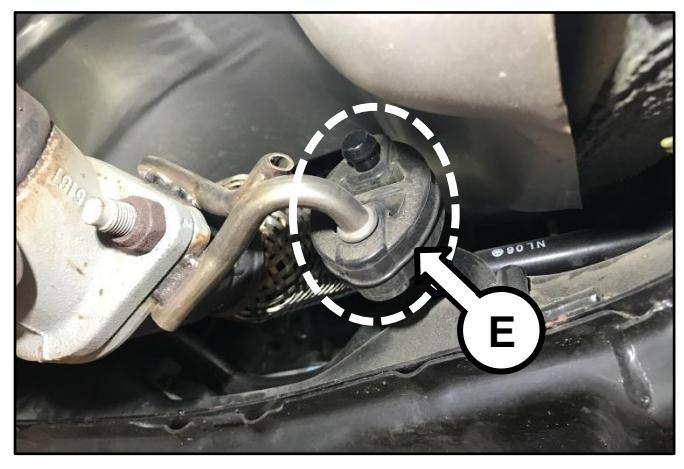
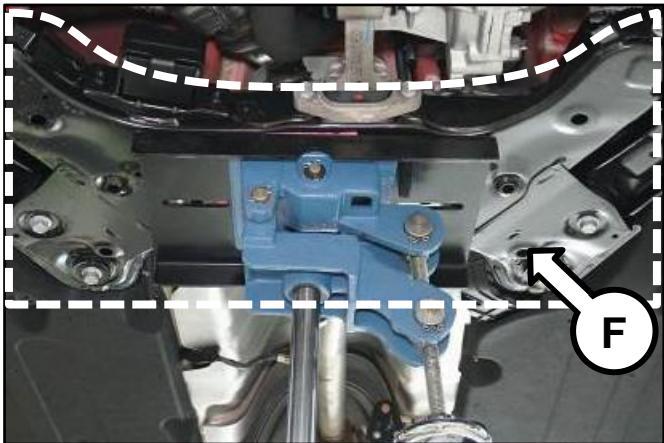
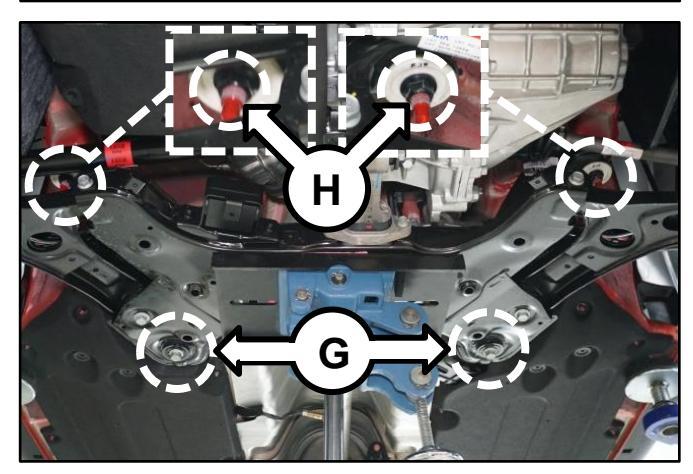
Detach the roll rod stopper retaining bolt (D).

6. Detach the exhaust pipe hanger (E) from the subframe.

7. Support the subframe (F) with a suitable powertrain lift or equivalent.

Remove the two subframe retaining bolts (G) and two subframe retaining nuts (H) then carefully lower the subframe enough (8 to 12 inches) to allow space for the next step.

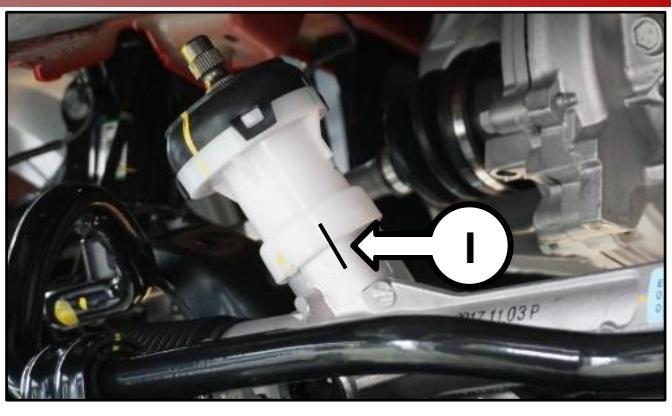
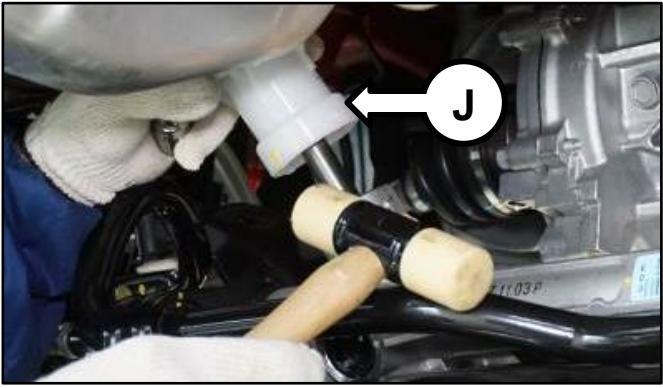
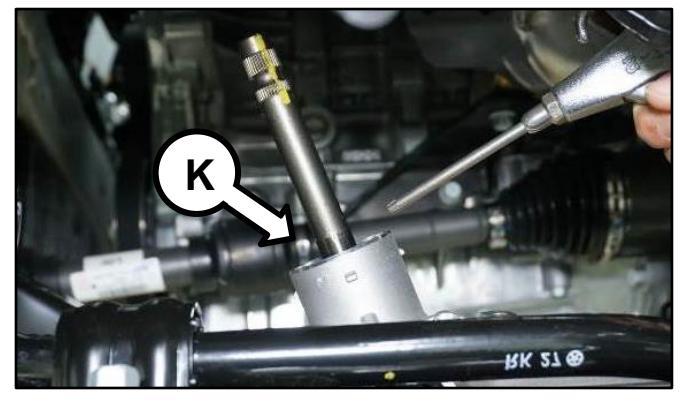
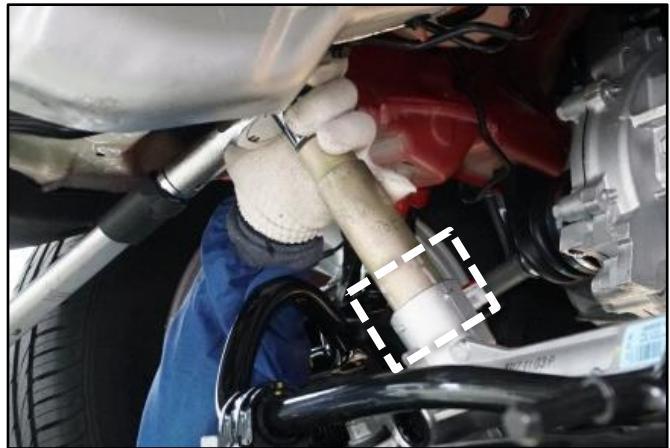
9. With a black marker, place a mark (I) on the dust cap and steering gear to ease reinstallation and to ensure centered alignment of dust cap to steering gear.

Using a plastic hammer or rubber mallet, remove the dust cap (J) and set aside. <u>Do not discard the dust cap</u>.

Using compressed shop air, remove any foreign materials/debris around the steering gear shaft and pinion plug area (K).

12. With a torque wrench and the provided SST socket, tighten and torque the steering gear pinion plug to the specified torque.

### Tightening torque: 57.56 lb.ft (78 N.m, 7.95 kgf.m)

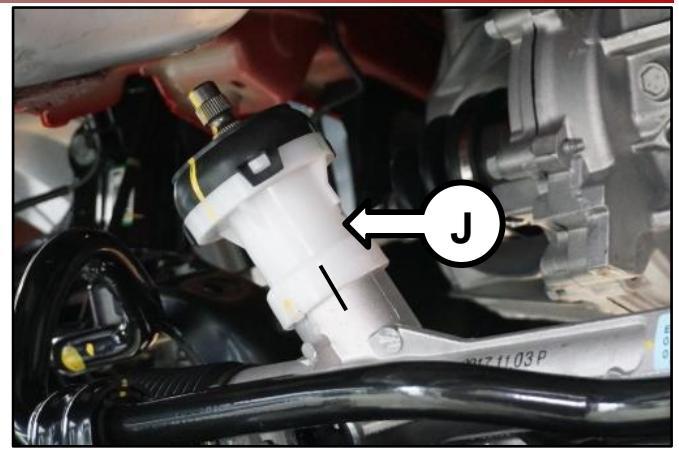
Reinstall the dust cap (J), aligning the marks made prior to removal. Then proceed to the Set Screw Installation Procedure on page 8.

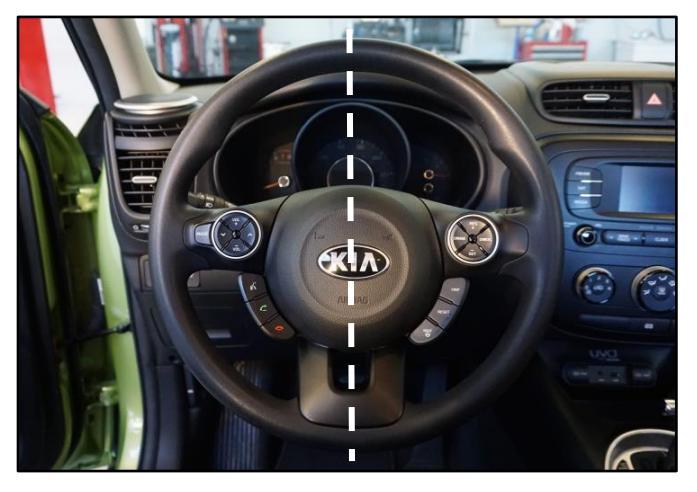
Open the driver's door, start the engine, and center the steering wheel as shown. <u>Ensure the vehicle is placed on all four</u> wheels and **not** raised on a lift.

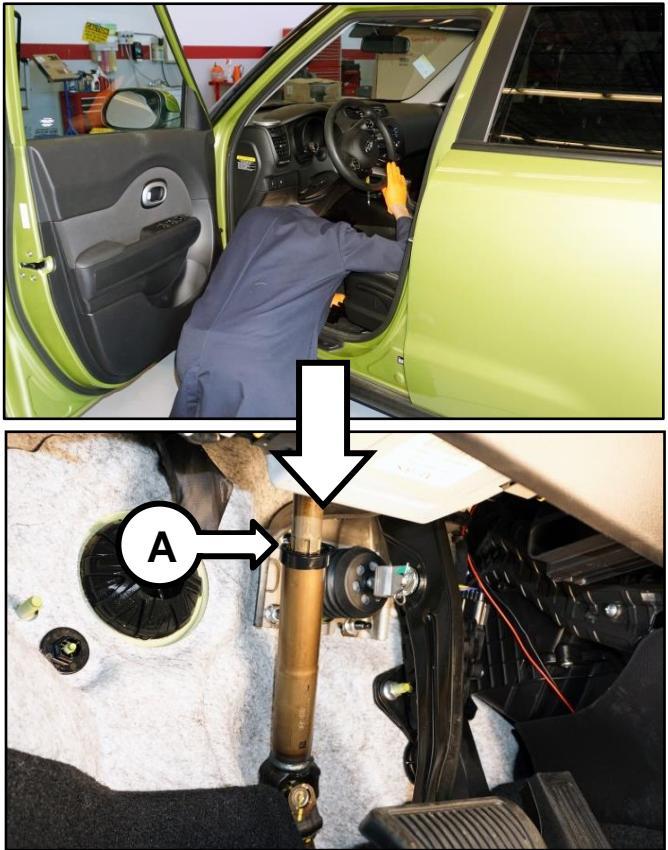
2. Turn the steering wheel from right to left, multiple times, while observing the intermediate shaft (A) for up and down movement.

intermediate shaft movement.

- If the intermediate shaft <u>does not move up and down</u> when the steering wheel is turned, proceed to the Set Screw Inspection/Repair Procedure below.
- If the intermediate shaft moves up and down (indicating that the pinion plug has backed off) when the steering wheel is turned, perform the SC155A Pinion Plug Tightening and Set Screw Installation procedure on page 3.
- If one (1) or more of the three (3) conditions listed below exists, replace the steering gear assembly by referring to the "Steering System → Electric Power Steering → Steering Gear Box → Repair procedures" chapter in the applicable Shop Manual on KGIS.
  - Pinion shaft has separated from the steering gear assembly.
  - It is impossible to properly secure the pinion plug for any reason.
  - There is physical damage to the steering gear.

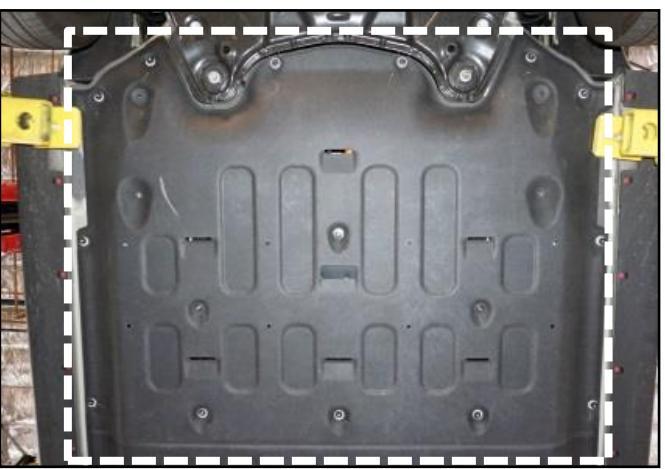
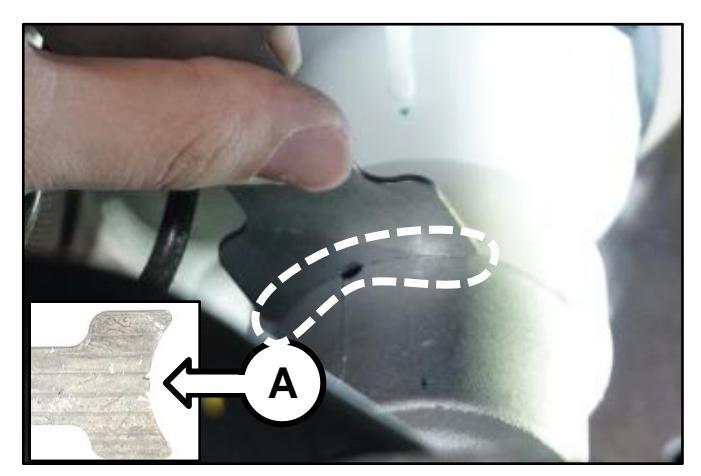
Soul (PS EV) Front Battery Cover shown

- With the ignition off, vehicle raised on a lift, and the engine under-cover (PS) or front battery cover splash shield (PS EV) removed, check to see if a set screw was previously installed.
  - If so, remove the RTV silicone previously applied during the SC125 repair.
  - If there is no set screw installed, proceed with the Set Screw Installation Procedure on page 8.
- Verify that the previously installed set screw is installed properly and not protruding by using the provided 0.01 in. (0.3mm) depth gauge. Insert the notch (A) of the depth gauge into the screw hole, as shown, and ensure there is no gap between the gauge and the steering gear. See examples of gap/no gap below.

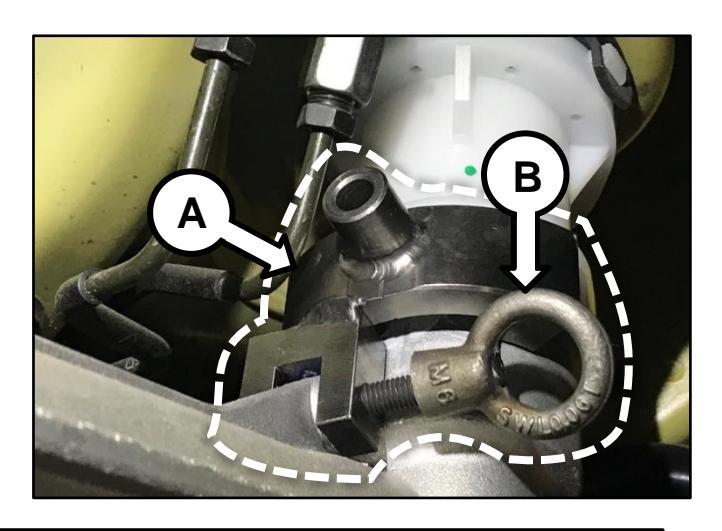
Install the drill-guide (A) onto the steering gear as shown, and tighten the Eye bolt (B) by hand. Confirm that drill-guide is secure and positioned properly.

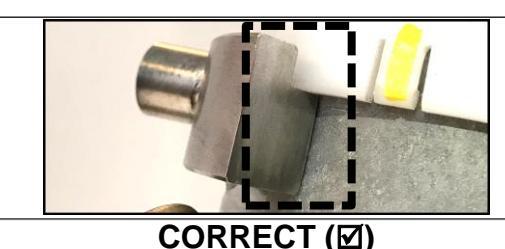
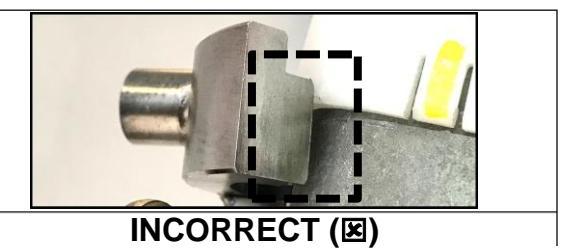
When positioning the drill-guide, ensure the drill-guide is flush with the steering gear and dust boot, as shown ( $\square$ ). Incorrect positioning of the drill-guide ( $\square$ ) will invalidate the entire repair.

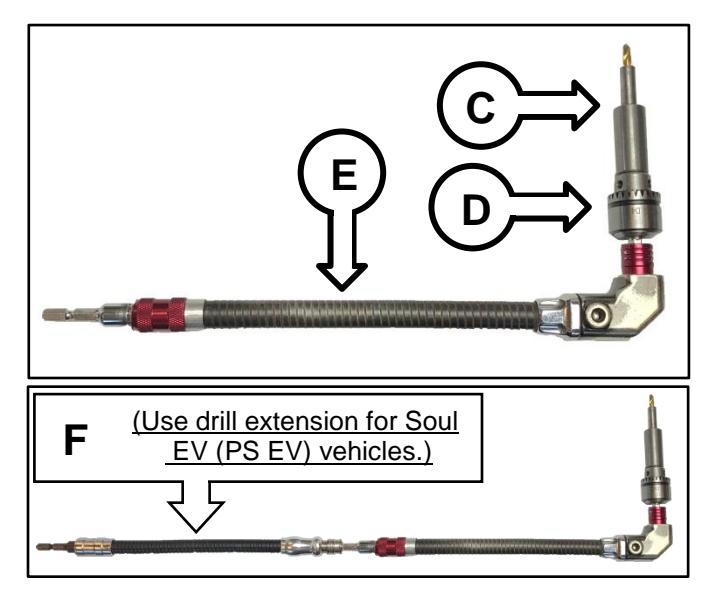
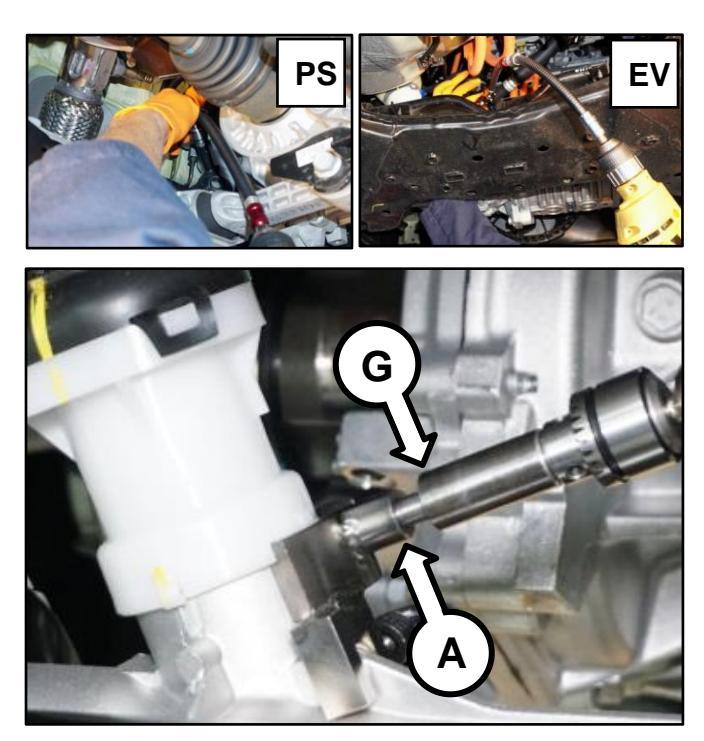
Prior to performing the next step, check the drill-stop depth (1<sup>3</sup>/<sub>8</sub> in / 35.1mm) using the drill-bit stop and setting gauge as shown below. Ensure the drill-bit is flush with the gauge. <u>Click here for video of drill-stop depth setting.</u>

Assemble the drill-bit and stop (C), chuck (D), and right angle drive (E), as shown. The extension (F) is to be used with Soul EV (PS EV) vehicles. Tighten the chuck securely to avoid drill bit of drill-head from moving deeper in the chuck.

- 3. Install the assembled drill-head, chuck, and drive onto a drill then insert the drillbit into the opening of the drill-guide. Use the provided extension as appropriate if drilling without the subframe lowered.
- With the drill set properly aligned with the drill-guide, apply even pressure to the drill-set to drill a hole into the steering gear. <u>At a low drill speed</u>, continue to drill until the shoulder of the drill-stop collar (G) sits flush against the body of the drillguide (A).

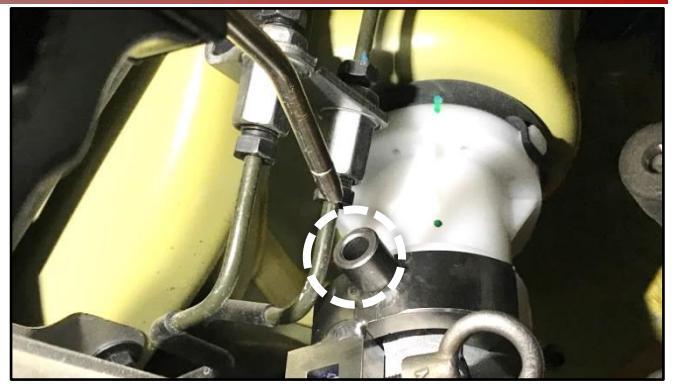
5. Use compressed shop air to remove any debris from inside the drilled hole.

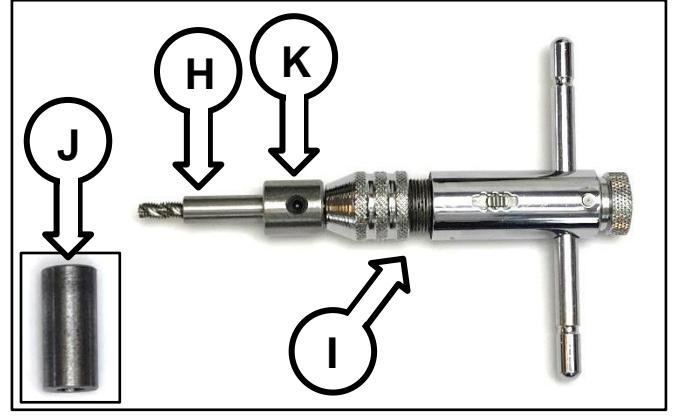
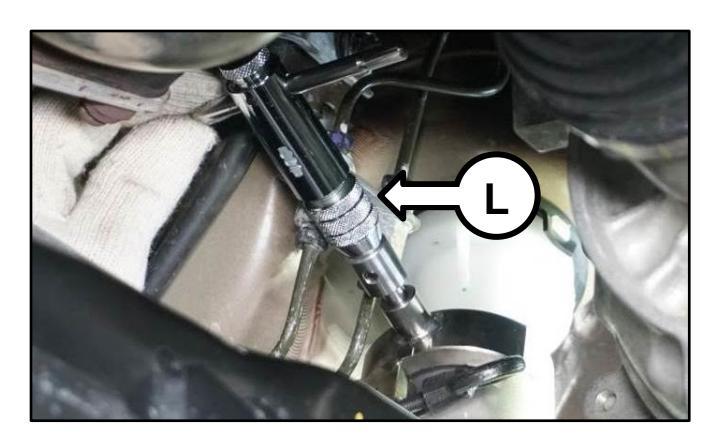
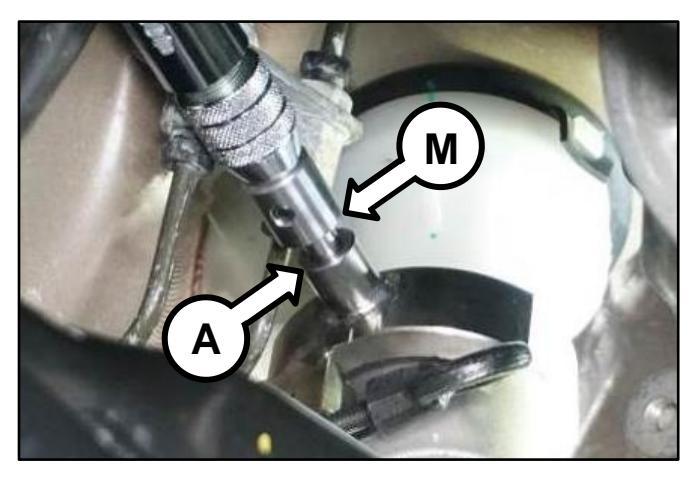
Insert the pre-assembled tap-head (H) into the tapping tool body (I), as shown.

**NOTE**: prior to tapping the hole, check the tap-stop collar depth setting (1<sup>3</sup>/<sub>8</sub> in. / 35.1mm) using the tap-stop and setting gauge (J) as shown below. Additionally, tighten the set screw (K) on the taphead, periodically.

7. Insert the assembled tapping tool (L) into the opening of the drill-guide, as shown.

Continue turning the tapping tool until the shoulder on the collar (M) is flush against the body of the drill-guide (A). <u>When</u> <u>flush, do not continue to turn as damage</u> to the thread and/or tool may result.

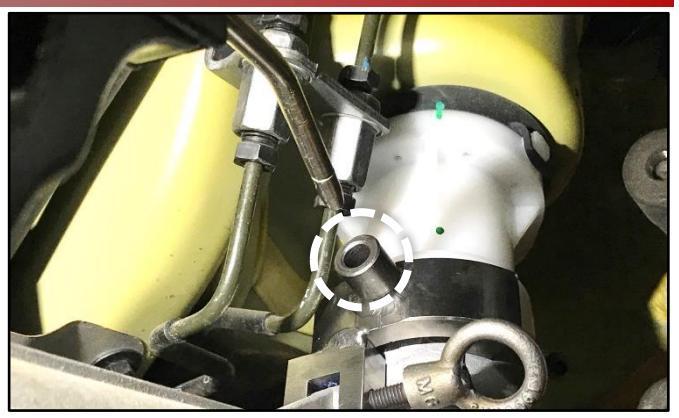
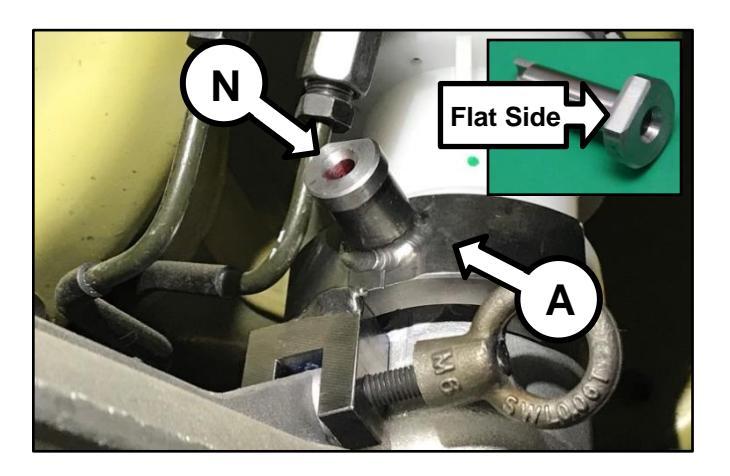
Install the set screw guide (N) into the drill-guide (A) with the flat side of the set screw guide facing upwards and ensure the set screw guide is flush with the drillguide.

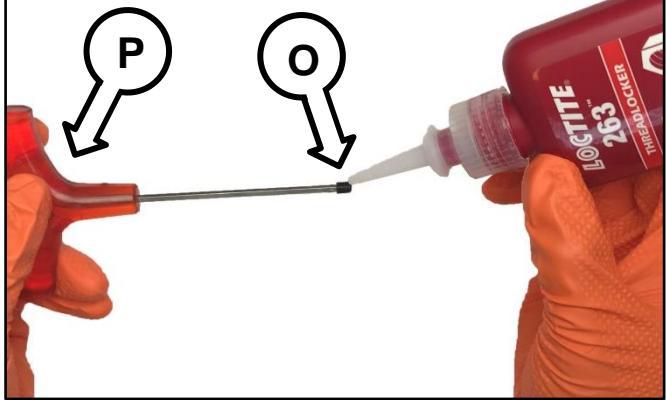
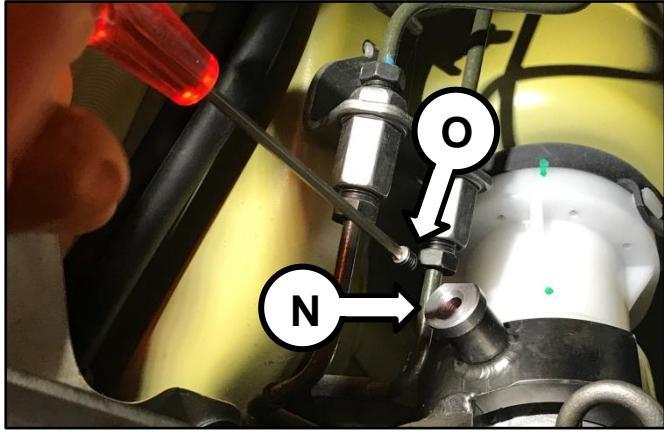
Place the provided set screw (O) on the end of the provided hex key wrench (P), as shown, and apply LOCTITE® 263 or equivalent <u>high strength threadlocker</u>.

12. Install the set screw (O) through the set screw guide (N) as shown and tighten by

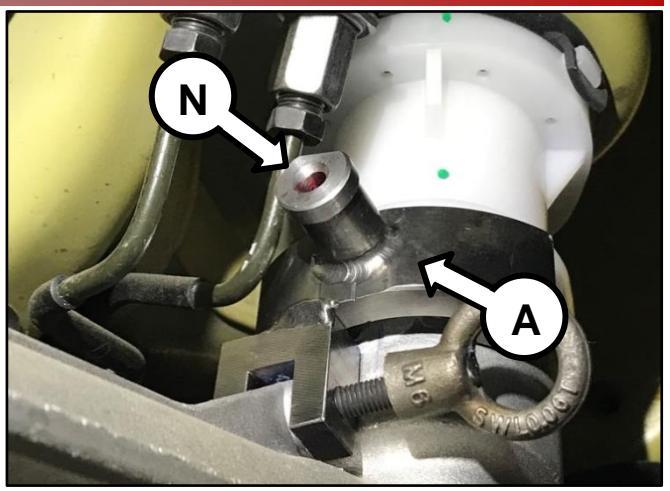
Once tight, remove the set screw guide (N) and drill-guide (A).

Proper installation of the set screw is critical! Improper installation may result in the pinion plug not being properly secured.

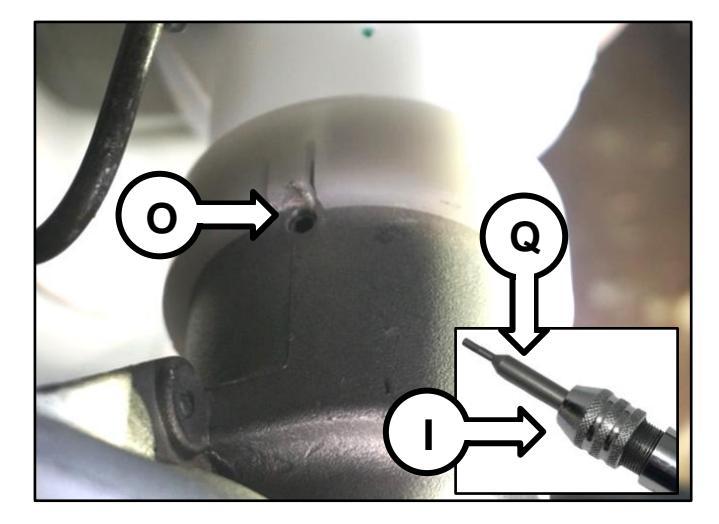
14. Once again, secure the set screw (O) with the wrench head (Q) attached to the tapping tool body (I). Ensure a thread of the tapped opening in the steering gear is shown. If a thread is not visible, uninstall the set screw, reinstall the drill-guide, then tap additional required thread (do not drill), and reinstall the set screw.

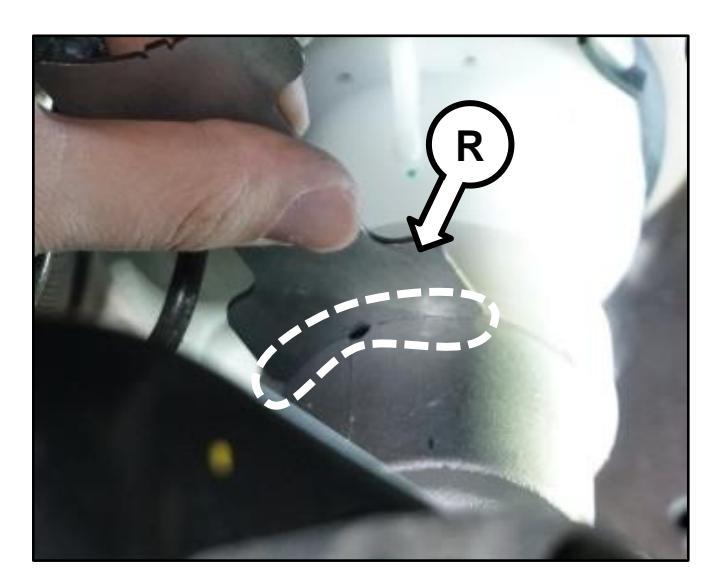
15. Using the <u>side</u> of the set screw depth gauge (R) without the notch, ensure the set screw is not protruding. Tighten the set screw using the hex key wrench, if necessary, and verify that the set screw is not protruding.

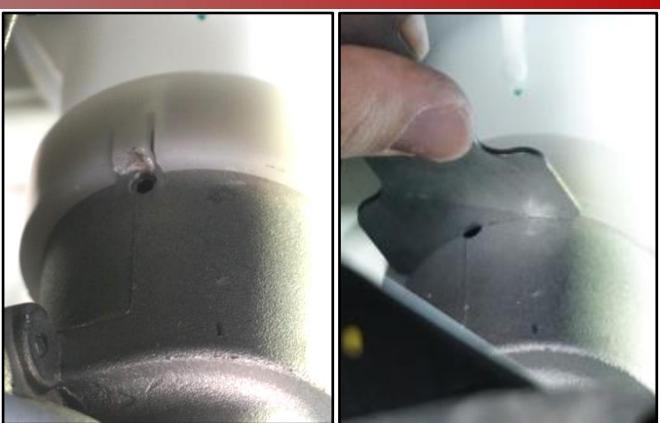
Take two (2) photos of the new installed set screw (using KVID, refer to page 19 of <u>KVID User Guide</u>) and attach them to the warranty claim (attachment type "XX: Other" in WebDCS). <u>See Appendix 1 on</u> page 16 for a guideline of positioning the depth gauge for photos.

Ensure the photos are <u>bright and clear</u> enough to distinguish an exposed thread (photo 1) and no gap between the gear assembly and side of the set screw depth gauge without the notch (photo 2). <u>Photo of the repair order is not required.</u>

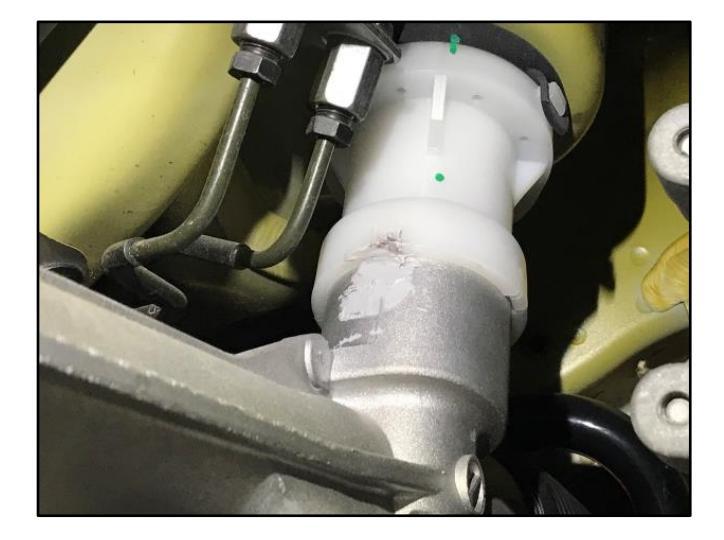
17. Seal the old (if applicable) <u>and</u> new set screw opening(s) with RTV silicone, as shown.

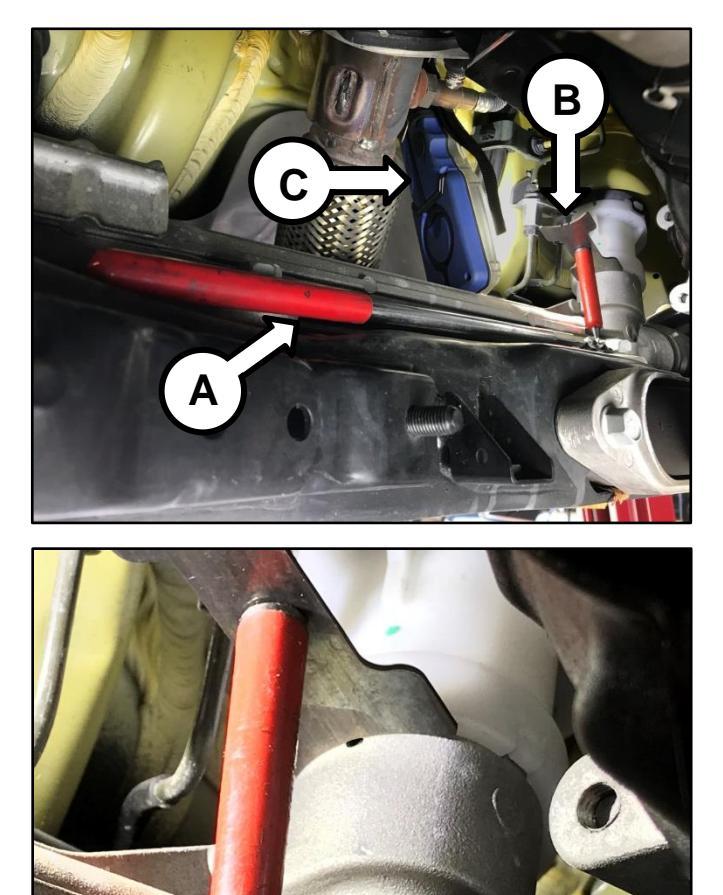
Sample Photo

- 1. Position a swivel telescopic magnet (A) or equivalent equipment, as shown, to hold the depth gauge (B) in position.
- 2. Set a flashlight or droplight (C) in place for better exposure of the depth gauge in position with no gap between the gear assembly and depth gauge.

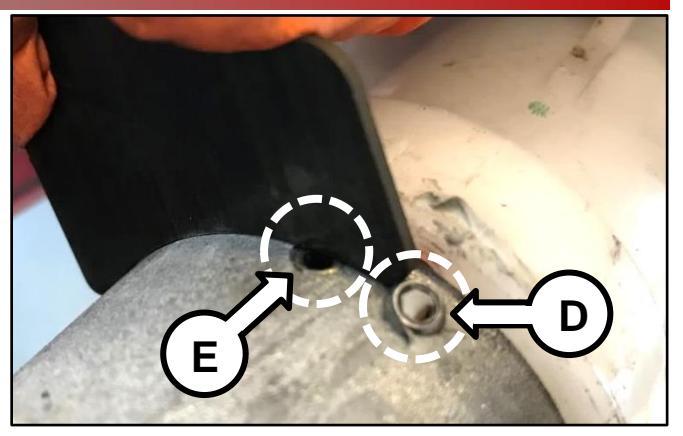
If the old set screw (D) is protruding, move the depth gauge away from the old set screw but still placed over the new set screw (E), as shown.

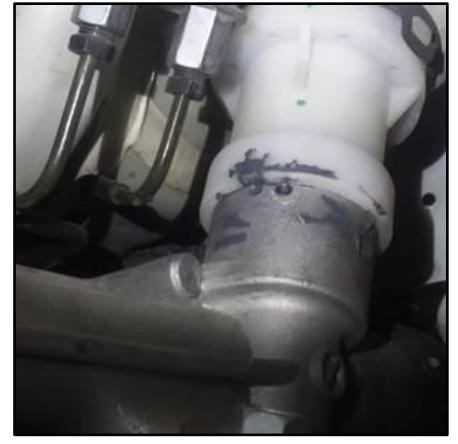
No Depth Gauge Shown

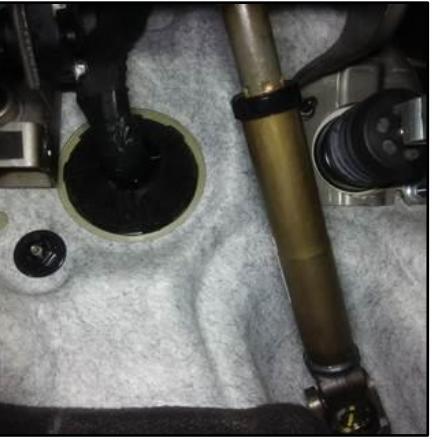
Wrong Component
