Dealer Service Instructions for:

Safety Recall T79 / NHTSA 17V-821 Brake Transmission Shift Interlock

2009 - 2017 (DS) RAM 1500 Pickup 2010 - 2017 (DJ) RAM 2500 Pickup 2010 - 2017 (D2) RAM 3500 Pickup 2011 - 2017 (DD) RAM 3500 Chassis Cab 2016 - 2017 (DF) RAM 3500 10K GVWR Chassis Cab 2011 - 2017 (DP) RAM 4500/5500 Chassis Cab

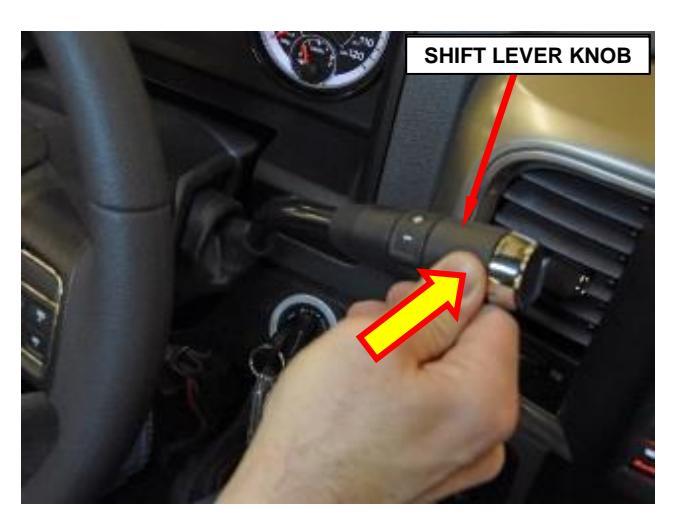
Figure 1 – Push Lightly On Shift Lever Knob Toward Instrument Panel To Feel BTSI Solenoid Pin Movement

- 5. Place your hand on the shift lever knob and push lightly on the shift lever toward the instrument panel. This will allow you to feel a click sensation from BTSI solenoid pin movement when the brake pedal is applied and released (Figure 1).
- 6. Listen for a click sound from the BTSI solenoid pin movement while also feeling for the corresponding click sensation in the shift lever when the brake is applied and released.

- 7. After you are familiar with both the sound and feel of the BTSI pin movement in **Steps 5 and 6**, continue with **Step 8**.
- 8. Place your hand on the shift lever knob as instructed in **Step 5** then apply and hold the brake pedal for a count of five seconds.

- 9. After five seconds of holding the brake pedal down, release the brake pedal while both listening and feeling for the click of the BTSI pin movement. The sound and feel of the BTSI pin movement should occur immediately within 0-2 seconds upon release of the brake pedal.

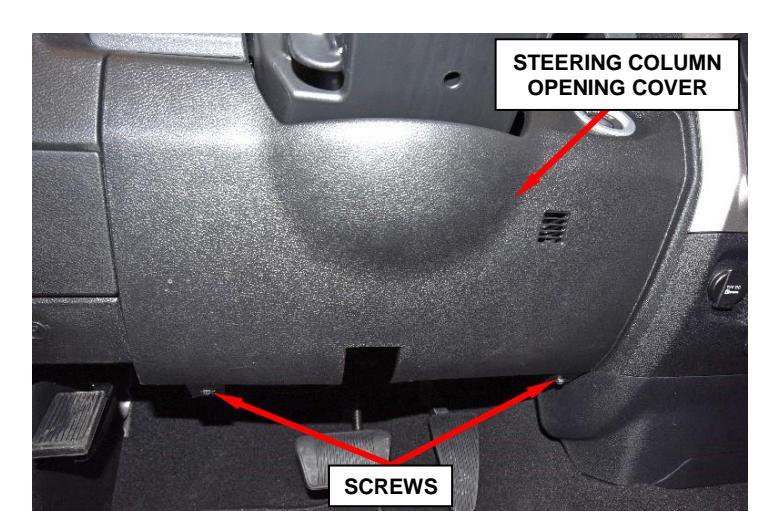
Figure 3 – Steering Column Opening Cover

- 4. Remove and save the two screws that secure the bottom of the steering column opening cover to the instrument panel (Figure 3).
- 5. Using a trim stick C-4775 or equivalent, release the eight spring clips that attach the steering column opening cover to the instrument panel (Figure 3)

- 43. Attach the steering column opening cover to the instrument panel with the eight spring clips (Figure 3).
- 44. Install the two screws that secure the steering column opening cover to the instrument panel. Tighten the screws to 3.6 N⋅m (32 in. lbs.) (Figure 3).

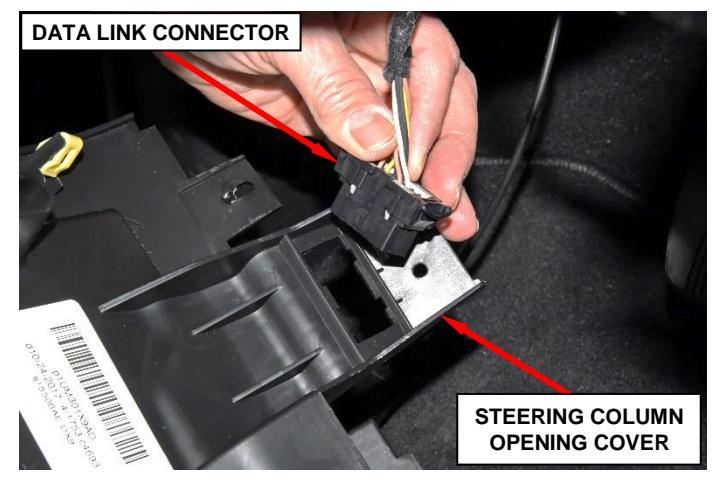
Figure 4 – Data Link Connector

6. Remove the data link connector from the steering column opening cover by pressing in the tabs and pushing the connector through the opening on the back side of the cover (Figure 4).

- 41. **If equipped:** Connect the electrical connectors for any electrical devices to the steering column opening cover.
- 42. Install the data link connector to the steering column opening cover by pushing the connector through the opening on the back side of the cover and fully engaging the lock tabs of the connector (Figure 4).

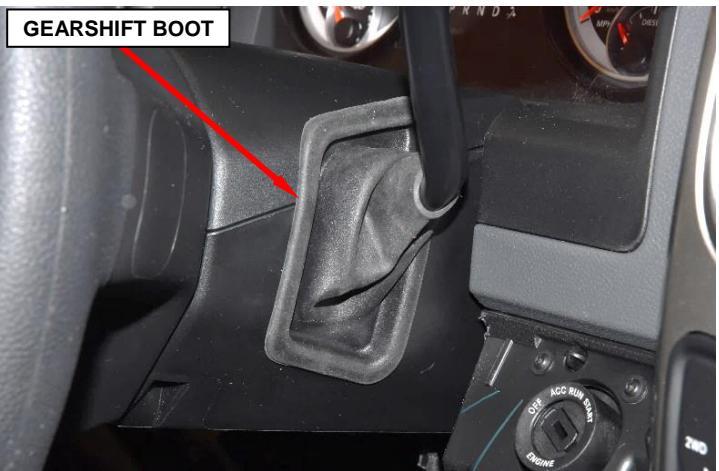
Figure 5 – Gearshift Boot

9. Using a trim stick, disengage the gearshift boot from the steering column shrouds (Figure 5).

- 40. Attach the shift boot to the upper and lower steering column shrouds (Figure 5).

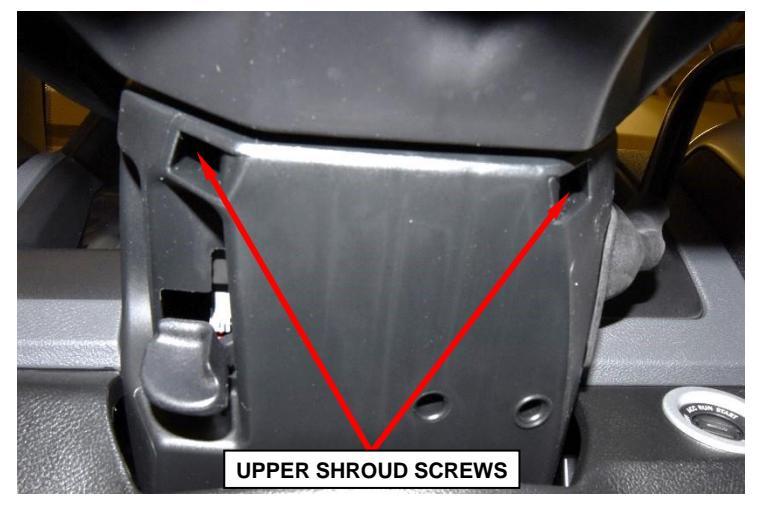
Figure 6 – Upper Shroud Screws

10. Remove and save the two T20 star-head screws that attach the upper steering column shroud to the lower steering column shroud. The screws are located on the underside of the lower steering column shroud (Figure 6).

- 39. Install the two T20 star-head screws that attach the lower steering column shroud to the upper shroud. Tighten the screws to 1.3 N⋅m (12 in. lbs.) (Figure 6).

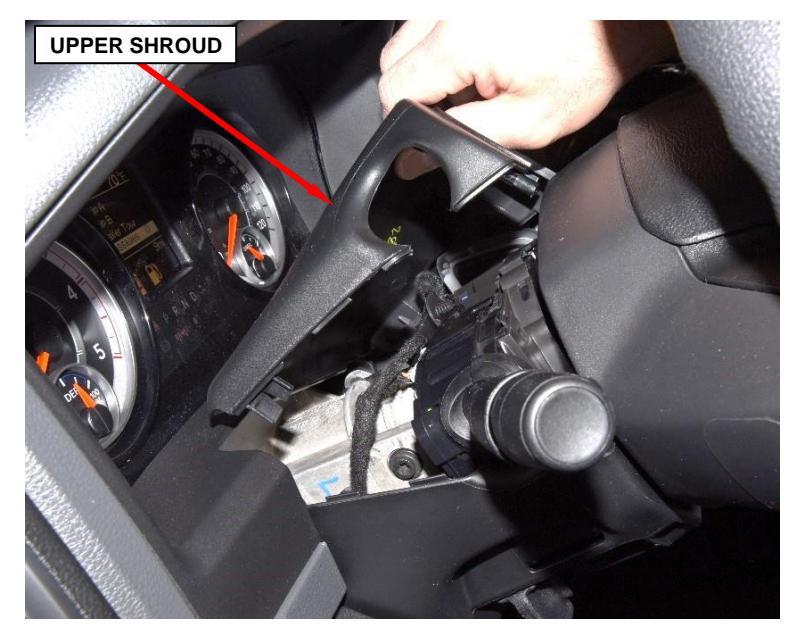
Figure 7 – Steering Column Upper Shroud

11. Remove and save the upper steering column shroud by pushing gently inward and upward on both sides of the upper shroud just above the joint line to the lower shroud to release the snap features that secure the shrouds together (Figure 7).

- 37. Install the T20 star-head screw that retains the lower shroud to the steering column. Tighten the screw to 2.3 N⋅m (20 in. lbs.) (Figure 8).
- 38. Attach the upper steering column shroud by pushing gently inward on both sides of the upper shroud just above the joint line to the lower shroud and attach to the lower shroud using the snap features (Figure 7).

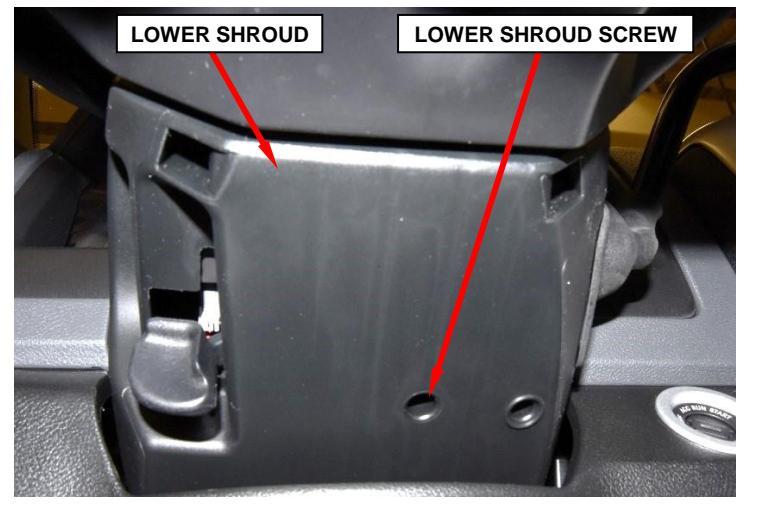
Figure 8 – Steering Column Lower Shroud

12. Remove and save the T20 starhead screw that retains the lower shroud to the steering column (Figure 8).

13. Carefully move the lower shroud to clear the steering column tilt lever then remove and save the lower shroud. (Figure 8).

- 35. Connect the shift cable to the gearshift bracket (Figure 9).
- 36. Carefully position the lower shroud over the steering column tilt lever and onto the steering column (Figure 8).

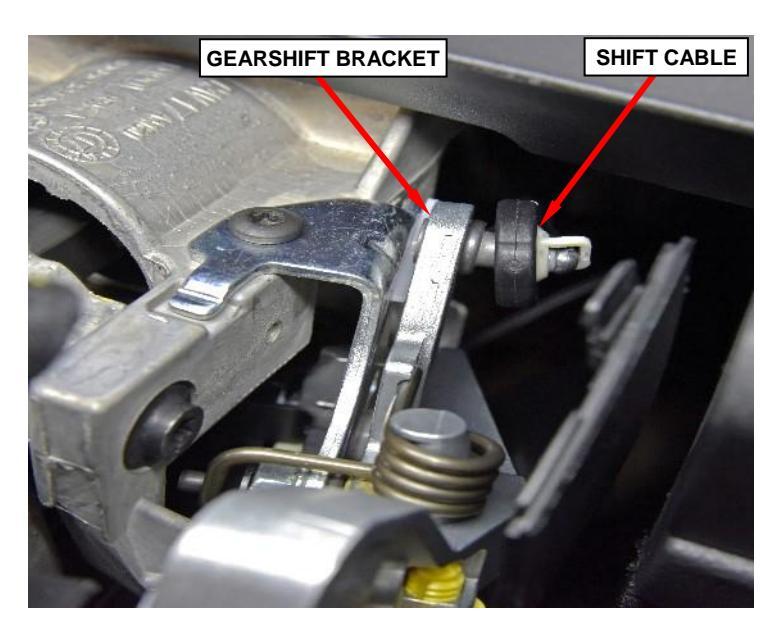
Figure 9 – Shift Cable

14. Disconnect the shift cable from the gearshift bracket (Figure 9).

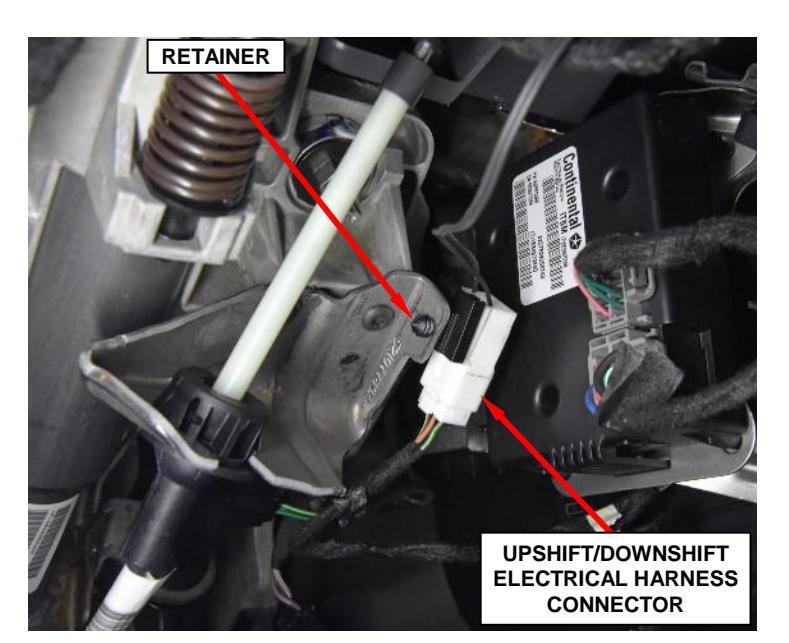
Figure 10 – Upshift/Downshift Electrical Harness

15. Disconnect the upshift/downshift electrical harness connector (Figure 10).

16. Release the upshift/downshift electrical harness connector retainer (Figure 10).

- 32. Connect the BTSI electrical harness connector (Figure 11).
- 33. Install the upshift/downshift electrical harness connector retainer (Figure 10).
- 34. Connect the upshift/downshift electrical harness connector (Figure 10).

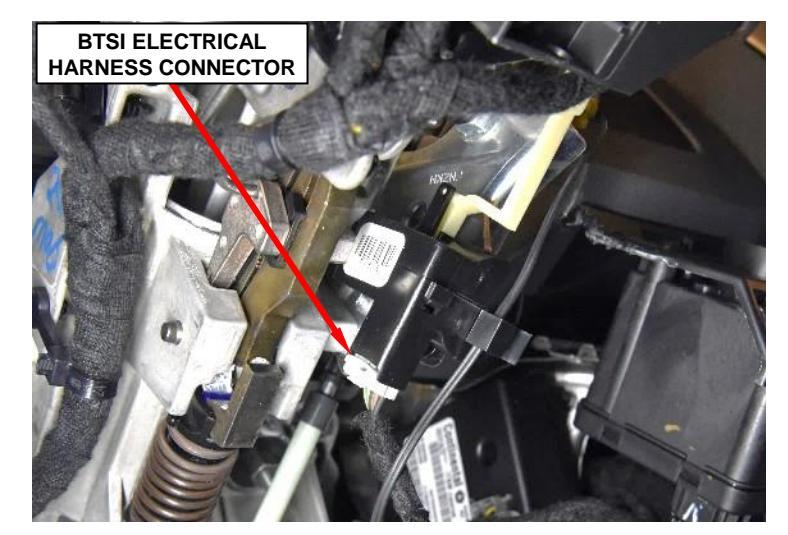
Figure 11 – BTSI Electrical Harness

17. Disconnect the BTSI electrical harness connector (Figure 11).

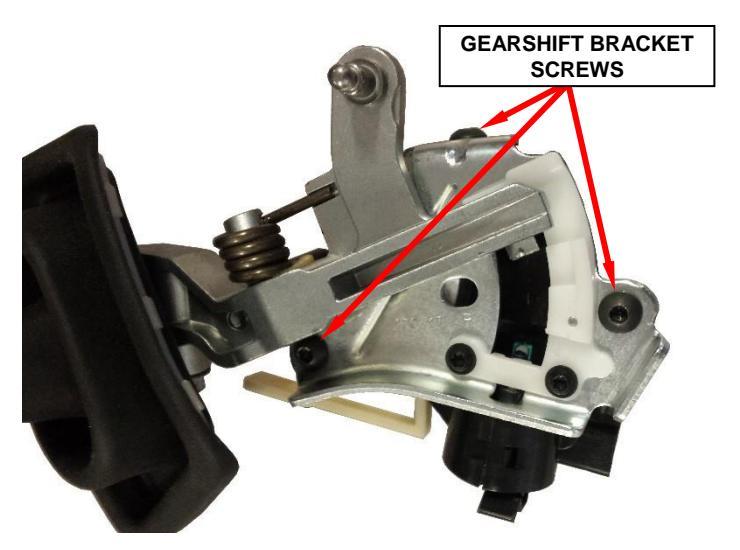
Figure 12 – Gearshift Bracket / BTSI Assembly Screws

- 18. Remove and save the three T27 star-head screws securing the gearshift bracket / BTSI assembly to the steering column (Figure 12).
- 19. Remove the gearshift bracket / BTSI assembly with shift lever from the steering column then transfer to bench (Figure 13).
- 20. Remove the upshift/downshift electrical harness from the retaining clip (Figure 13).
- 21. Release the upshift/downshift electrical harness retainer from the gearshift bracket / BTSI assembly (Figure 13).
- 22. Remove and save the E10 starhead pinch bolt securing the shift lever to the gearshift bracket / BTSI assembly (Figure 13).
- 23. Remove and save the gearshift lever from the gearshift bracket / BTSI assembly (Figure 13).

- 31. Install the three T27 star-head screws securing the gearshift bracket / BTSI assembly to the steering column. Tighten the screws to 10 N⋅m (89 in. lbs.) (Figure 12).

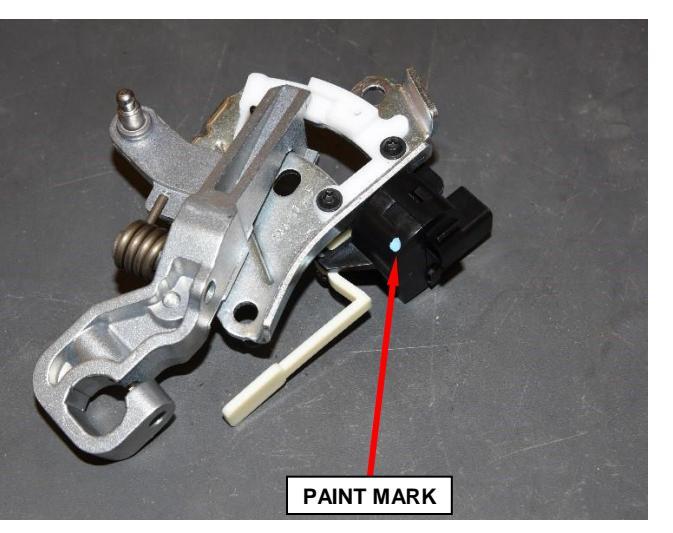
Figure 14 – Gearshift Bracket / BTSI Assembly Paint Mark Verification

- 24. Discard the old gearshift bracket / BTSI assembly.
- 25. Verify the **new** gearshift bracket / BTSI assembly to be used has a paint mark on the BTSI solenoid (Figure 14).
- 26. Install the gearshift lever to the **new** gearshift bracket / BTSI assembly and ensure the gearshift lever is fully inserted into the gearshift bracket (Figure 15).

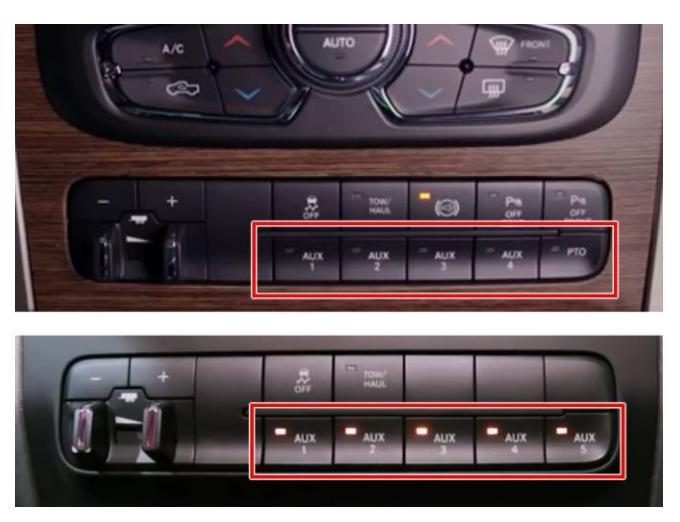
Figure 16 – Auxiliary Switches

NOTE: If the vehicle is equipped with instrument panel mounted auxiliary switches located below the HVAC controls (AUX 1 through AUX 5 or PTO), the customer preferred switch settings may be erased during reprogramming of the BCM. It is advisable to record the customer preferred auxiliary switch settings prior to BCM reprogramming that SO the customer preferred switch settings are not lost during the BCM reprogramming process.
