SuperSport Model Year 2017-2018 (All Model Versions)

NHTSA Campaign I.D. Number: 18V-793 Transport Canada Safety Recall I.D. Number: 2018623

CR166 – Replacing the Rear-View Mirrors Safety Recall Campaign SRV-RCL-18-005 SuperSport Model Version

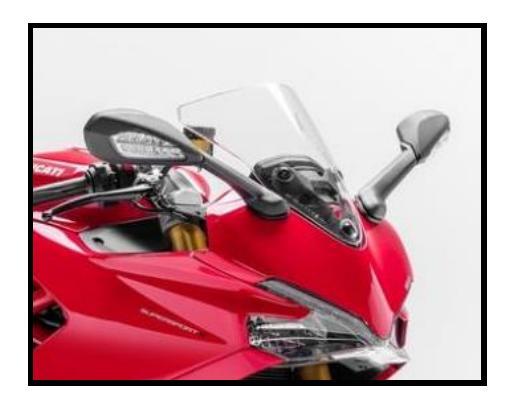
Ducati's ongoing quality testing combined with customer feedback have identified a potential problem of visibility with the rear-view mirrors installed on the above-indicated model. Under certain conditions, due to a combination of vehicle speed and engine RPM, vibration can result in poor visibility of the reflected image in the mirrors.

Ducati has elected to change both rear-view mirrors installed to the motorcycles affected by this Campaign. The new rear-view mirrors have been redesigned to improve visibility in the above conditions.

To implement this change, your authorized Ducati dealer will install Kit part no. 69928761A, which includes new RH and LH rear-view mirrors.

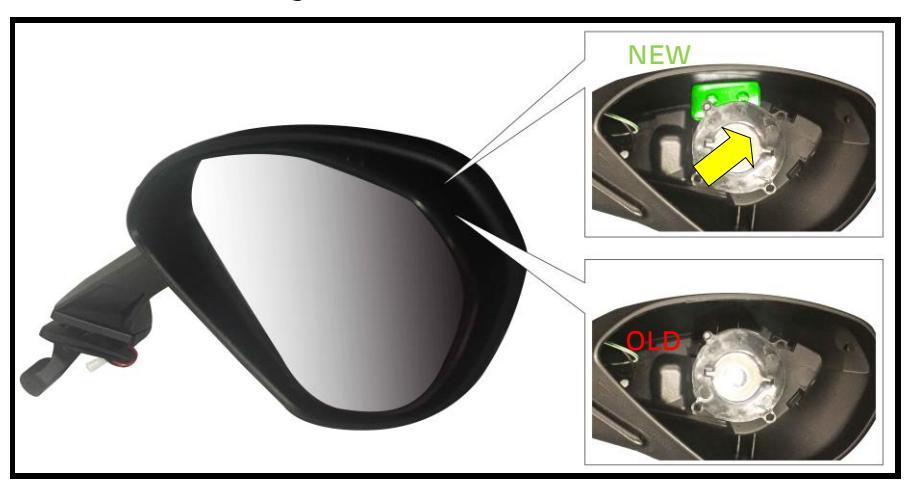
The new rear-view mirrors can be identified because they feature a reinforcement plate behind the mirror, as shown in the figure.

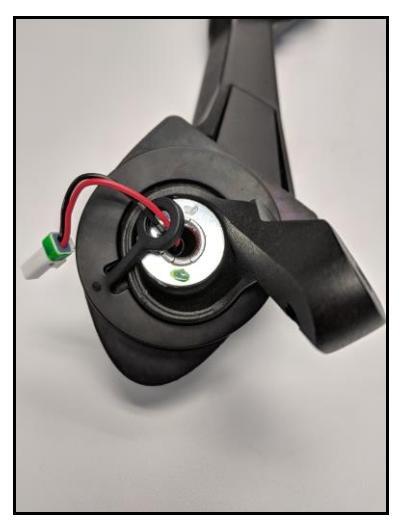
1. Mark the new mirrors at the base of the pivot bolt and on the connector with a **green** paint line to denote the mirrors are the revised part number. This will be visible after assembly.

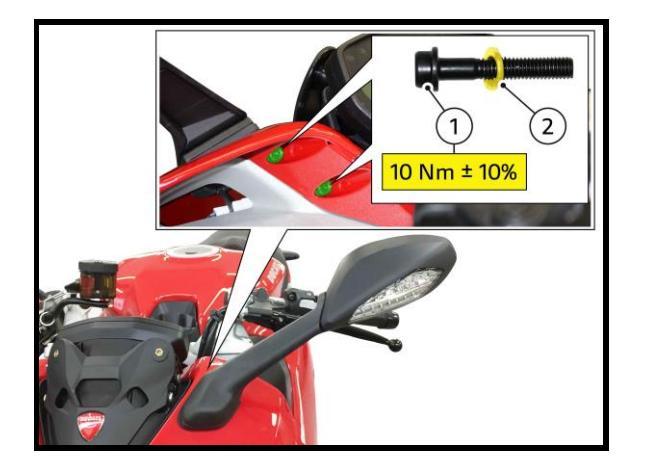
Tighten the 4 screws M6x35 (1) with washers (2) for RH and LH mirrors to 10 Nm ± 10%

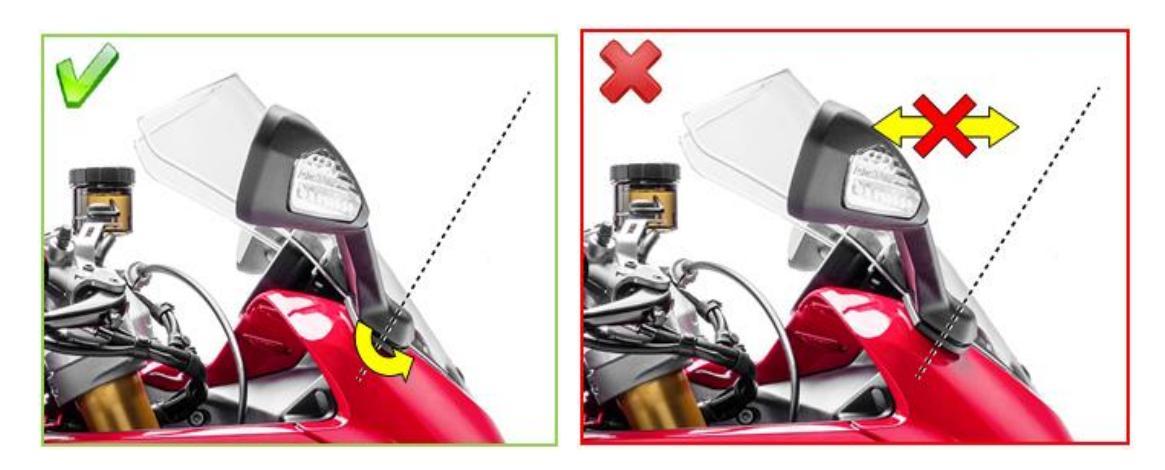
The rear-view mirror opening/closing operation must be performed by applying a force perpendicular to the rotation axis of the mirror on its support. It is important to pay attention while rotating the mirror on its axis not to apply a longitudinal or transversal force.
