Vehicle Alignment Clarification

Safety Recall V06 / NHTSA 19V-021 **Drag Link**

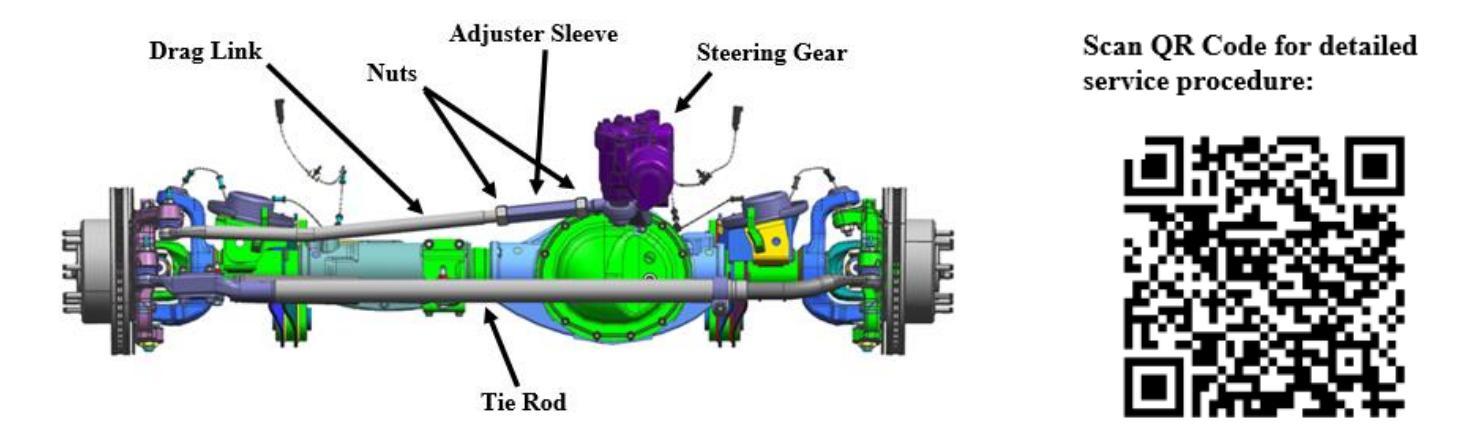
Description of how an alignment is performed after the drag link is welded:

Drag Link: The nuts on the drag link are welded to the adjuster sleeve during the recall procedure.

Steering Wheel/Steering Gear: When starting the alignment process, the dealer will center the steering wheel and then lock it to hold the steering wheel on center.

Tie Rod: With the drag link nuts welded and the steering wheel/steering gear locked on center, the dealer will adjust the tie rod to align the wheels to the steering wheel.

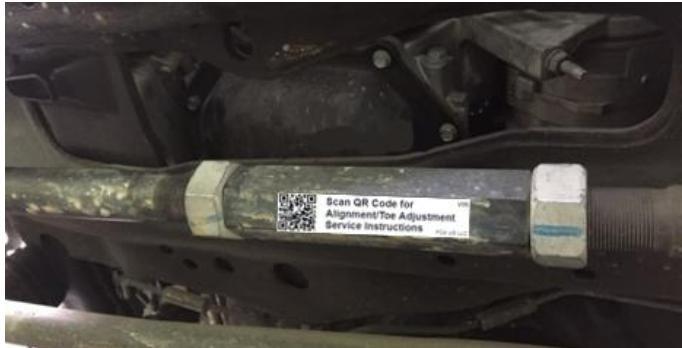
Apply provided label to drag link adjuster sleeve for reference during vehicle alignment. (Prior to applying label, ensure surface has been cleaned and is fully dry.)

Label 1: Remove label from backing and apply to drag link adjuster sleeve for reference during vehicle alignment.

Prior to applying label, ensure surface has been cleaned and is fully dry.
