GROUPNUMBERCAMPAIGN20-01-019HDATEMODEL(S)April, 2020Sonata (DN8)
Nexo (FE)

Technical Service Bulletin

2020MY SONATA AND 2020MY NEXO REMOTE SMART PARKING ASSIST (RSPA) CONTROL LOGIC IMPROVEMENT (RECALL CAMPAIGN 191)

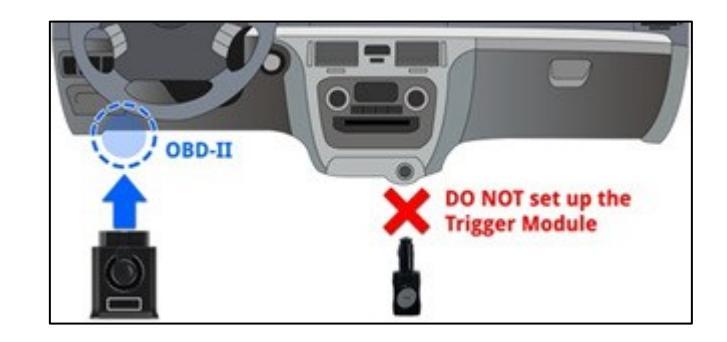
- Do not start the engine during update.
- Do not turn off the ignition switch during update unless specifically directed by the GDS Mobile.
- 1. Connect the VCI-II into the vehicle's DLC connector under the driver's side instrument panel.

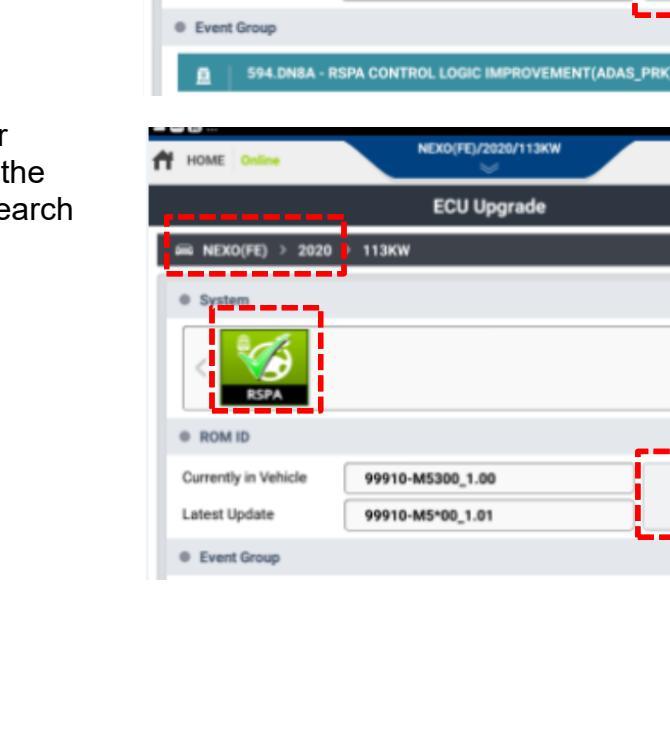
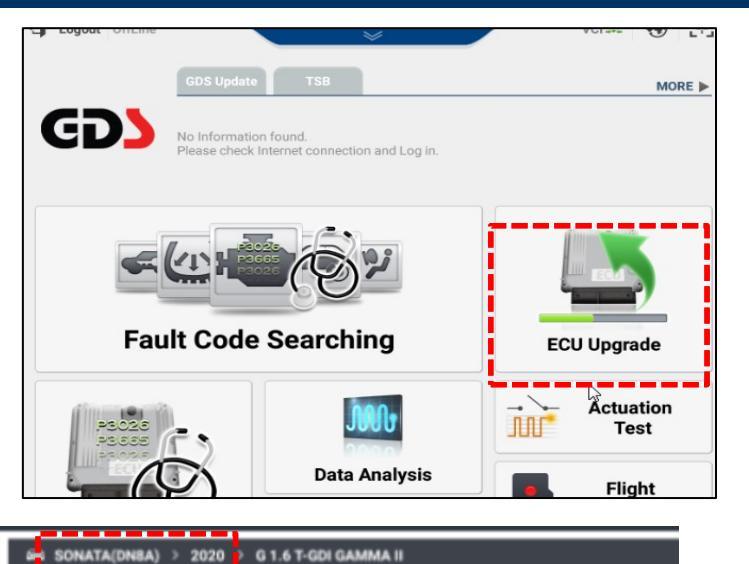
a. For Sonata (DN8) vehicles: Under 4. System, select ADAS_PRK to update the ECU. Then select ID Check to search for available updates.

> b. For Nexo (FE) vehicles: Under System, select RSPA to update the ECU. Then select **ID Check** to search for available updates.

ADAS_PRK	ENGINE	>
ROM ID		
Currently in Vehicle	99910-L0000_1.01	ID Church
Latest Update	99910-L0000_1.03	10 Check
Event Group		TSB
0 594.DN8A - 1	RSPA CONTROL LOGIC IMPROVEMENT(ADA	S_PRK)
_		
HOME Online	NEX0(FE)/2020/113KW	vci 🕿 😽 🕃
	ECU Upgrade	
📾 NEXO(FE) > 2020	> 113KW	
System		
<		>
ROM ID		
Currently in Vehicle	99910-M5300_1.00	ID Church
Latest Update	99910-M5*00_1.01	ID Check

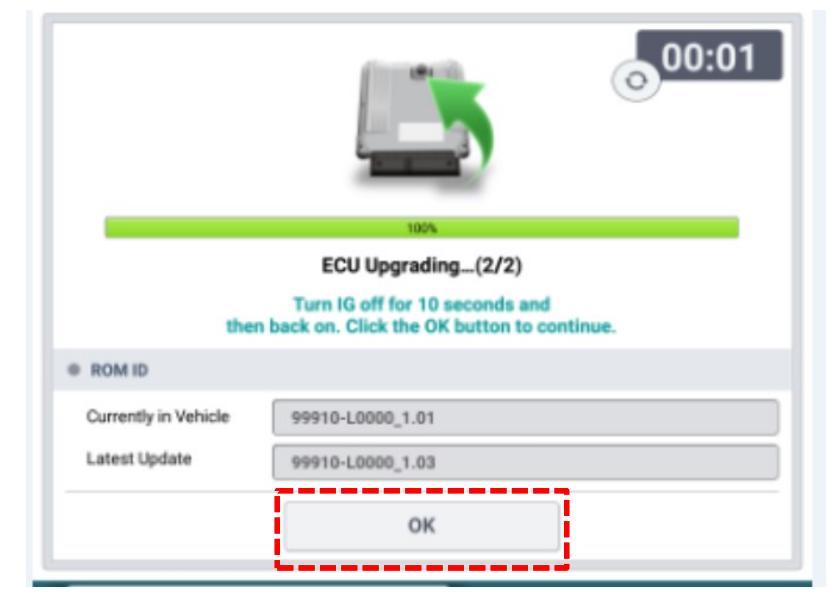
5. Confirm the ROM IDs match those in the ROM Information table for the respective vehicle. Select the event under **Event Group** and then select **Upgrade** to start the update.

> The update is performed in two parts. Follow the prompts on the GDS to complete the update.

SONATA(DN8A) >	2020 > G 1.6 T-GDI GAMMA II	
System		
		>
ROM ID		
Currently in Vehicle	99910-L0000_1.01	ID Check
Latest Update	99910-L0000_1.03	in chick
Event Group		TSB
A 594.DN8A -	RSPA CONTROL LOGIC IMPROVEMENT(ADAS_I	PRK)

After updates 1/2 and 2/2 are performed, follow the prompts and turn the ignition to Key Off position for 10 seconds. Then select OK to continue.

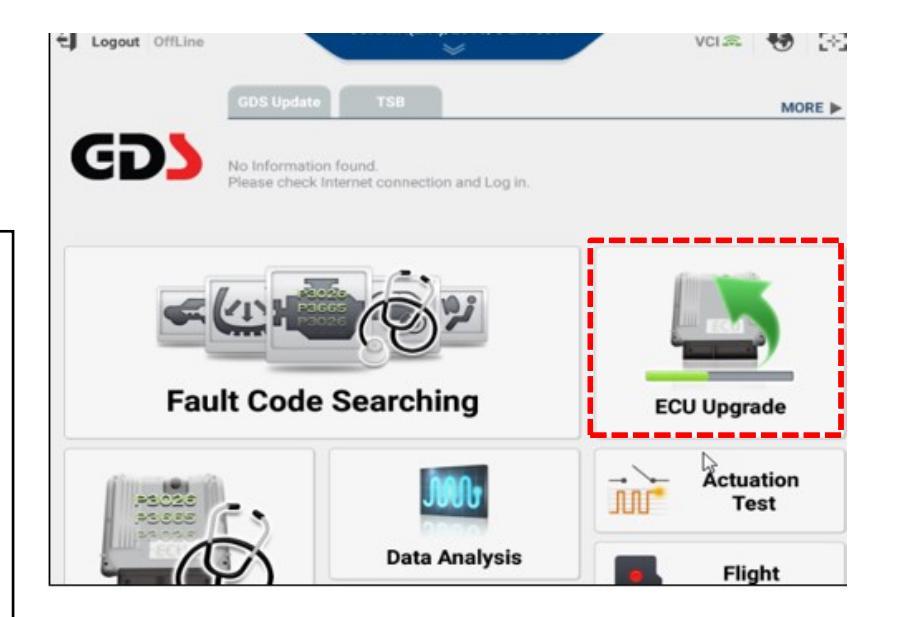
2. a. For **Sonata (DN8)** vehicles: Under **System**, select **ADAS_PRK** to update the ECU.

Select the appropriate update by referencing the ROM ID Information tables above and password tables below. Select **Upgrade** and follow the prompts on the GDS to complete the update.

b. For **Nexo (FE)** vehicles: Under **System**, select **RSPA** to update the ECU.

Select the appropriate update by referencing the ROM ID Information Tables above and password tables below. Select **Upgrade** and follow the prompts on the GDS to complete the update.

ECU Upgrade	P
📾 SONATA(DN8A) > 2020 > G 1.6 T-GDI GAMMA II	
System	
	>
Event Group	TS8
594.DN8A - RSPA CONTROL LOGIC IMPROV	EMENT(ADAS_PRK) 🗊
DN8A RSPA 99910-L0000

ECU Upgrade	-
🖴 NEXO(FE) > 2020 > 113KW	
• System	>
Event Group	TSB
595.FE - RSPA CONTROL LOGIC IMPROVEMENT FE RSPA 99910-M5300/400	Ŧ
