Keystone RV Company

SAFETY ADVISORY # 20-385

Fuzion Fuel Tank Bolts

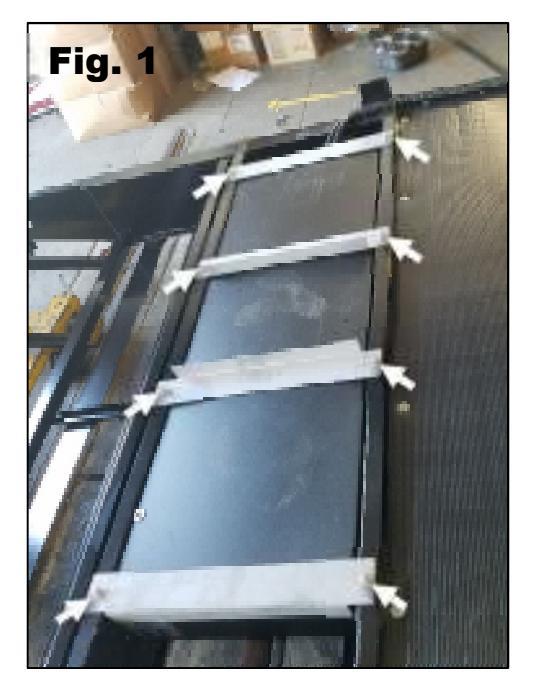
Locate the auxiliary fuel tank(s) in the rear of the unit, Figure 1, inspect the bolt heads. Grade 2 bolts have no hash marks on the head, grade 5 bolts have 3 hash marks on the head. <u>Replace all grade 2 bolts</u> (torque to 23 ft/lbs). If grade 5 bolts are found to be installed proceed to warranty reimbursement, no further repairs needed. Figure 2

The remedy is to support the auxiliary fuel tank support straps and remove the eight (per tank) grade 2 bolts, if equipped, and replace them with grade 5 bolts (torque to 23 ft/lbs). Nuts and washers can be reused.

Using a floor jack properly support the tank and replace one bolt at a time.
